**325 GILES BLVD W – OTR 21-316155**

Date of Inspection: July 14, 2021

Date OTR Issued: July 20, 2021

Date of Follow Up Inspection: September 30, 2021

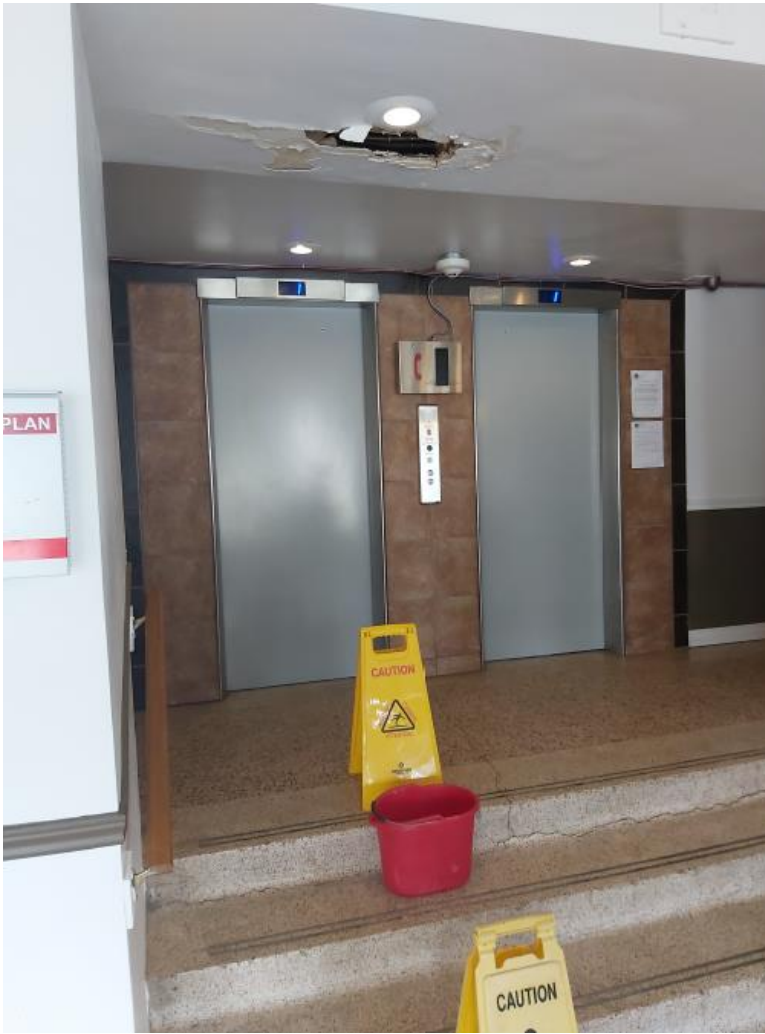
1. Water infiltration in lobby.

Engineer's report and permits for repairs due to:

- Water infiltration throughout building - NO ACTION TAKEN.
- Deteriorated concrete structure in underground parking garage and associated areas - NO ACTION TAKEN.
- Deteriorated balconies throughout building - NO ACTION TAKEN.
- Masonry facade cracking observed from exterior - NO ACTION TAKEN.

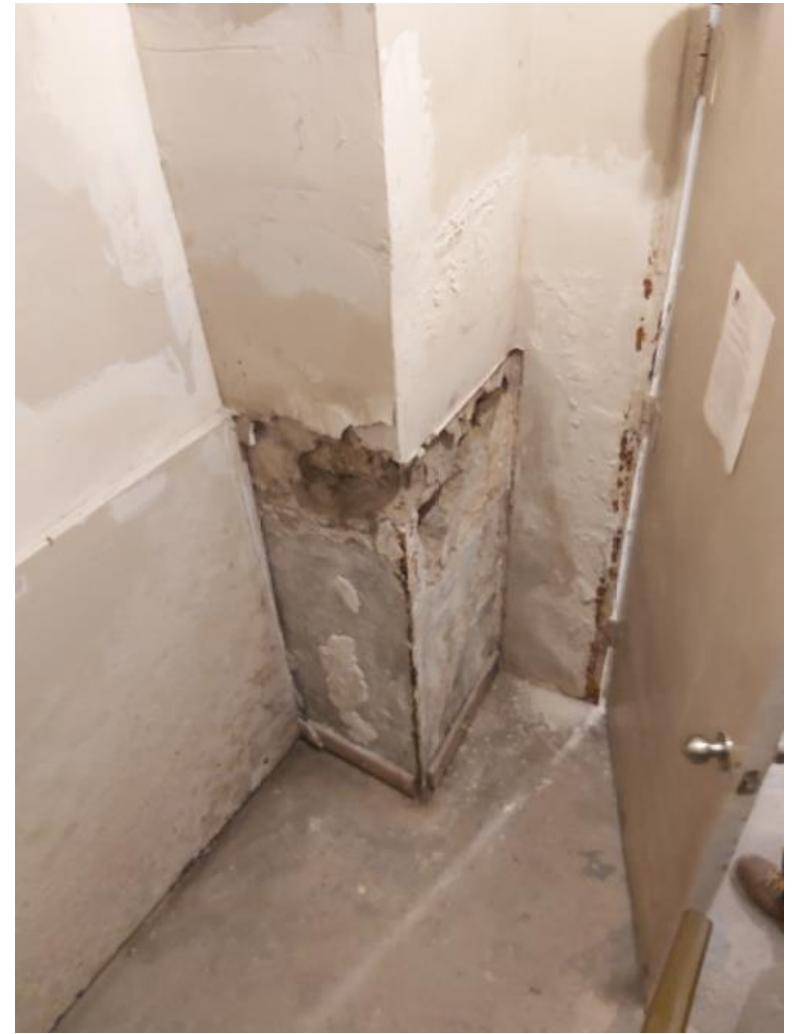
2. Concrete column delamination in stair well.

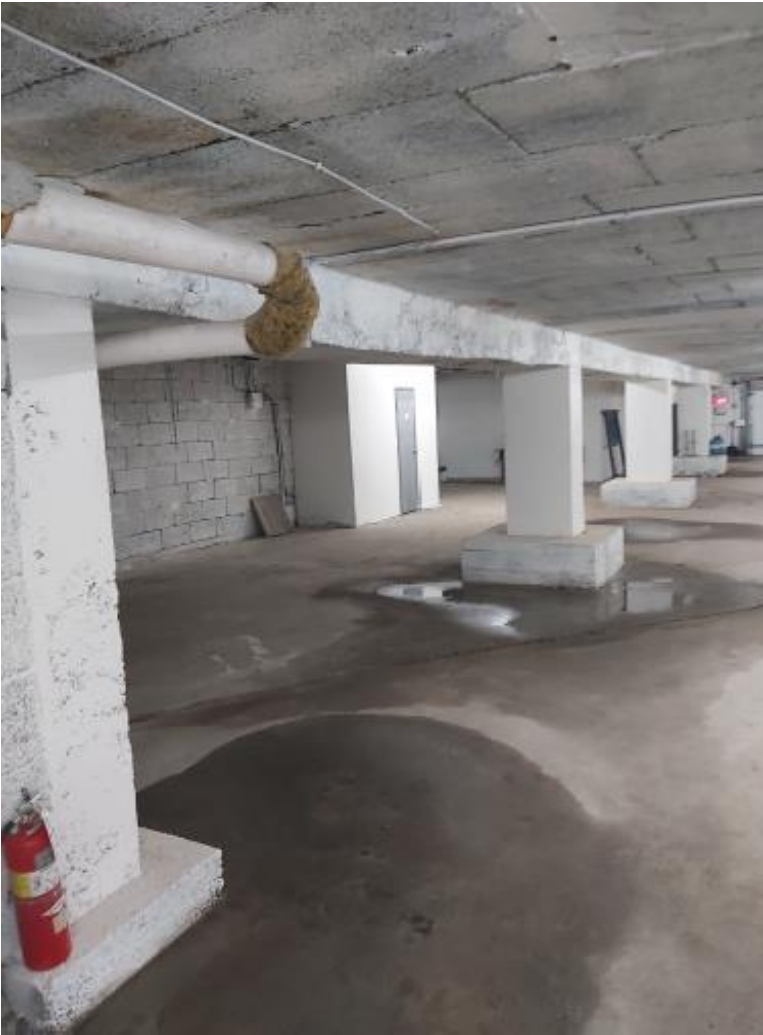
3. Condition of underground parking garage.

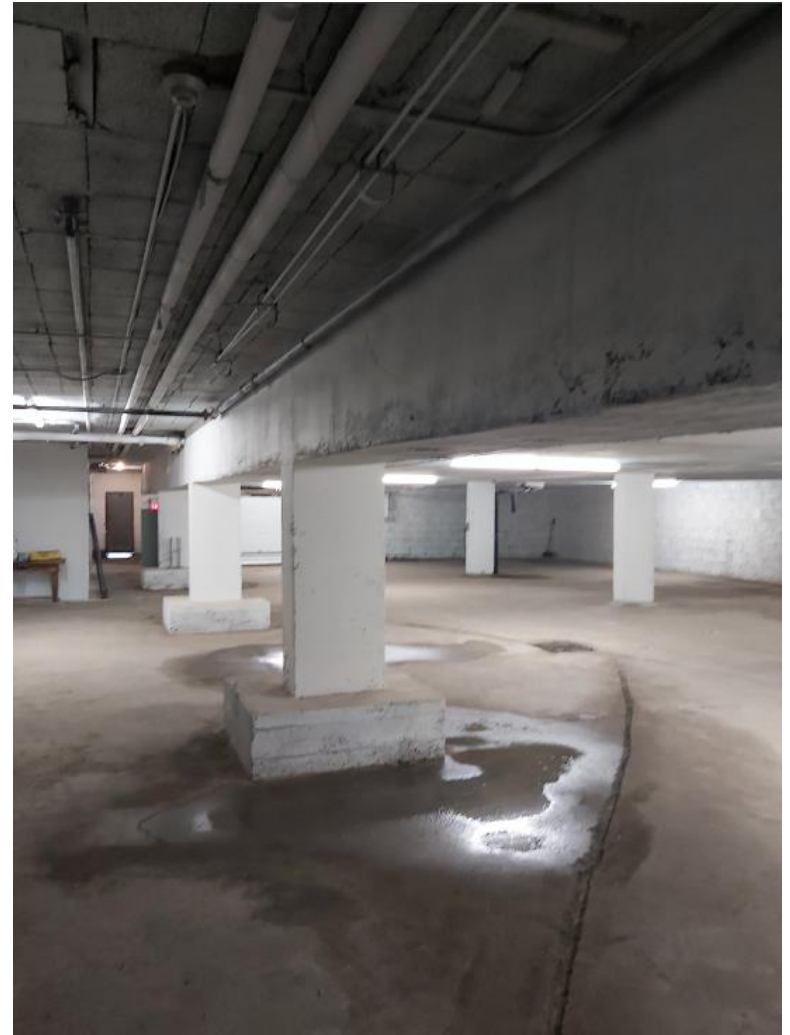
4. Condition of underground parking garage.

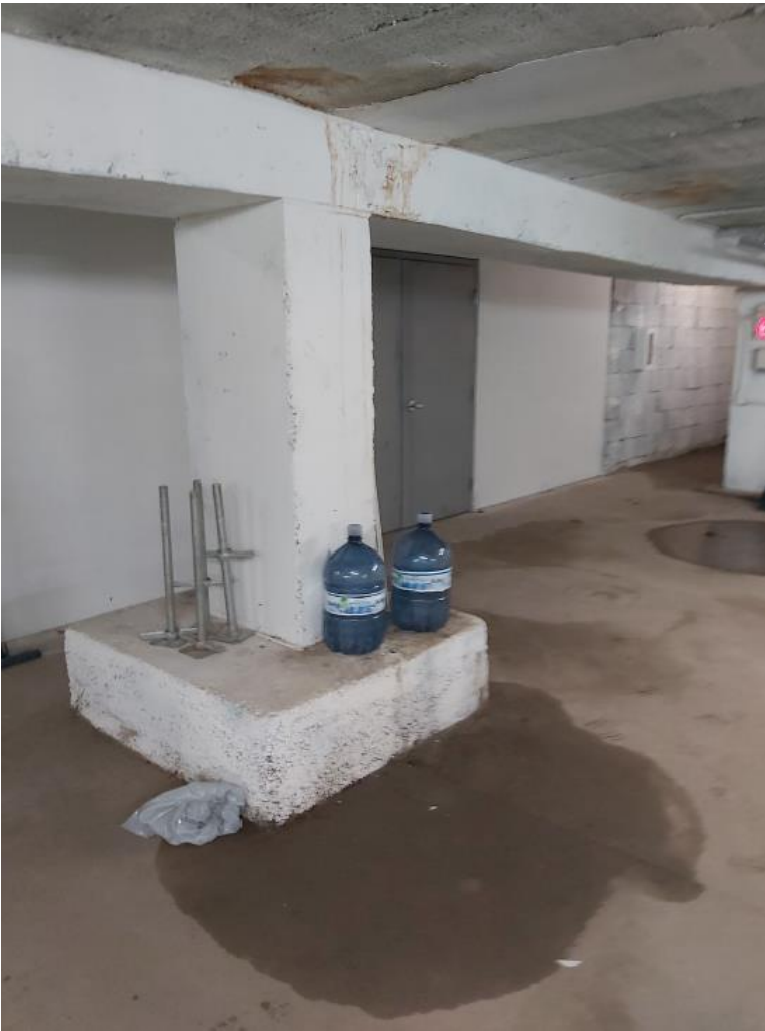
5. Water infiltration in underground parking garage.

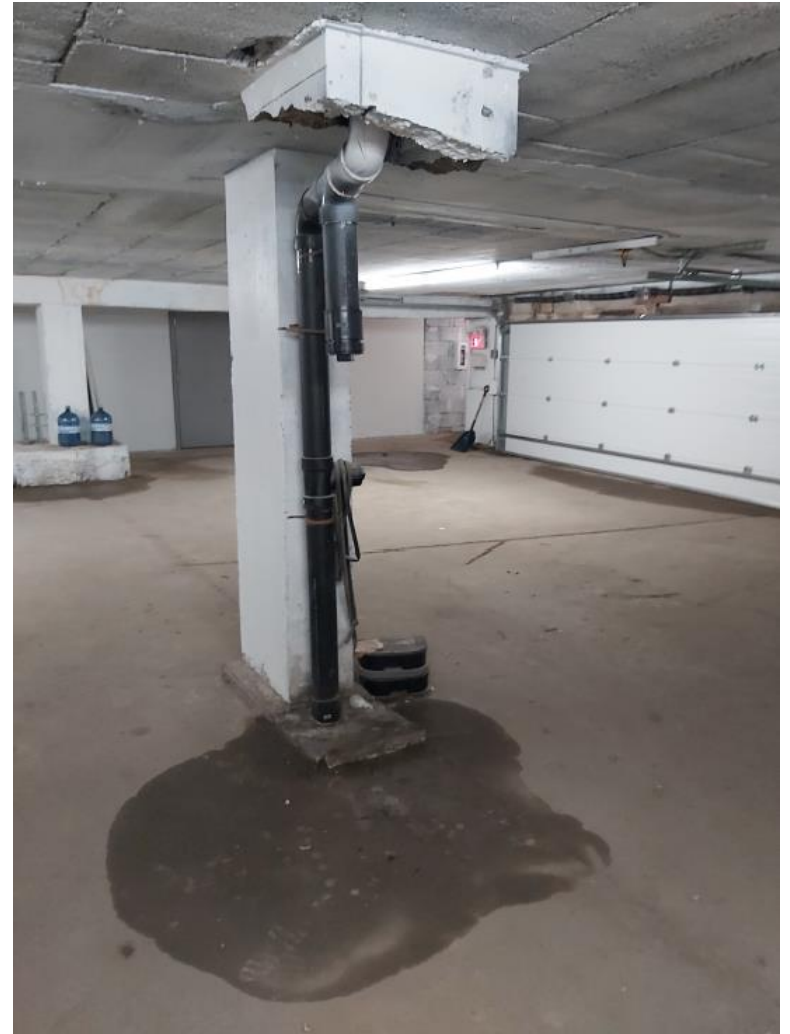
6. Water infiltration in underground parking garage.

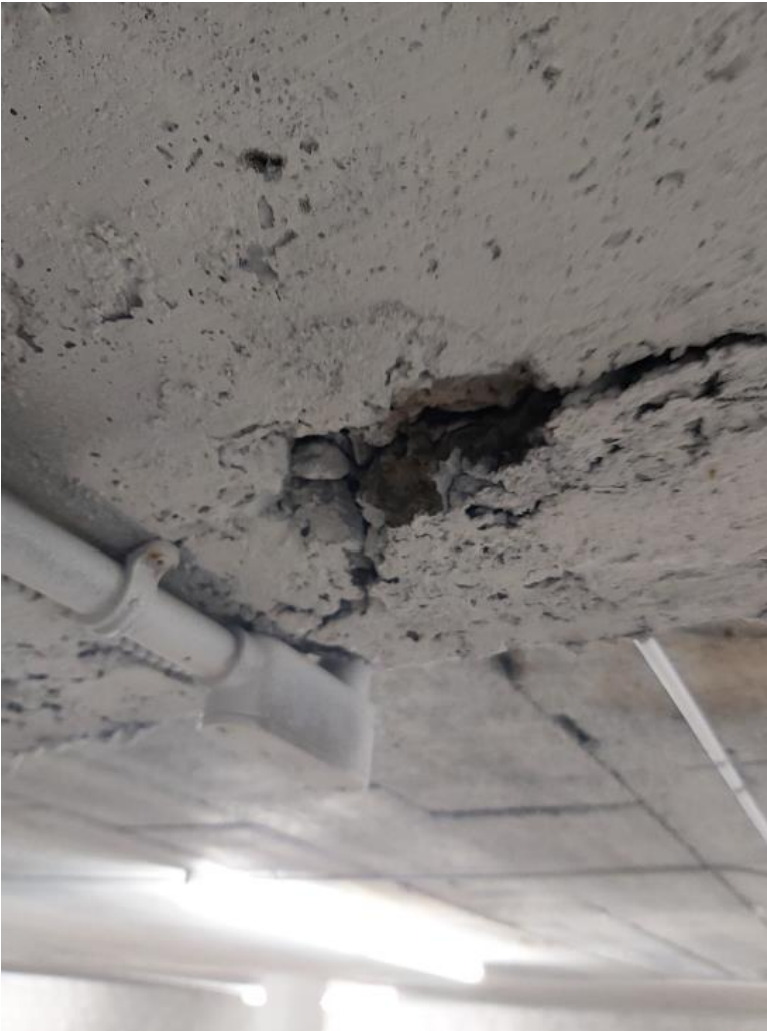
7. Close up of affected concrete structure.

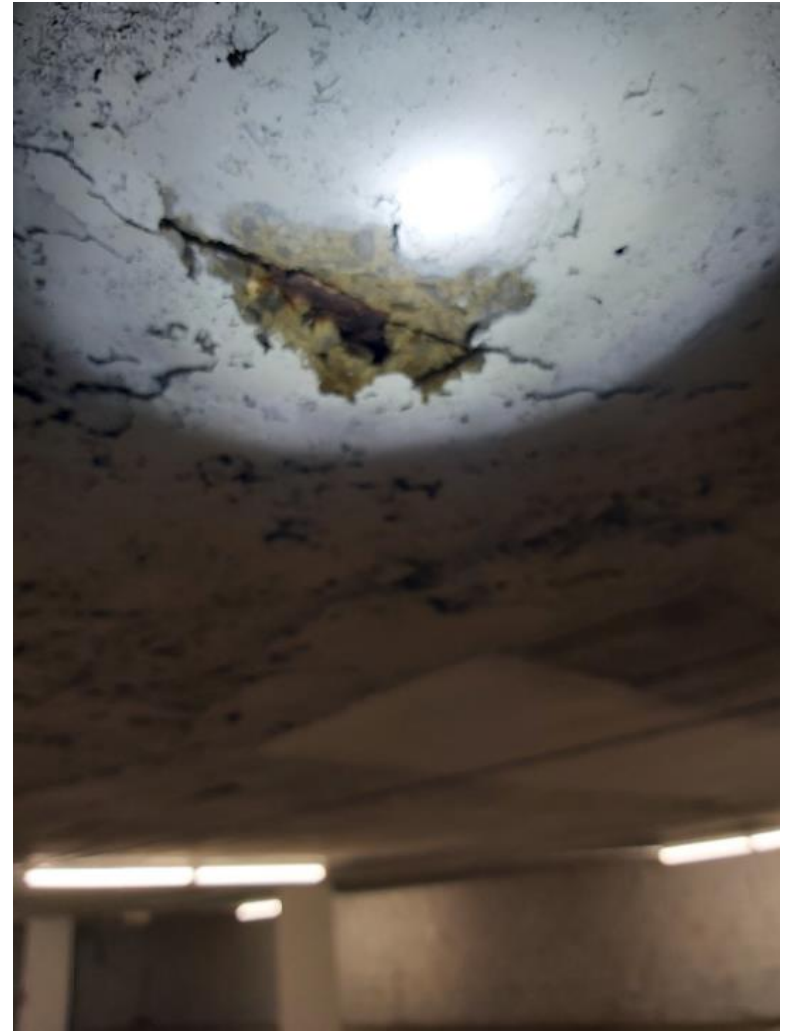
8. Close up of affected concrete structure.

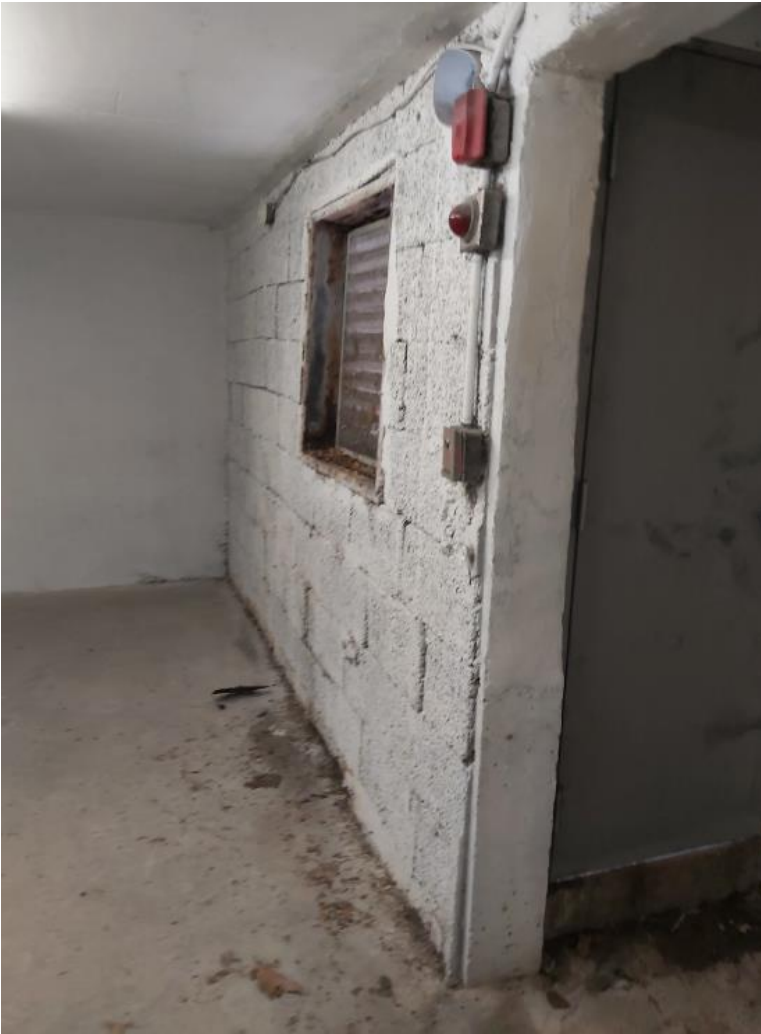
9. Defective exhaust system and defective door from interior.

- Repair / replace defective exterior doors - NO ACTION TAKEN.

- Obtain permits for repairs to defective underground garage mechanical exhaust system - NO ACTION TAKEN.

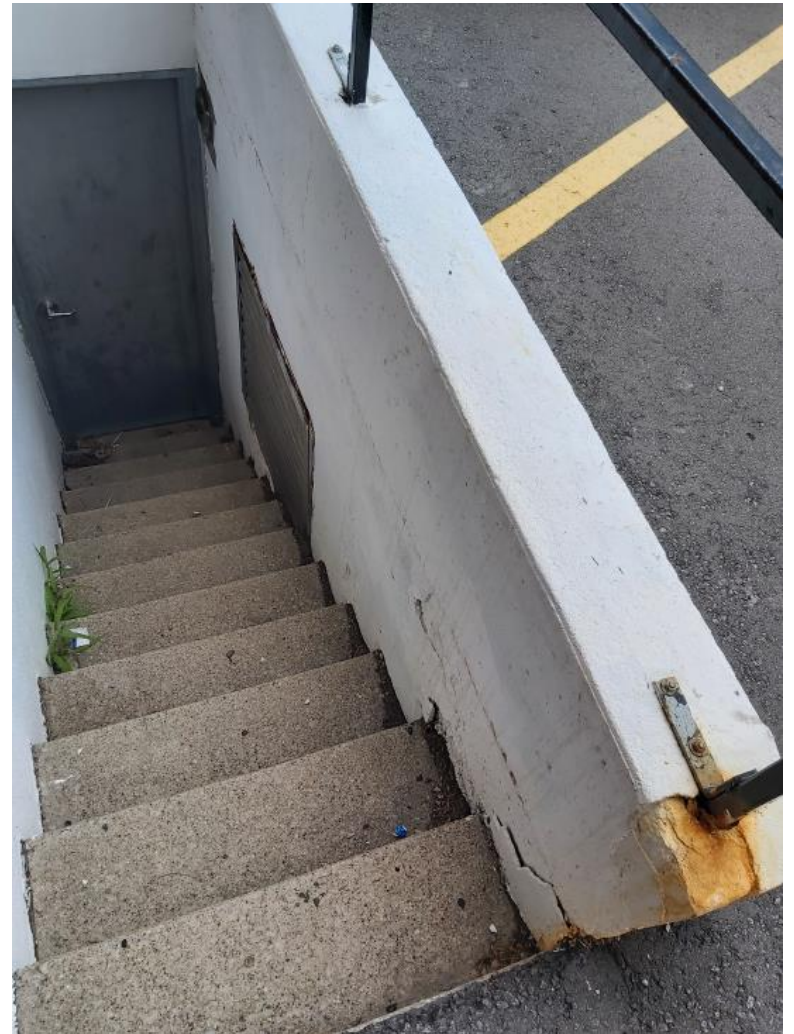
10. Defective exhaust system and defective door from exterior. Also wall cladding issues.

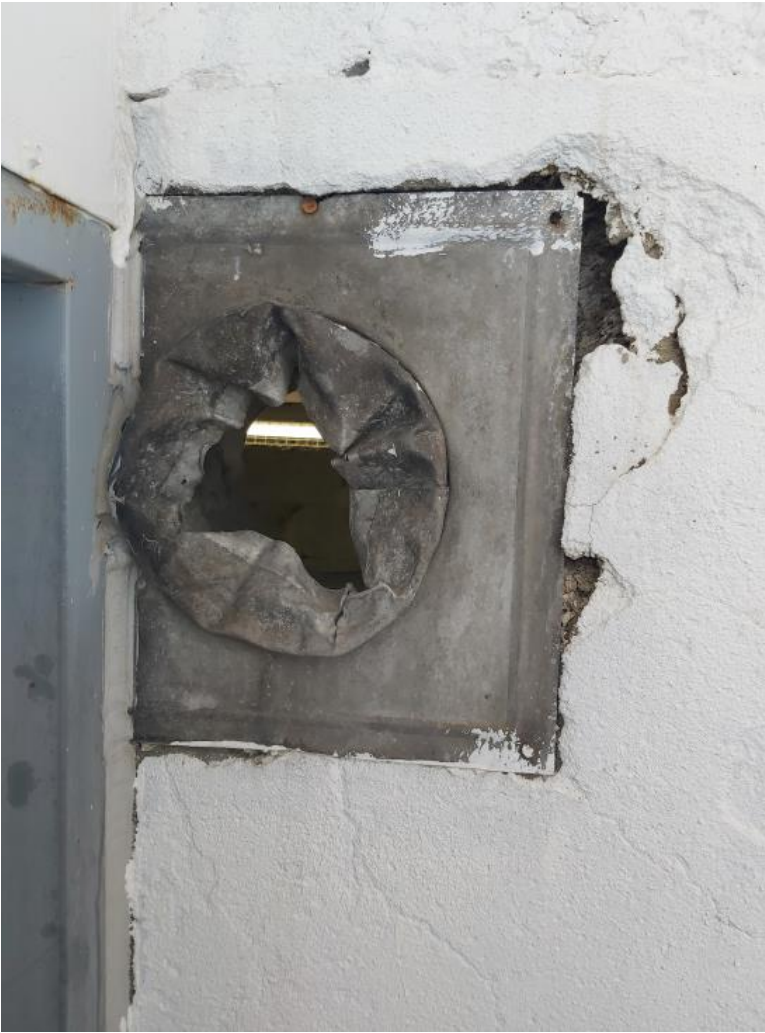
11. Defective exhaust system.

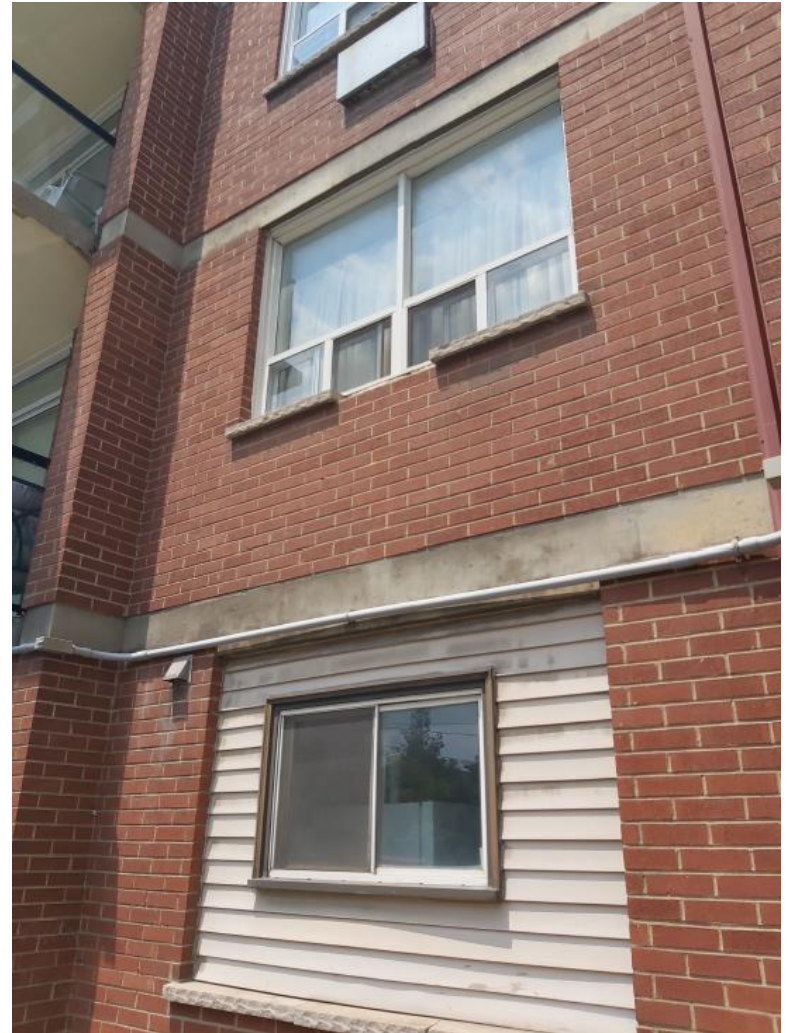
12. Missing concrete window sill.

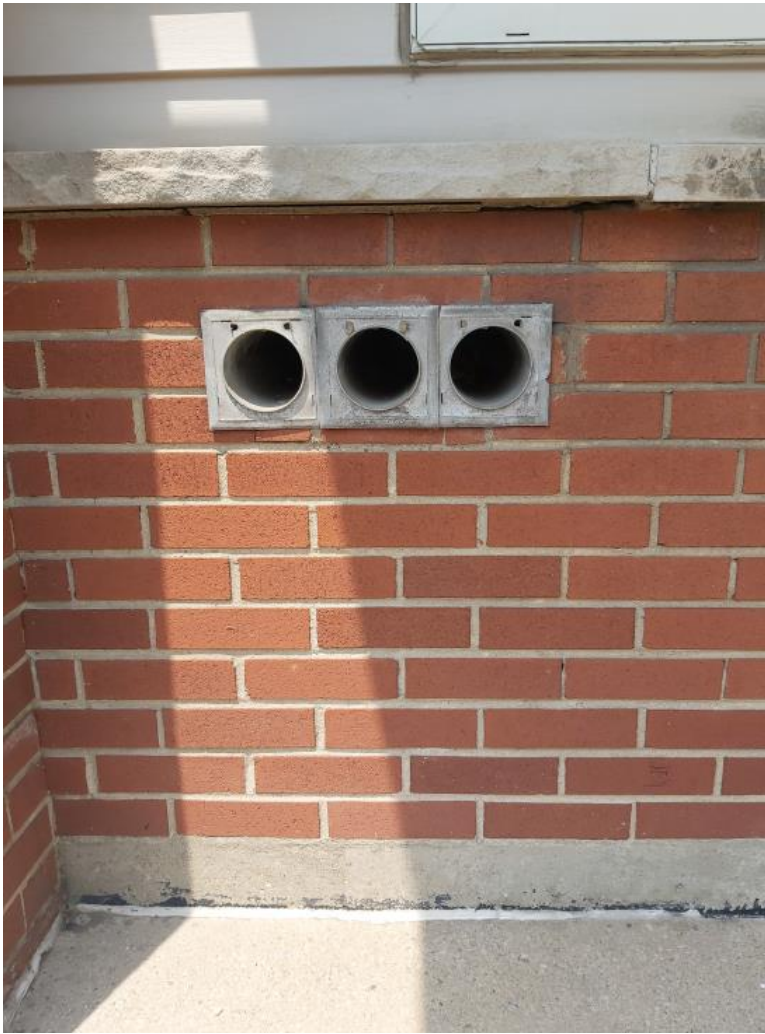
13. Missing / defective grilles.

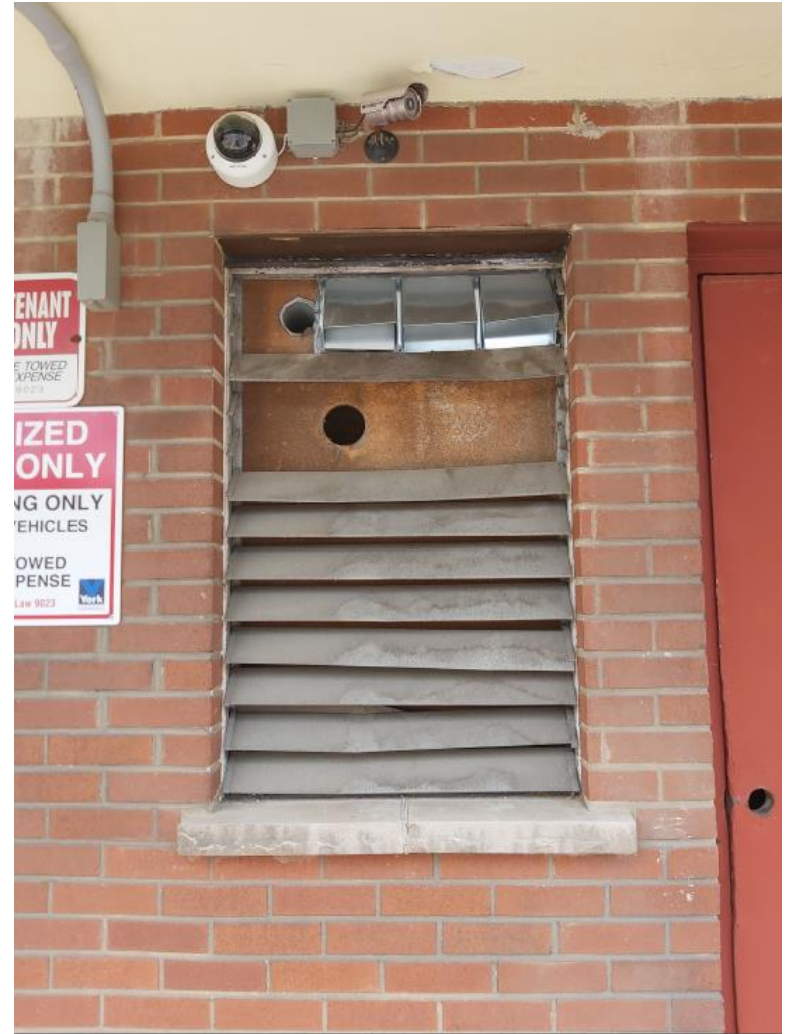
14. Missing / defective grilles. Defective boarding material and defective door.

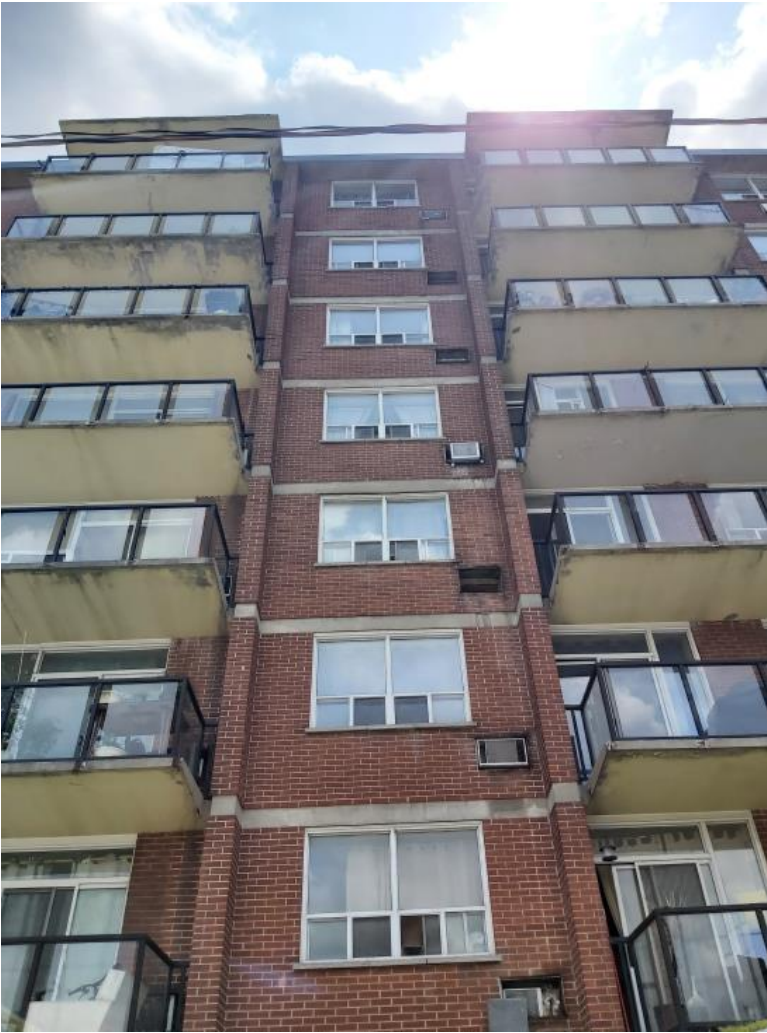
15. Defective balcony slabs and missing air conditioner sleeve cap panels.

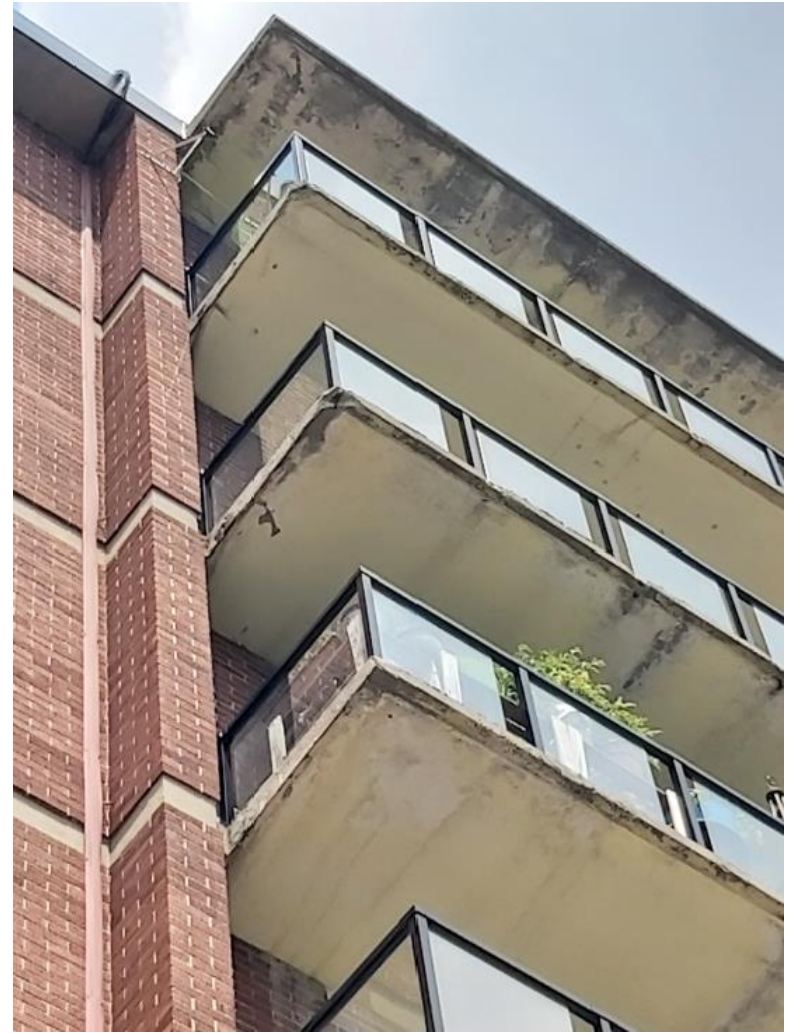
16. Defective balcony slabs.
