# THE CITY OF WINDSOR

**TO: ALL MEMBERS OF THE PROPERTY STANDARDS COMMITTEE**

Please find attached the minutes of the Property Standards Committee at its meeting held August 14, 2015.

A meeting of the **Property Standards Committee** is held this day commencing at 9:00 o'clock a.m. in the Walkerville Meeting Room, 3<sup>rd</sup> floor, City Hall, there being present the following members:

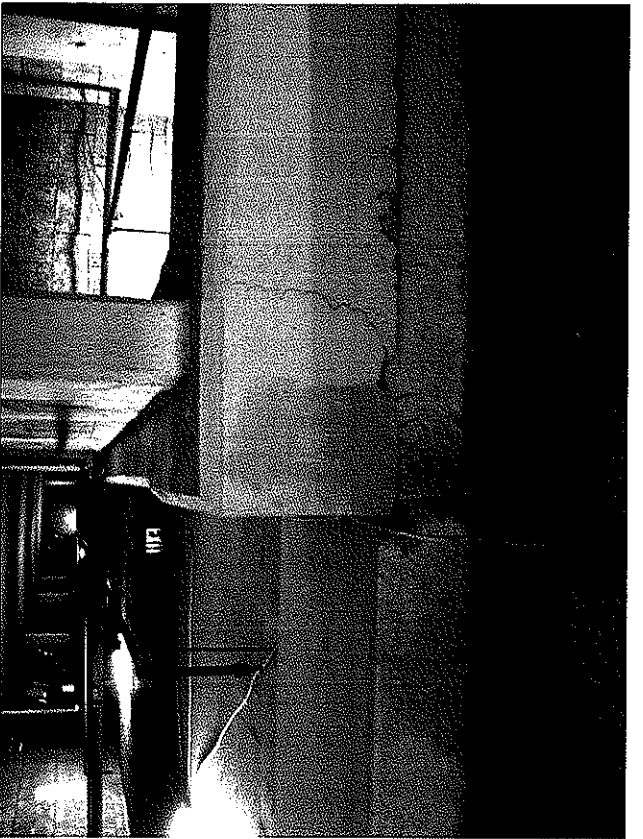
#381- 88 FLOOR REPAIR HOLLOW UNDER, OVER G2

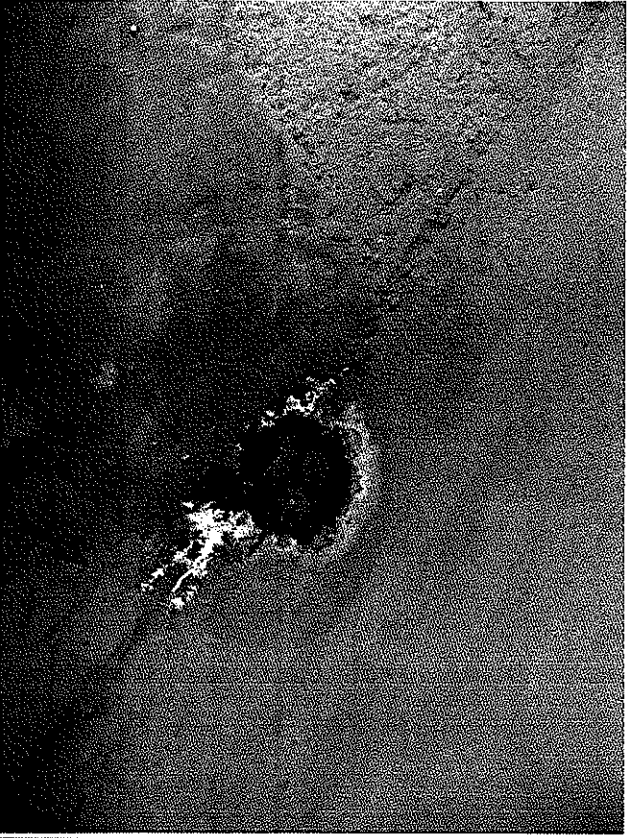
#382- 84 PATCH PAINT WASHING OUT

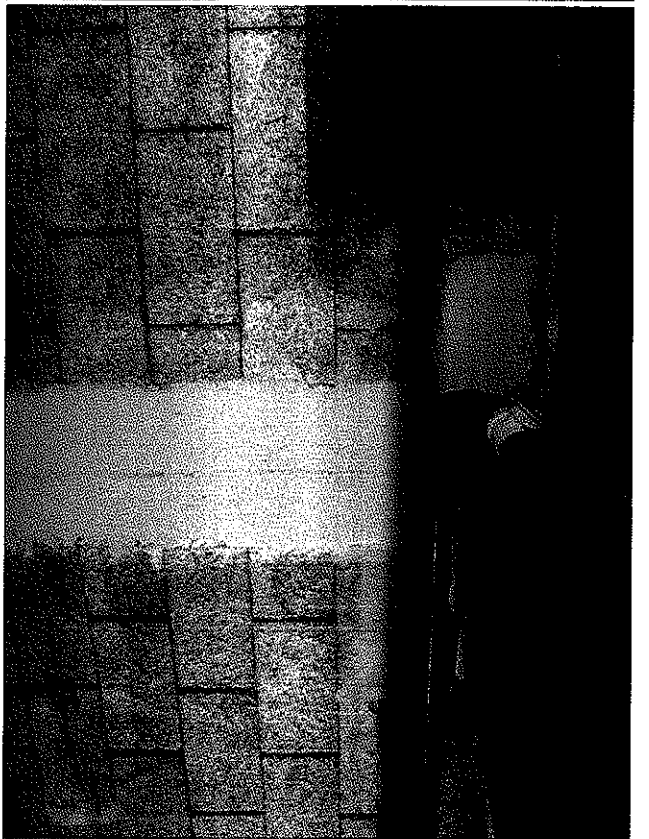
#385- PATCHED/PAINTED, NEW CRACK STILL WET FROM RECENT RAIN

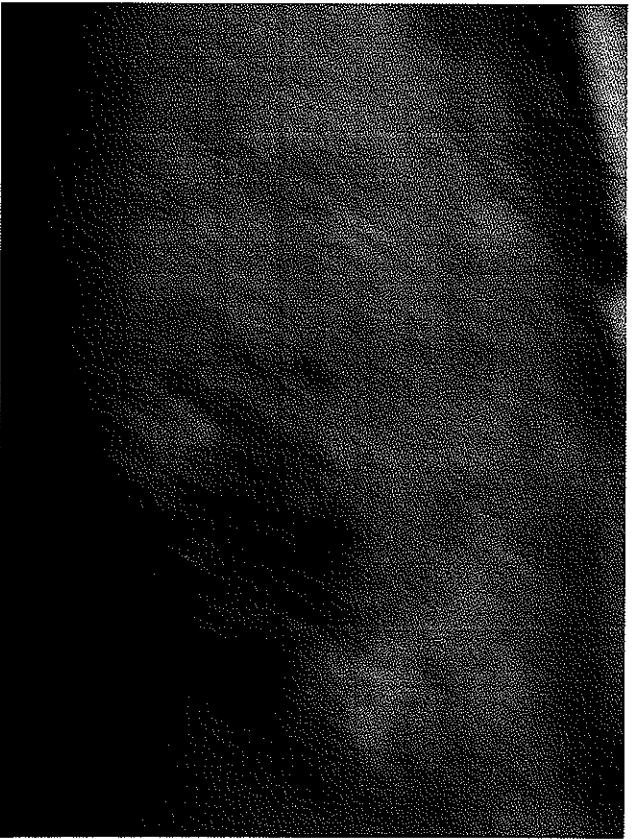
#387- 60 FLOOR PATCH INITIALS IN CONCRETE

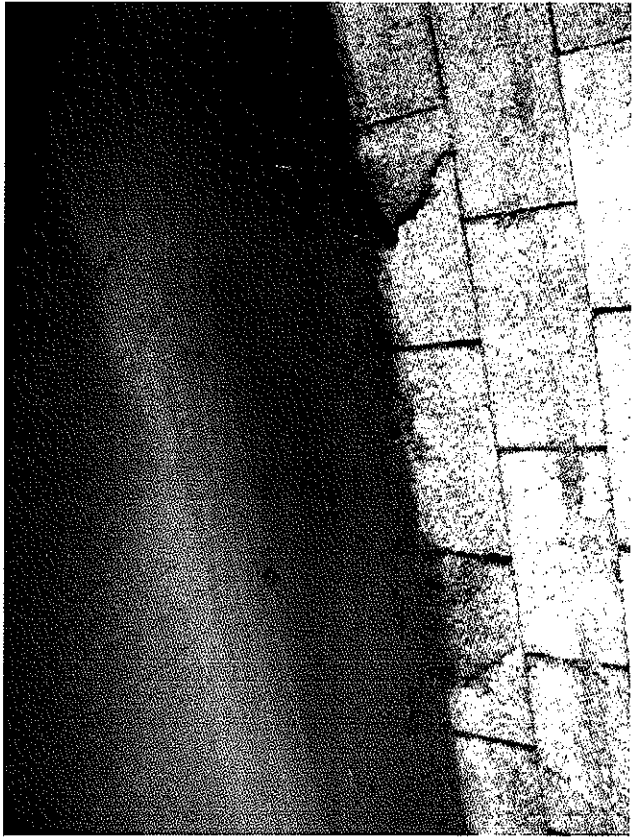
#388- 65 FLOOR PATCH

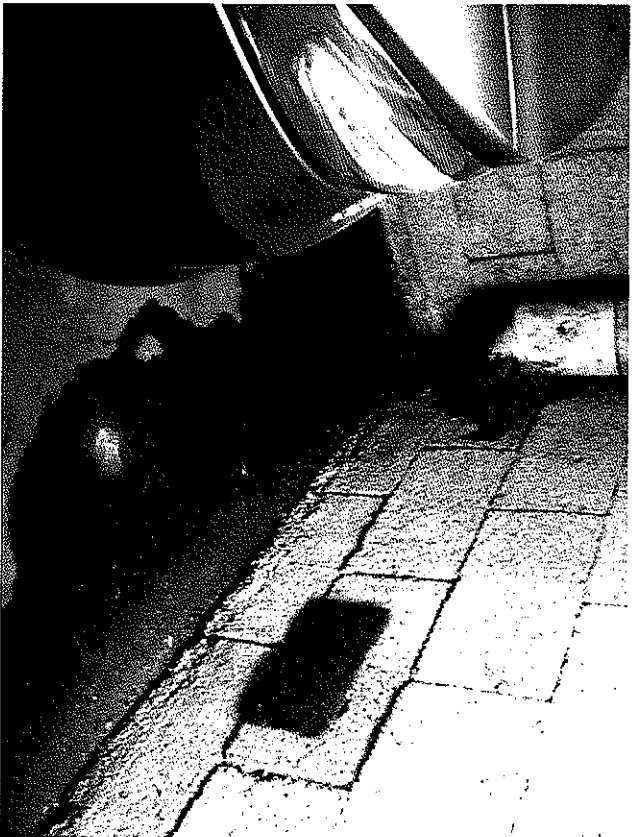
#389- 41 WALL CRUMBLING

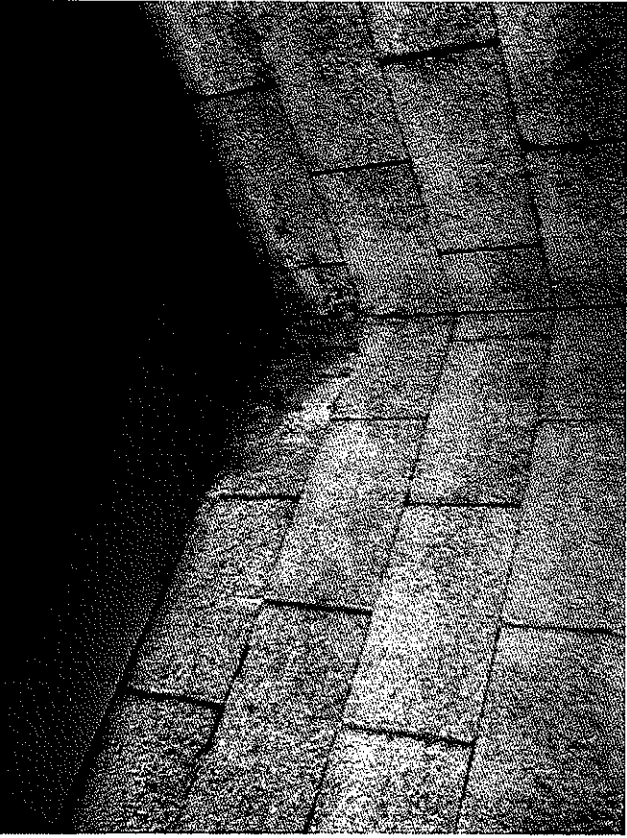
#390- 90 FLOODING AREA STILL WET

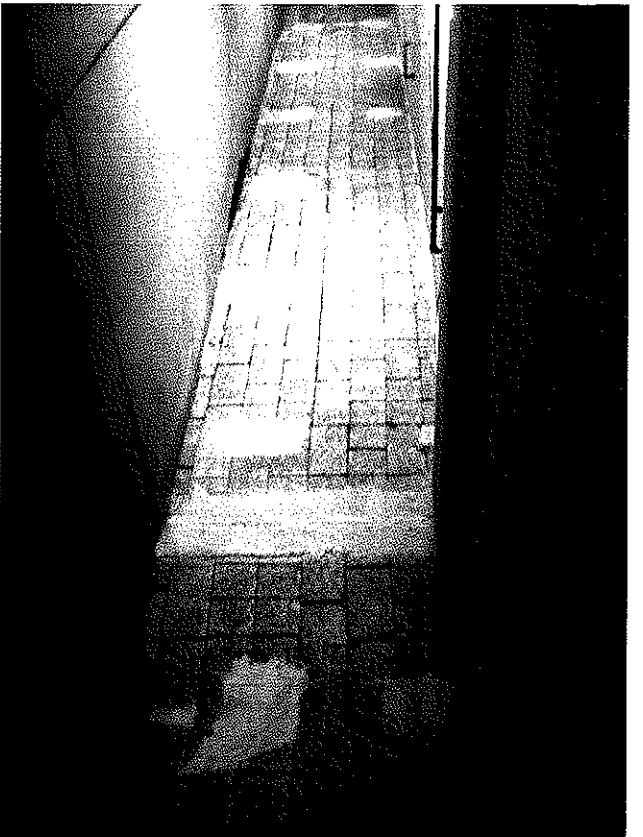
#393- 2 SCRAPED PATCHED PAINTED CEILING

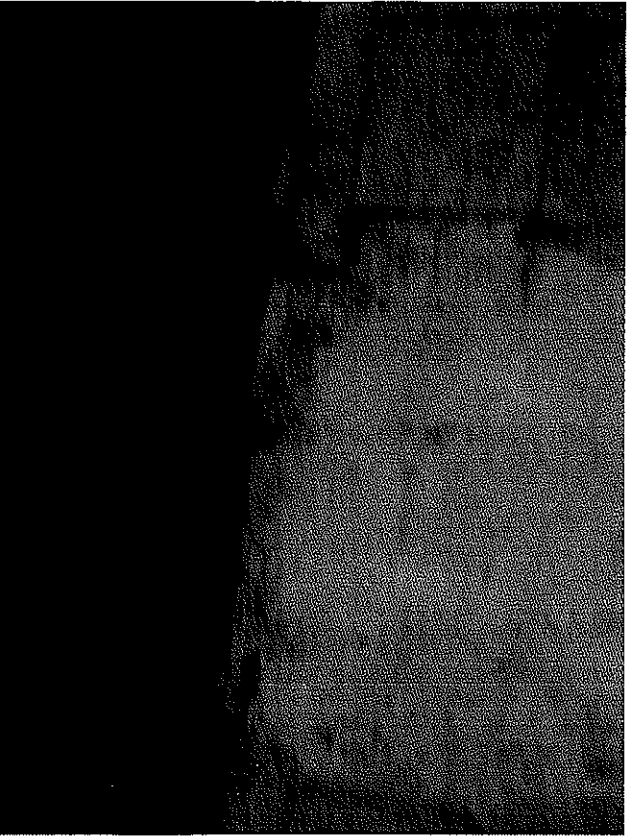
#394- WEST WALL PATCHES FRESH PAINT

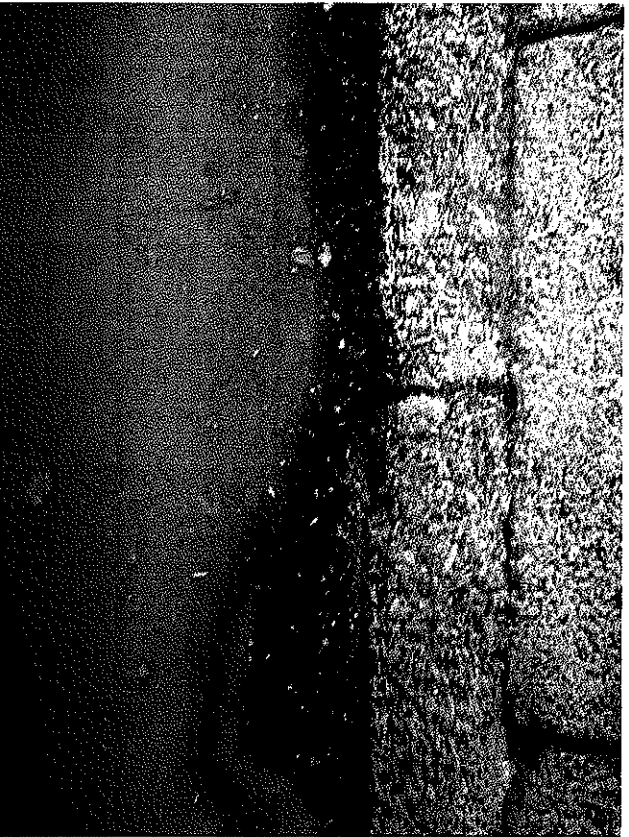
#395- NORTH WALL LEAKS

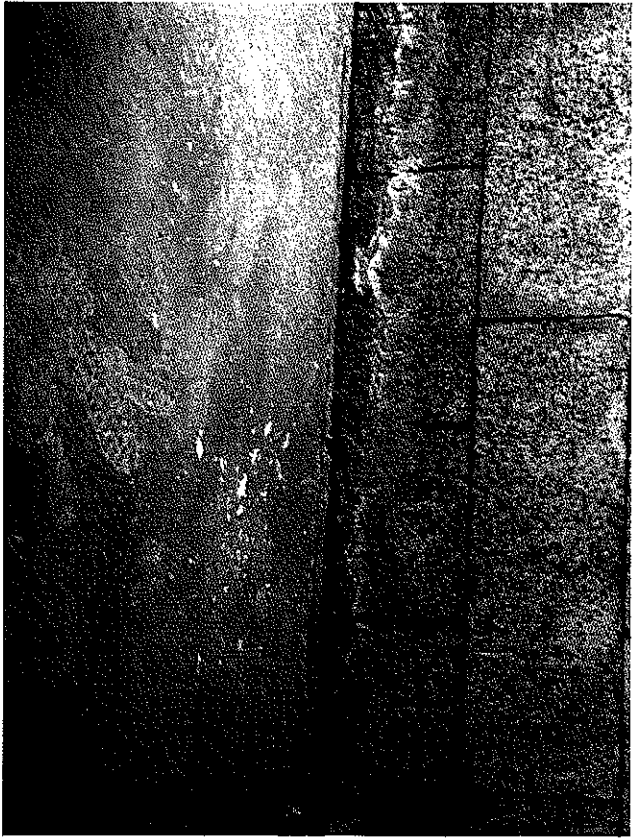
#396- NORTH WALL CRUMBLING AND FINISH FLAKES BY HAND

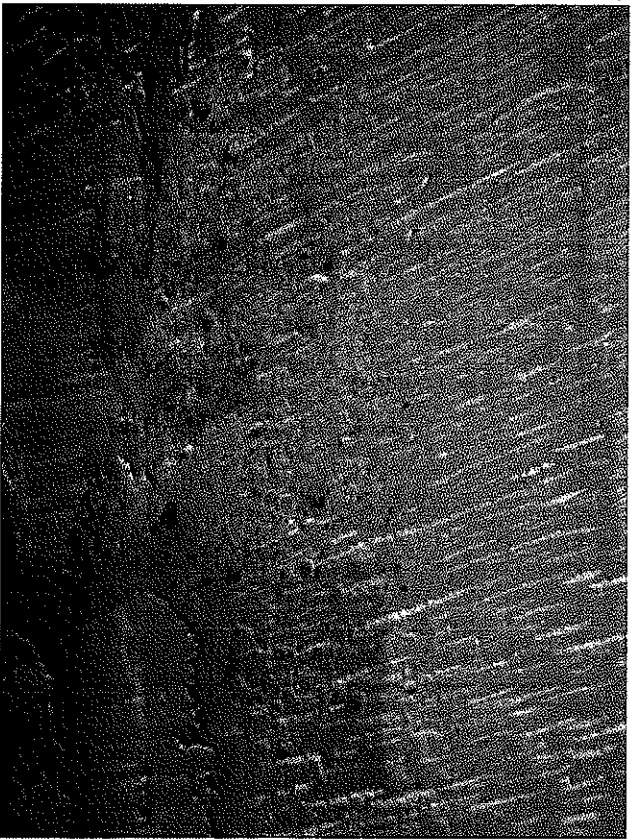
#397 - ACROSS 41 INNER WALL FLOODS IN RAIN

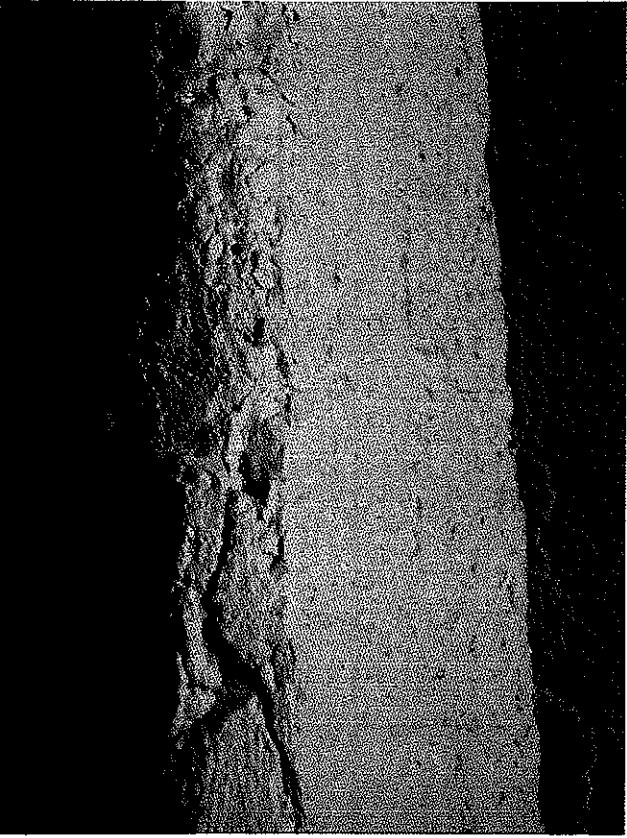
#398 - AT WEST ELEVATOR ENTRY SCRAPED, PATCHED, PAINTED

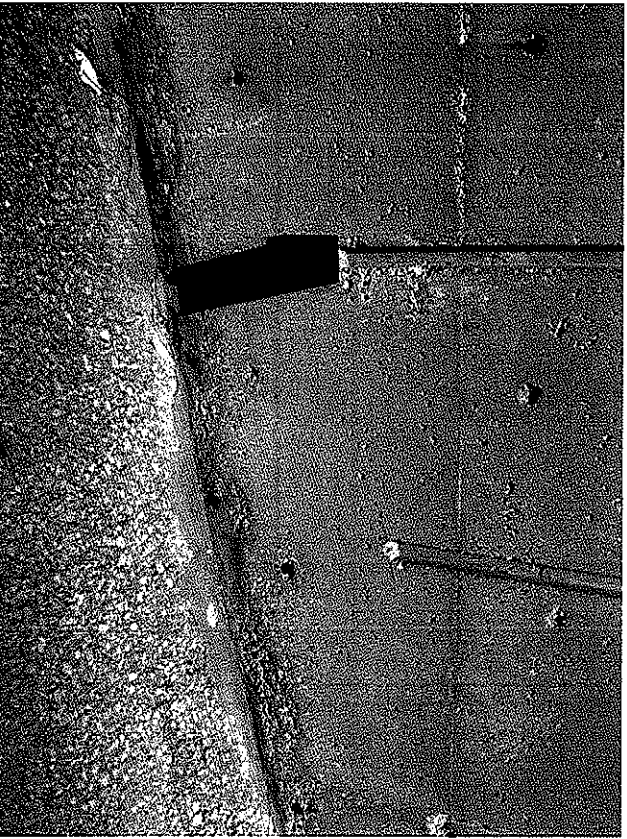
#399 - AT WEST ELEVATOR ENTRY SCRAPED, PATCHED, PAINTED
