Bezaire Partners

Re: Tree Condition Report

I am pleased to submit this report on the condition of trees located on your proposed subdivision lands.

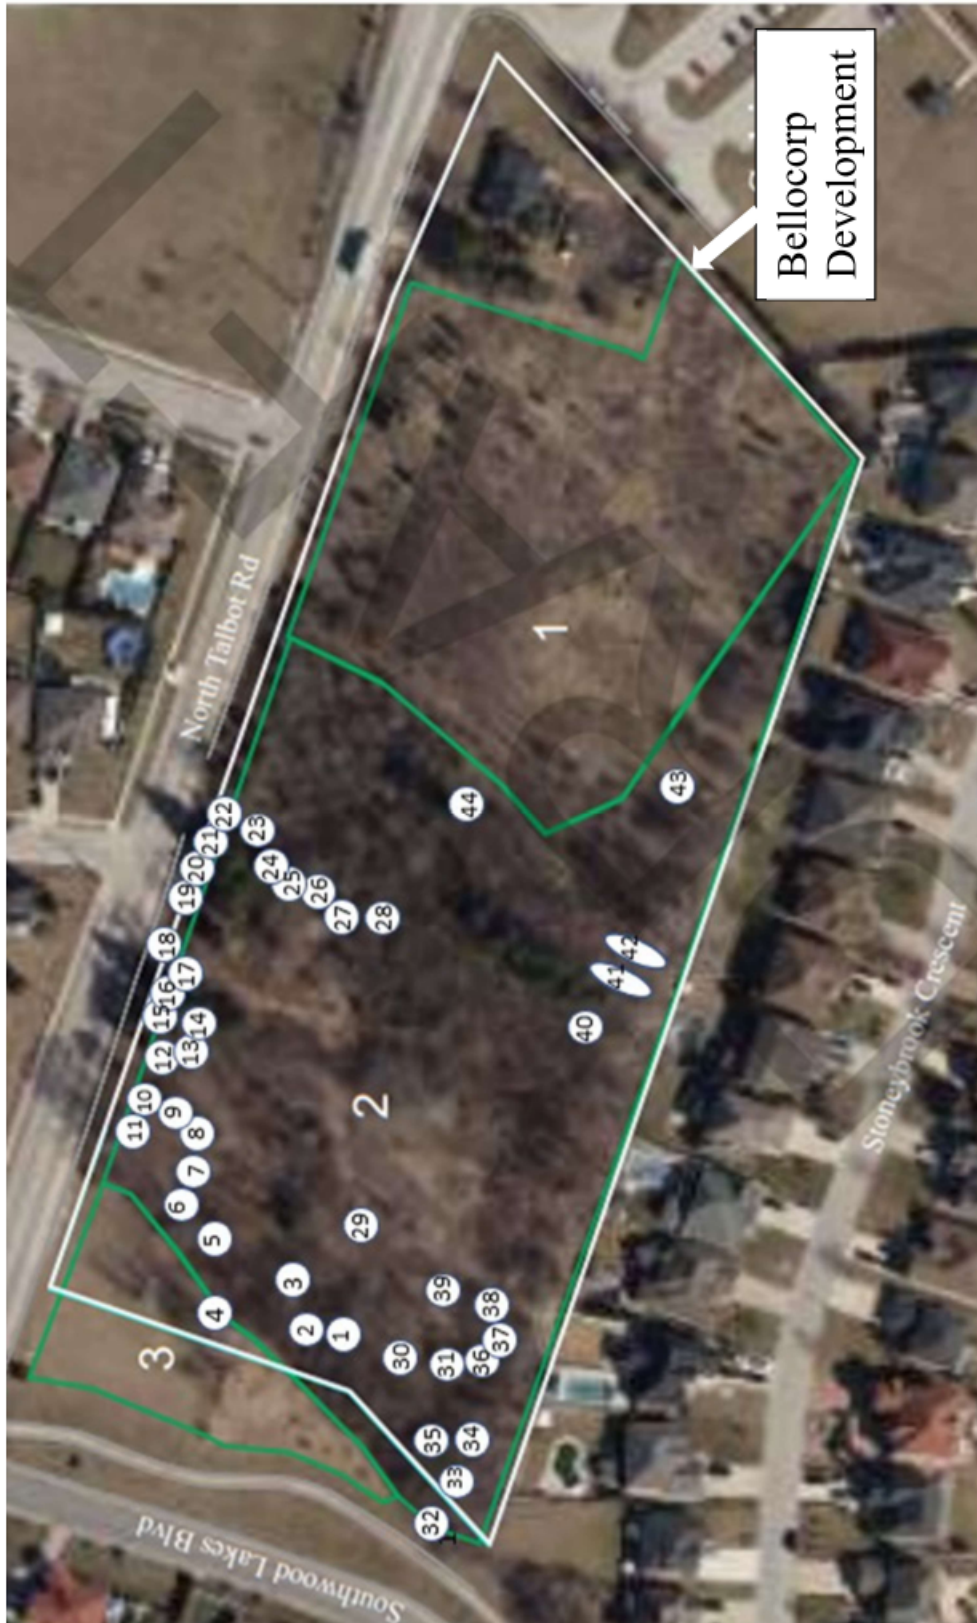
Appendix 3 MTE Site Plan with Tree Location Overlay (Not Surveyed)

The field work was completed by Bill Roesel (Professional Forester (retired)) on August 7, 2021. The following table shows the significant desirable species that were found on site. The key in the first column refers to the tree location shown on the plan at Appendix 3. Note that the locations on the site plan are not measured or surveyed. They locations are not to be used other than to assist a surveyor in locating the desirable species.

1. The desirable trees found in Table No. 1 have been tagged on site
2. The developer should engage a surveyor to obtain the location and relative elevation of each tree.
3. The location of each tree should be compared to the building envelope to determine which trees can be maintained.
4. The elevation of each tree should be compared to the proposed grade of the property. If the tree elevation is +/- 4 inches from the proposed grade, the tree can be saved without additional cost. (see [BlockTreeWell.jpg \(800x600\) \(tntech.edu\)](#))
