1495754 ONTARIO INC.

Tree Inventory & Preservation Study

0 Esplanade Drive

Tree Inventory & Preservation Study for 0 Esplanade Drive

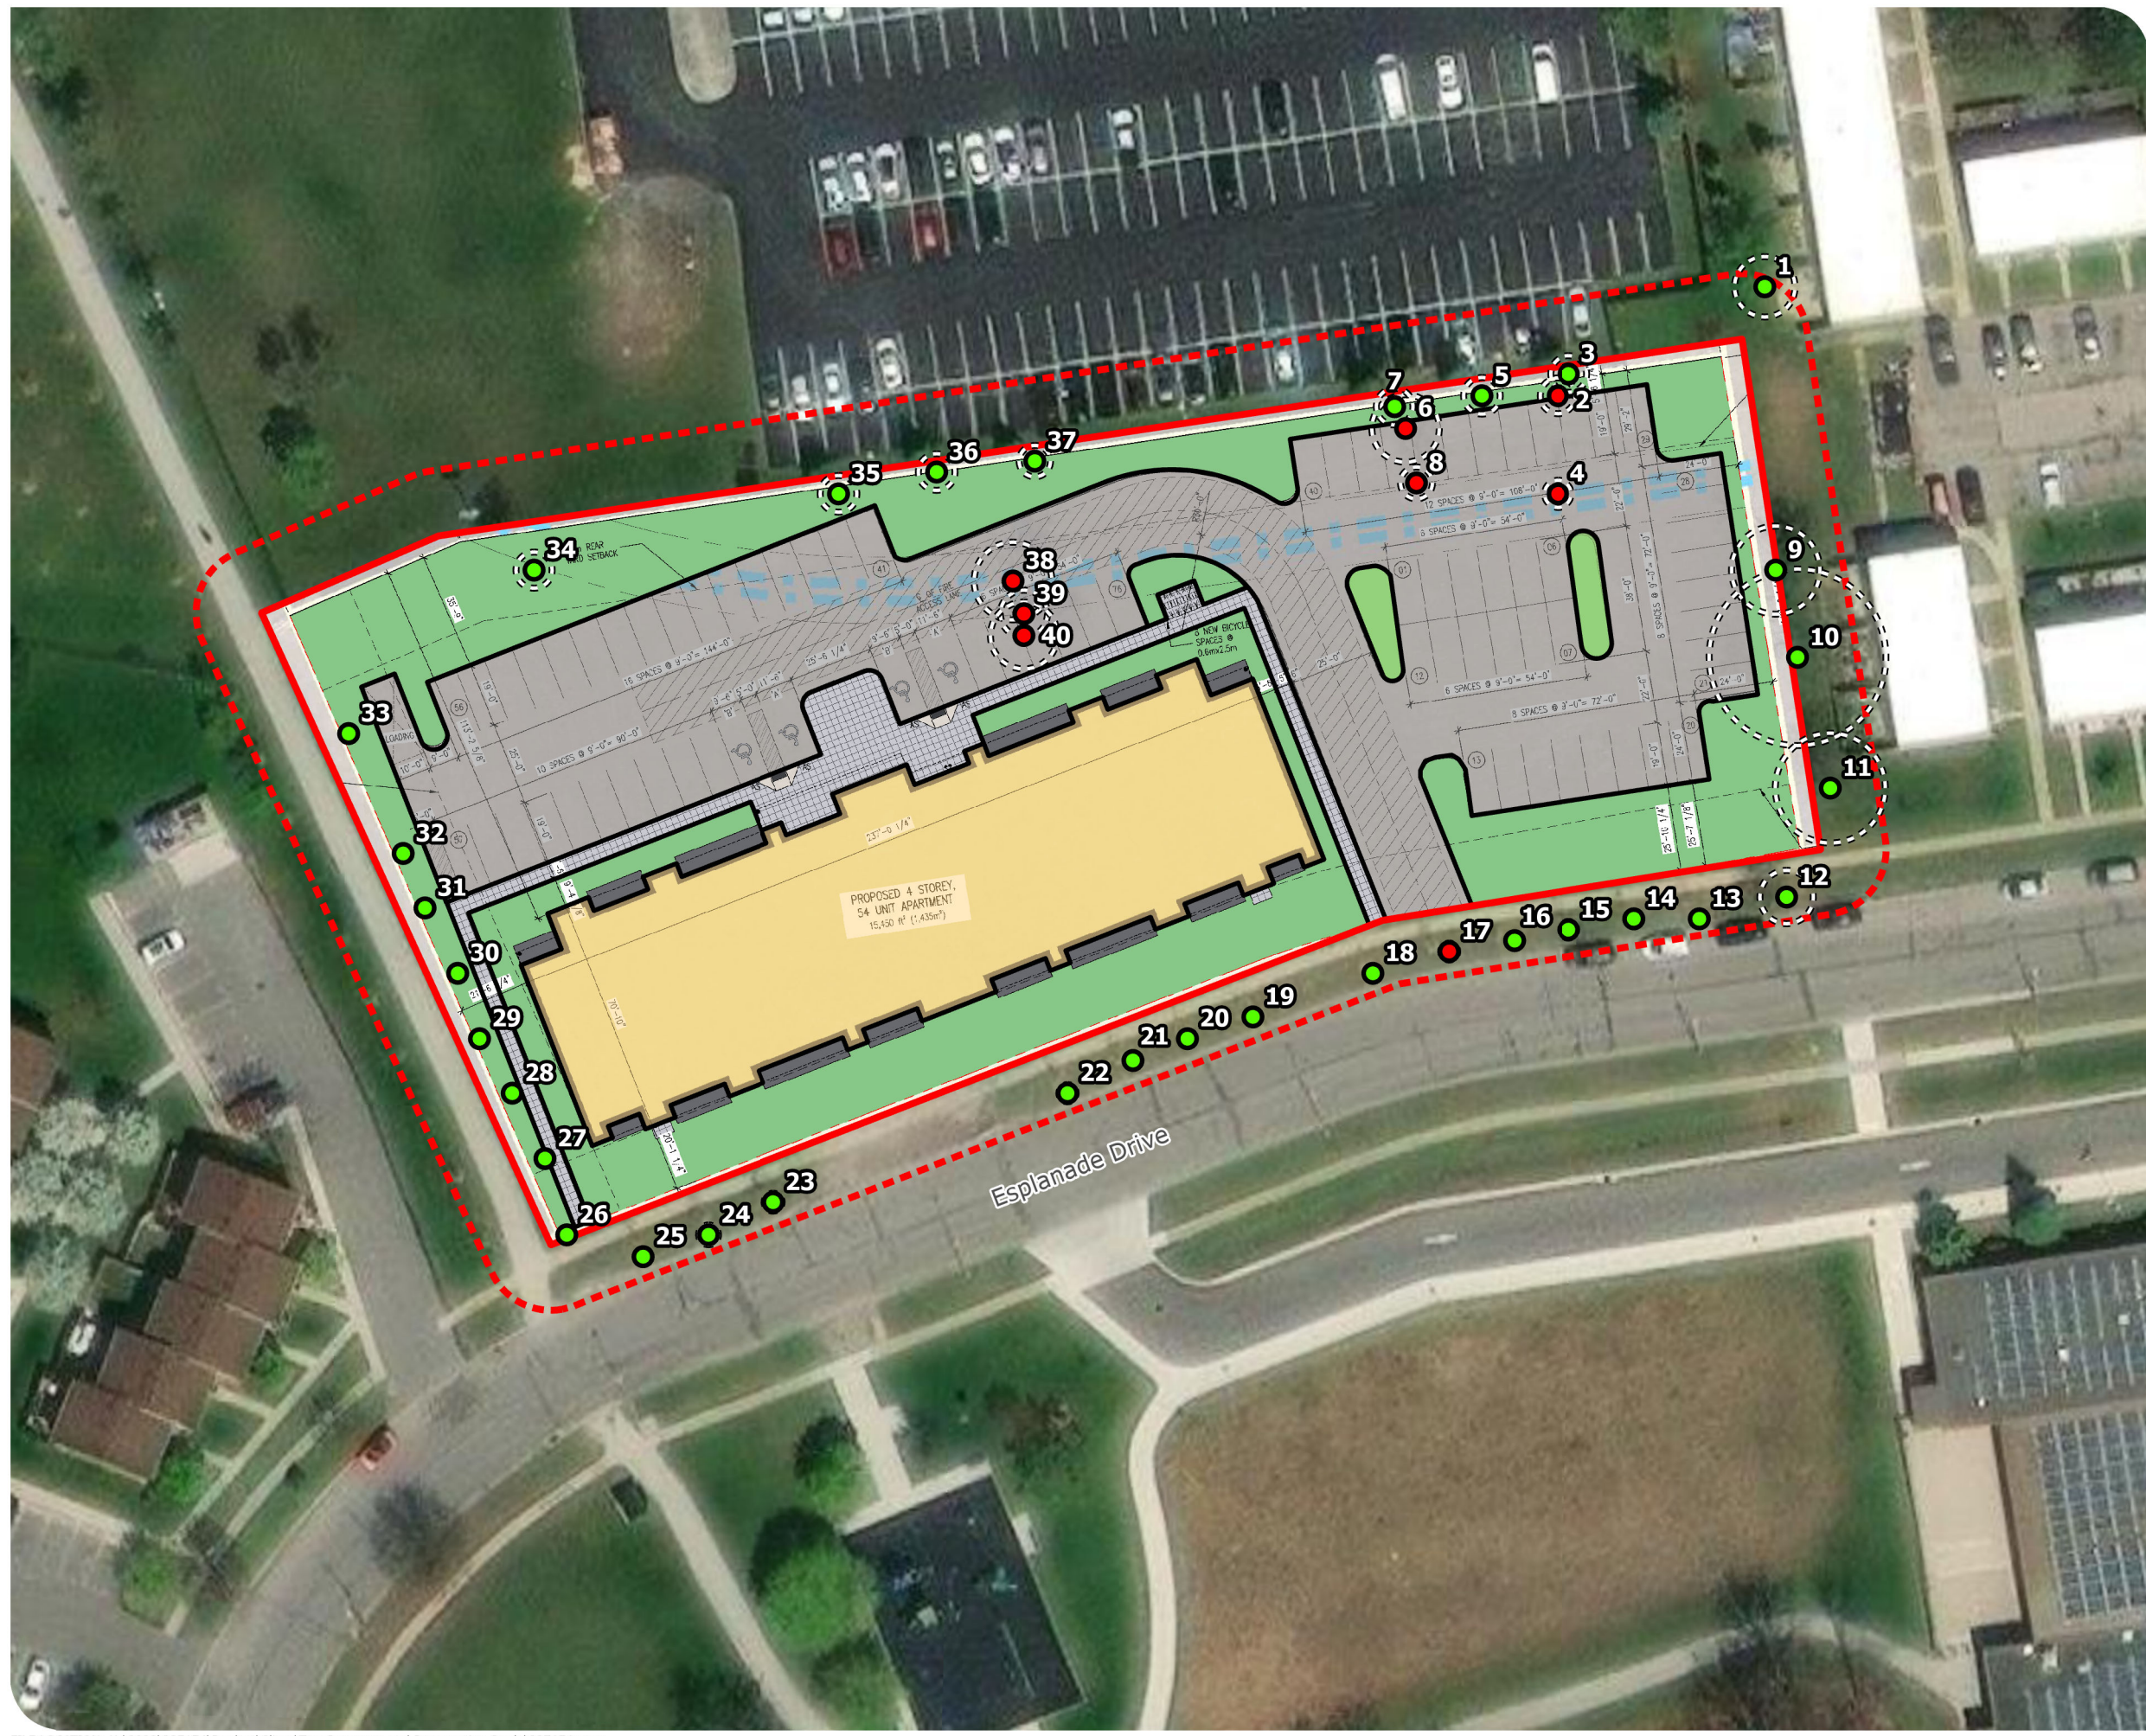
TREE INVENTORY
FIGURE #2

Trees recommended for removal are symbolized in red on the Tree Inventory figures (**Appendix A**; Figure 2) and are identified in the tree inventory table (**Appendix C**). All 8 trees identified for removal are in good condition.

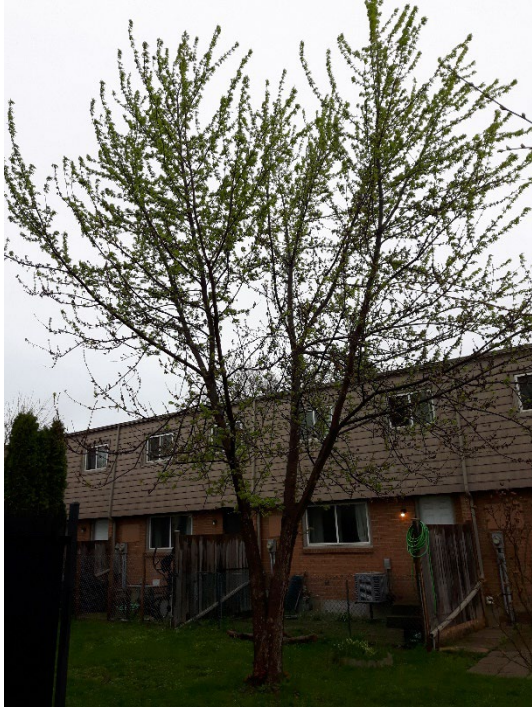
Tree 1: Silver Maple

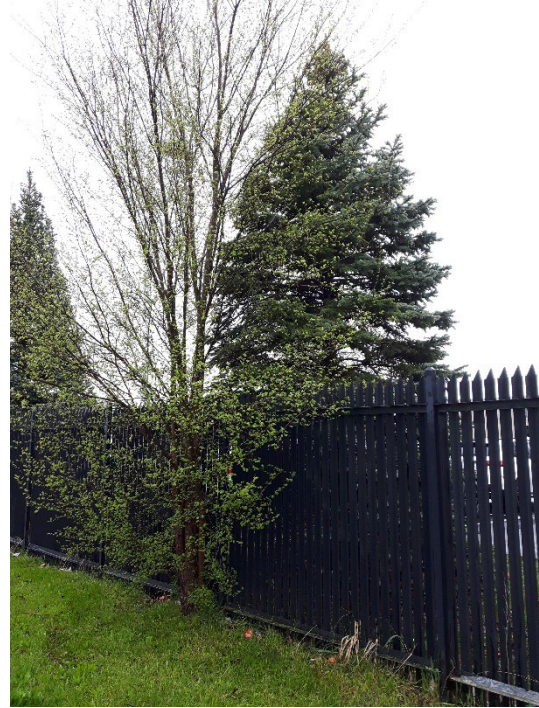
Tree 2 (left): White Elm
Tree 3 (right): Blue Spruce

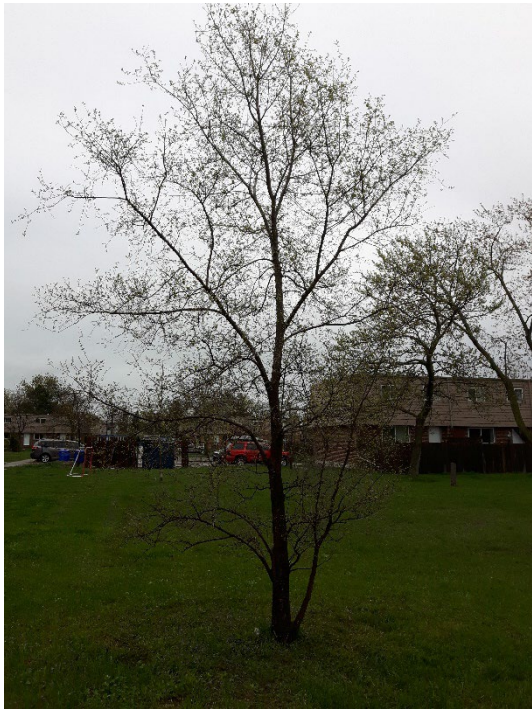
Tree 4: White Elm

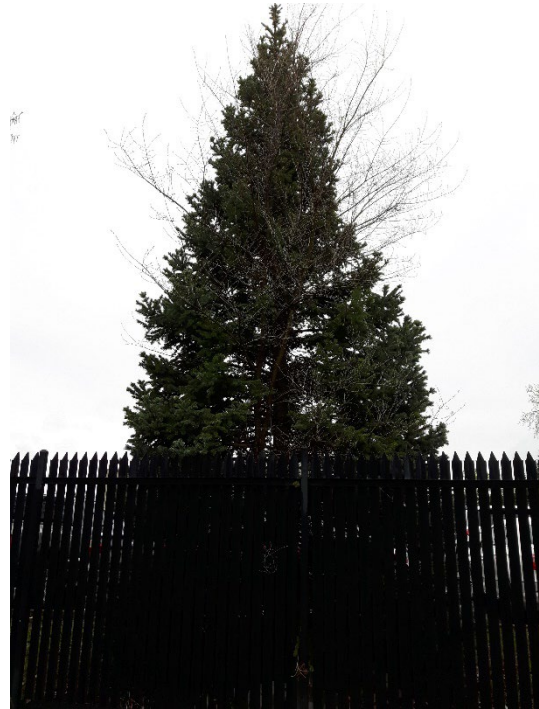
Tree 5: Blue Spruce

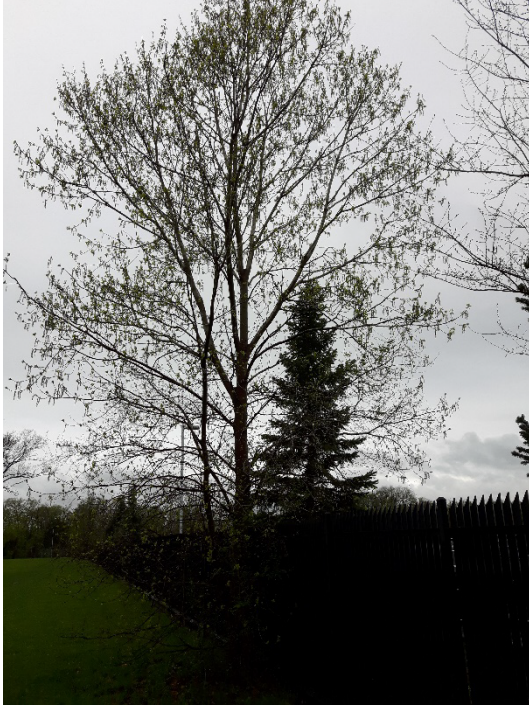
Tree 6 (left): Eastern Cottonwood
Tree 7 (right): Blue Spruce

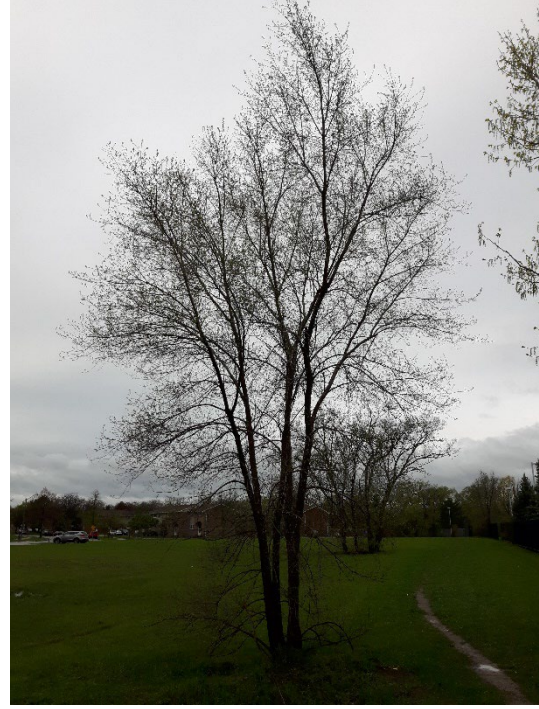
Tree 8: White Elm

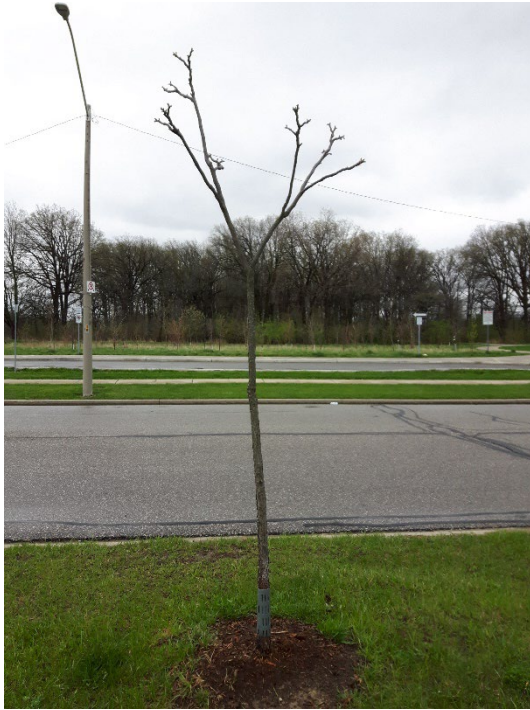
Of the inventoried trees, 32 are recommended to be preserved (19 client-owned trees and 13 City-owned trees). The one Kentucky Coffee-tree is part of the recommended trees to be preserved.

Tree 19: Kentucky Coffee-tree

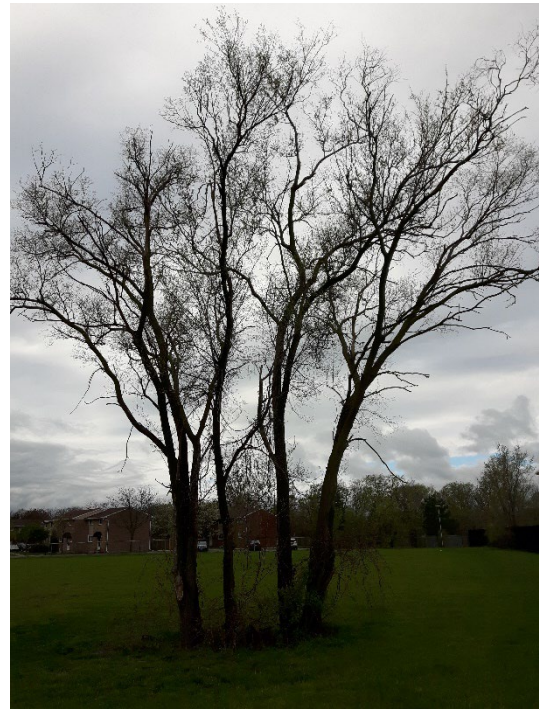
Tree 38 (right), 39 (centre), and 40 (left): White Elm

37	<i>Picea pungens</i>	Blue Spruce	~12	1.44	Good		Retain	Not within construction footprint
38	<i>Ulmus americana</i>	White Elm	29.7,27.3,20.8	3.56	Good		Remove	Within construction footprint
39	<i>Ulmus americana</i>	White Elm	18	2.16	Good		Remove	Within construction footprint
40	<i>Ulmus americana</i>	White Elm	25.6,20.5,19.9	3.07	Good		Remove	Within construction footprint

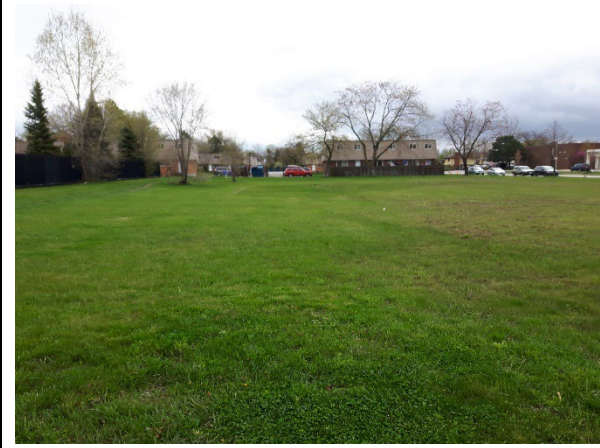
Looking east from the centre of the Project Location. Note: Regularly maintained lawn.

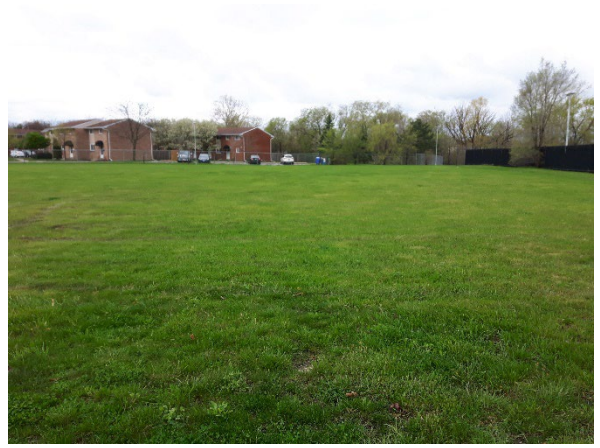
Looking west from the centre of the Project Location. Note: Regularly maintained lawn.
