## Welcome to the Public Information Centre

# Park Master Plan

## SANDPOINT BEACH PARK SHORELINE CLASS ENVIRONMENTAL ASSESSMENT

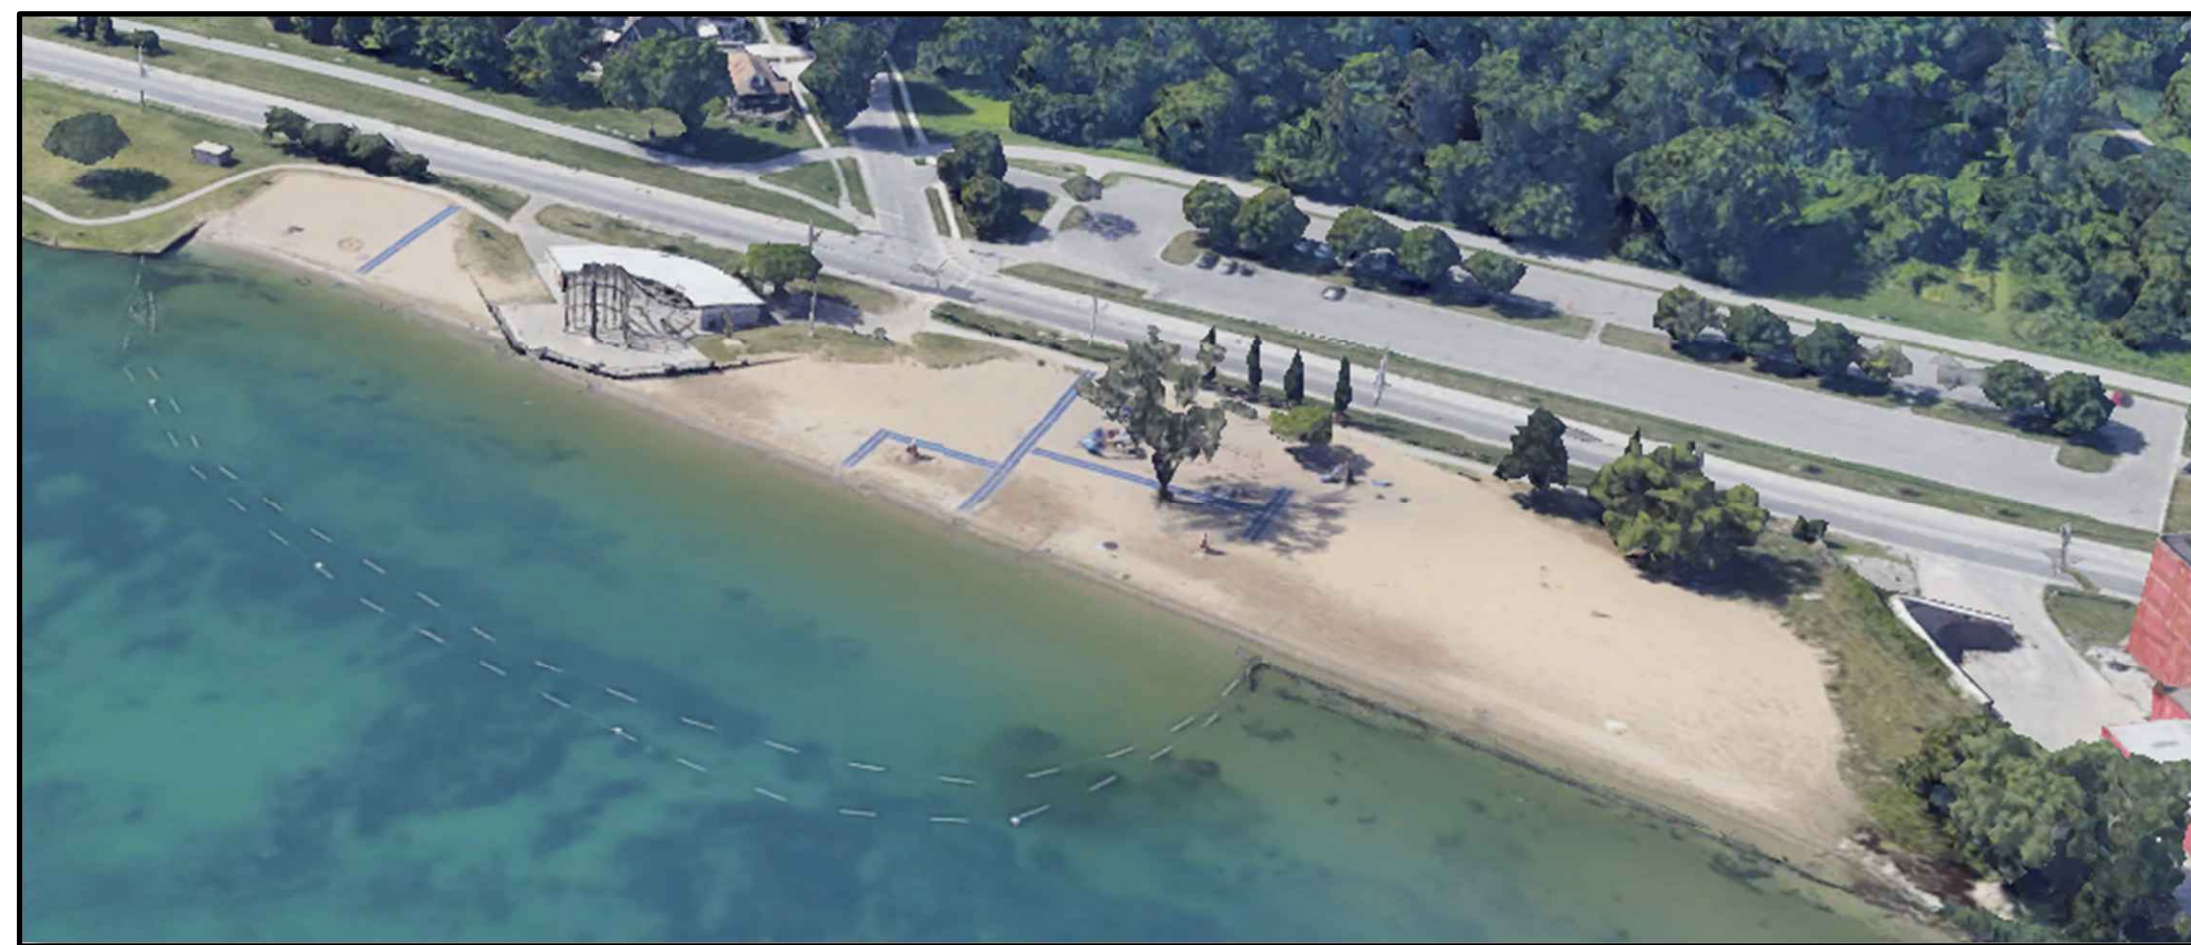
SANDPOINT BEACH

The public beach areas located within the study area appear to be stable and generally consists of naturally deposited, well-graded sand. Approximately half of the west beach is currently fenced off with a fence. Swimming areas are delineated with buoy lines that are deployed and maintained by City staff during the swimming season.

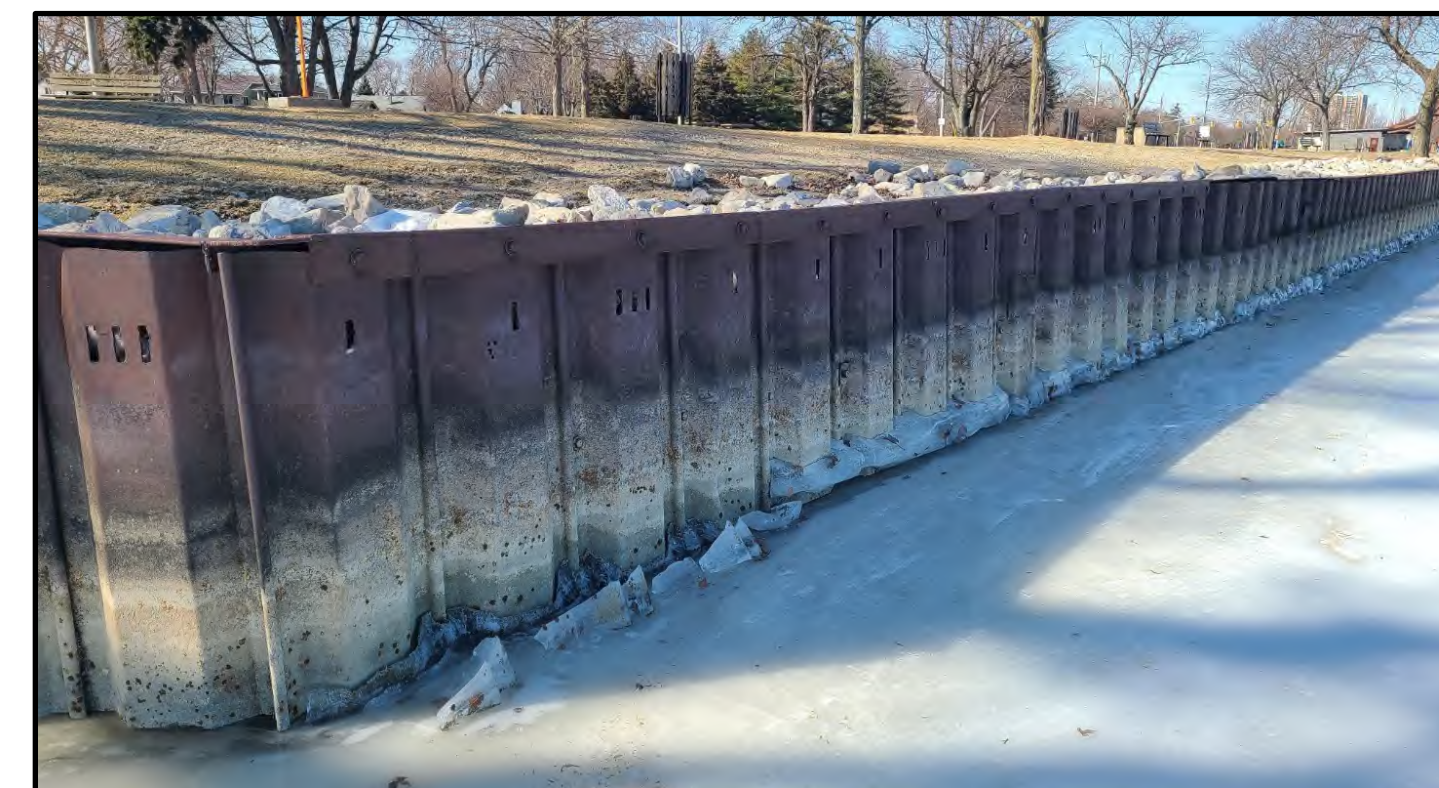
STEEL SHEET PILE SHOREWALL (SSP)

The existing steel sheet pile shorewall sections of the shoreline generally appear to be in fair condition. Based on historical photos and drawings, the walls appear to have been installed sometime in the 1980s. A gabion-sized rock apron has recently been added behind the wall east of the main beach to fill areas of substantial erosion in the backfill.

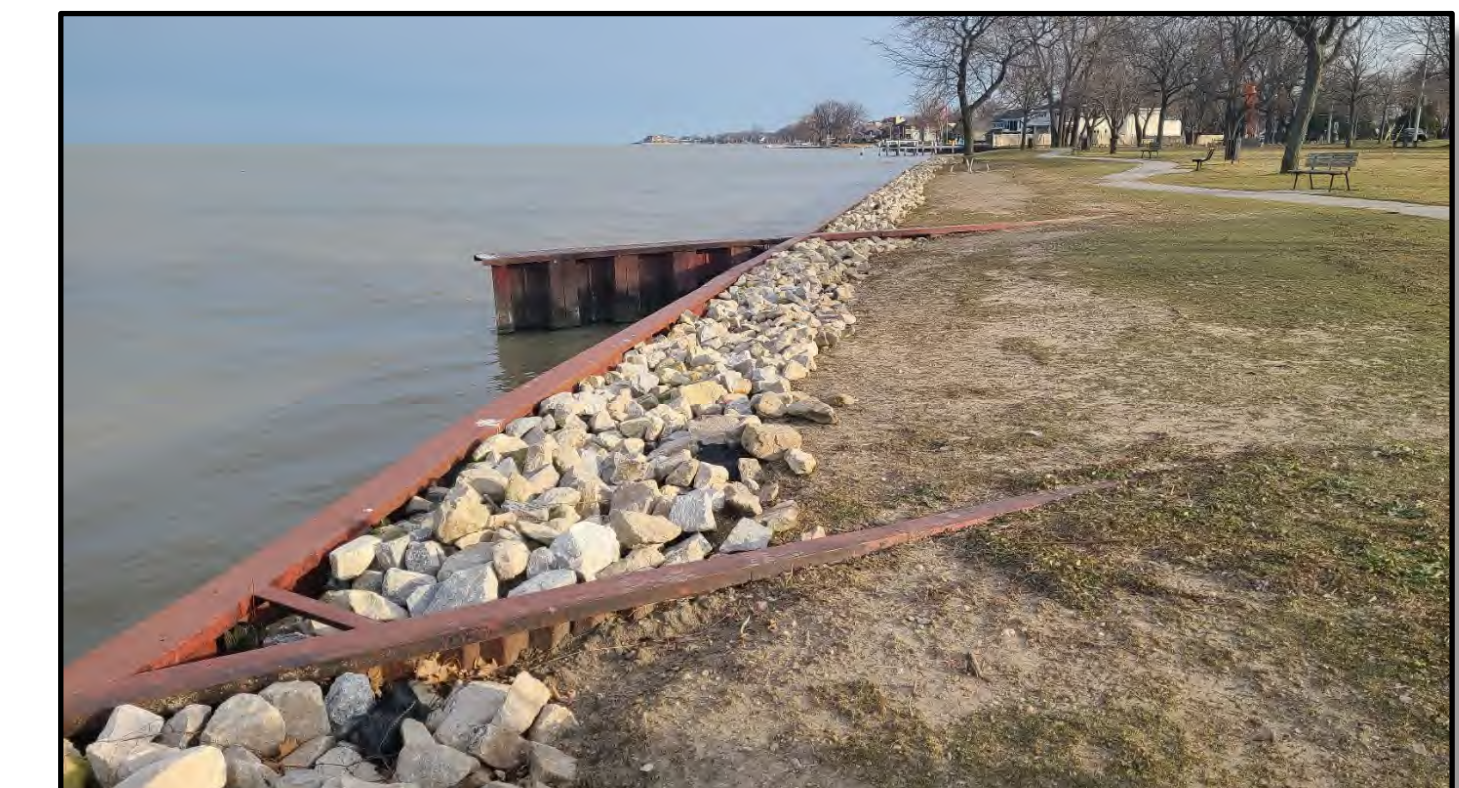
STEEL SHEET PILE SHORE WALL WITH ROCK APRON

The rock apron generally appears to be continuous and well graded and runs along the entire length of the steel sheet pile wall. There is currently no guardrail in place along this segment of the shorewall.

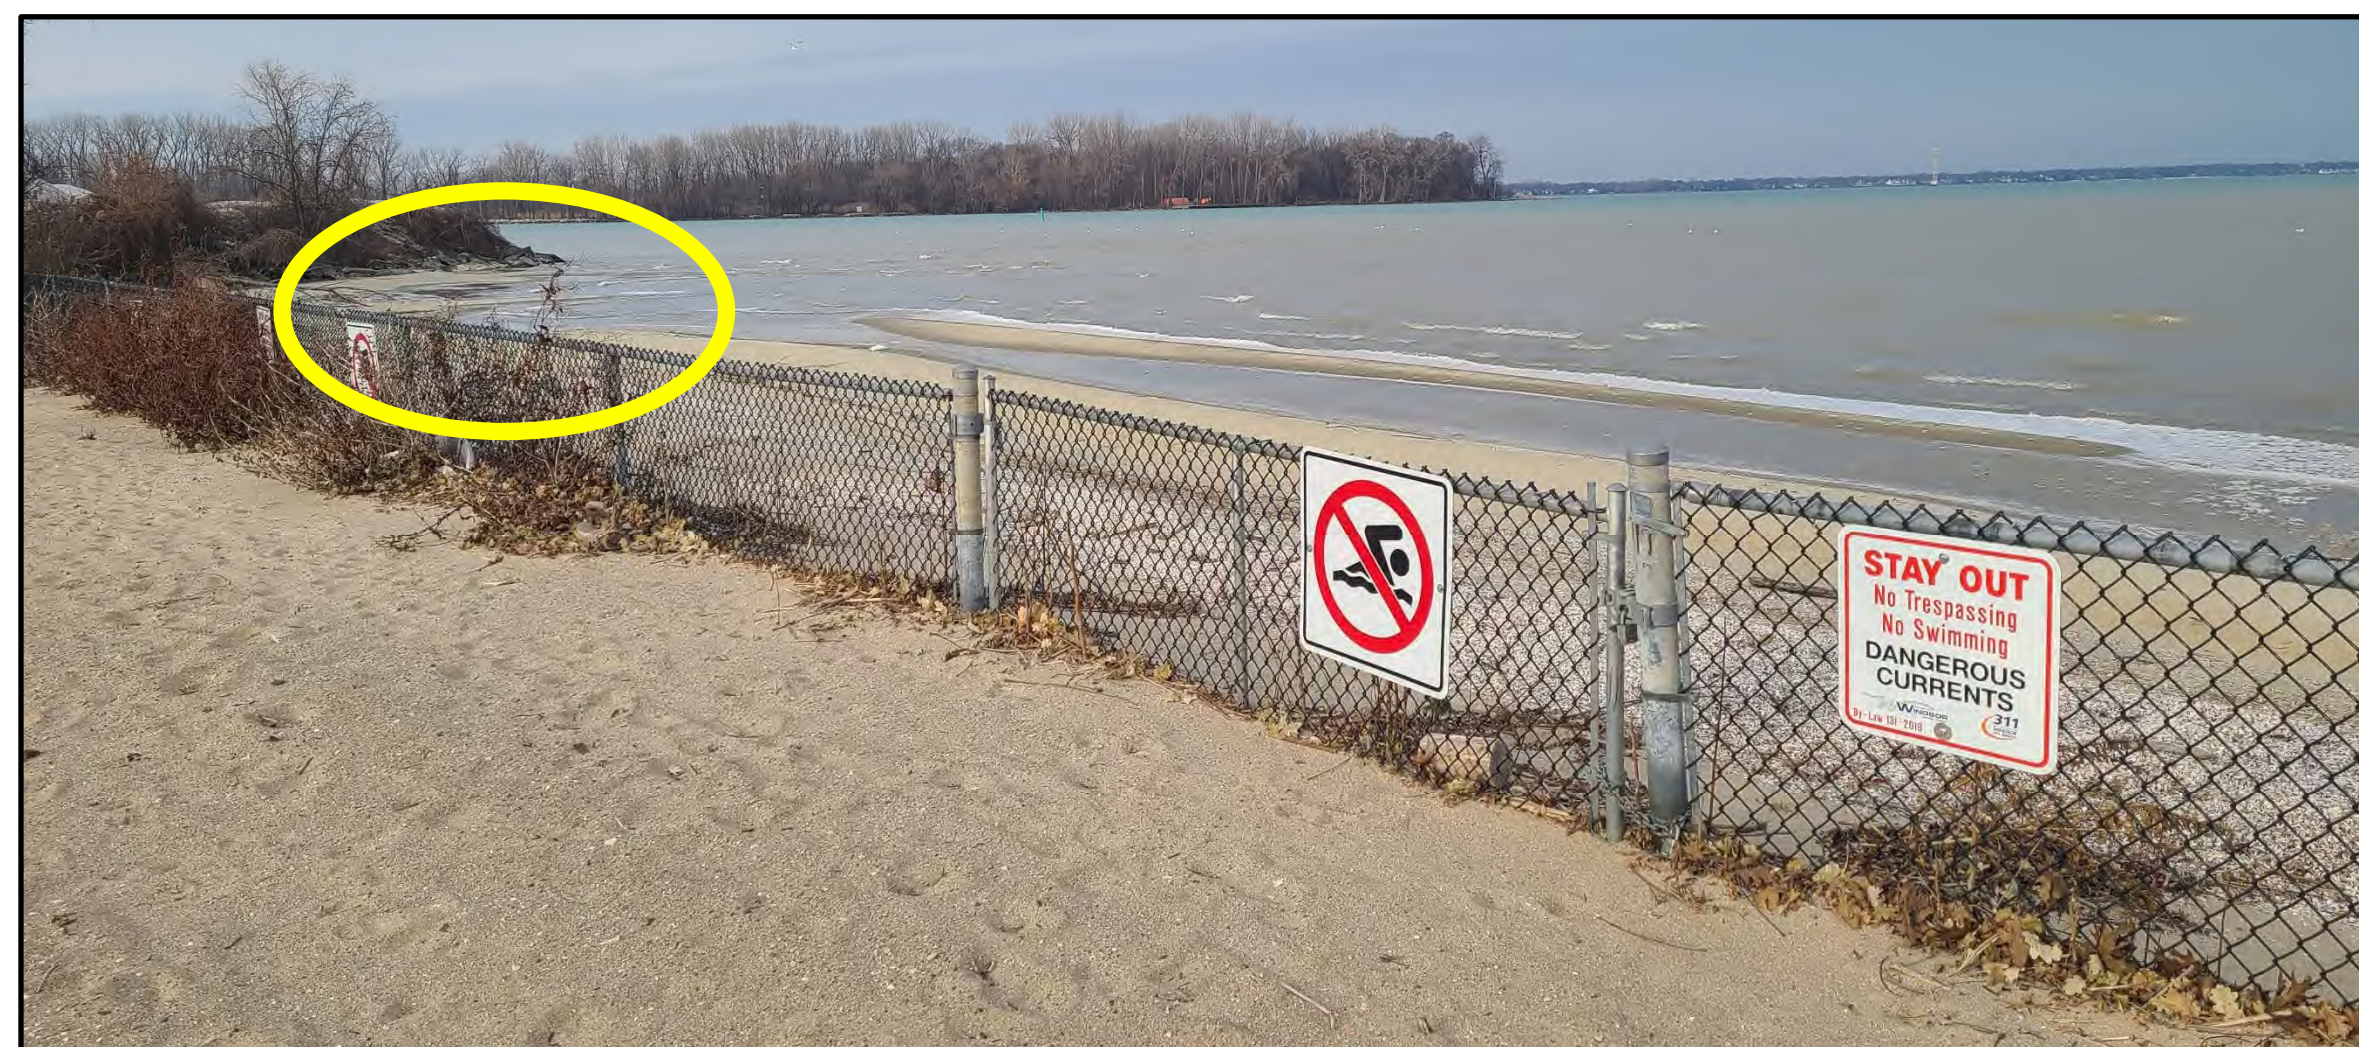
SANDPOINT BEACH: FENCED-OFF AREA LOOKING TOWARD AREA WITH STRONG CURRENTS

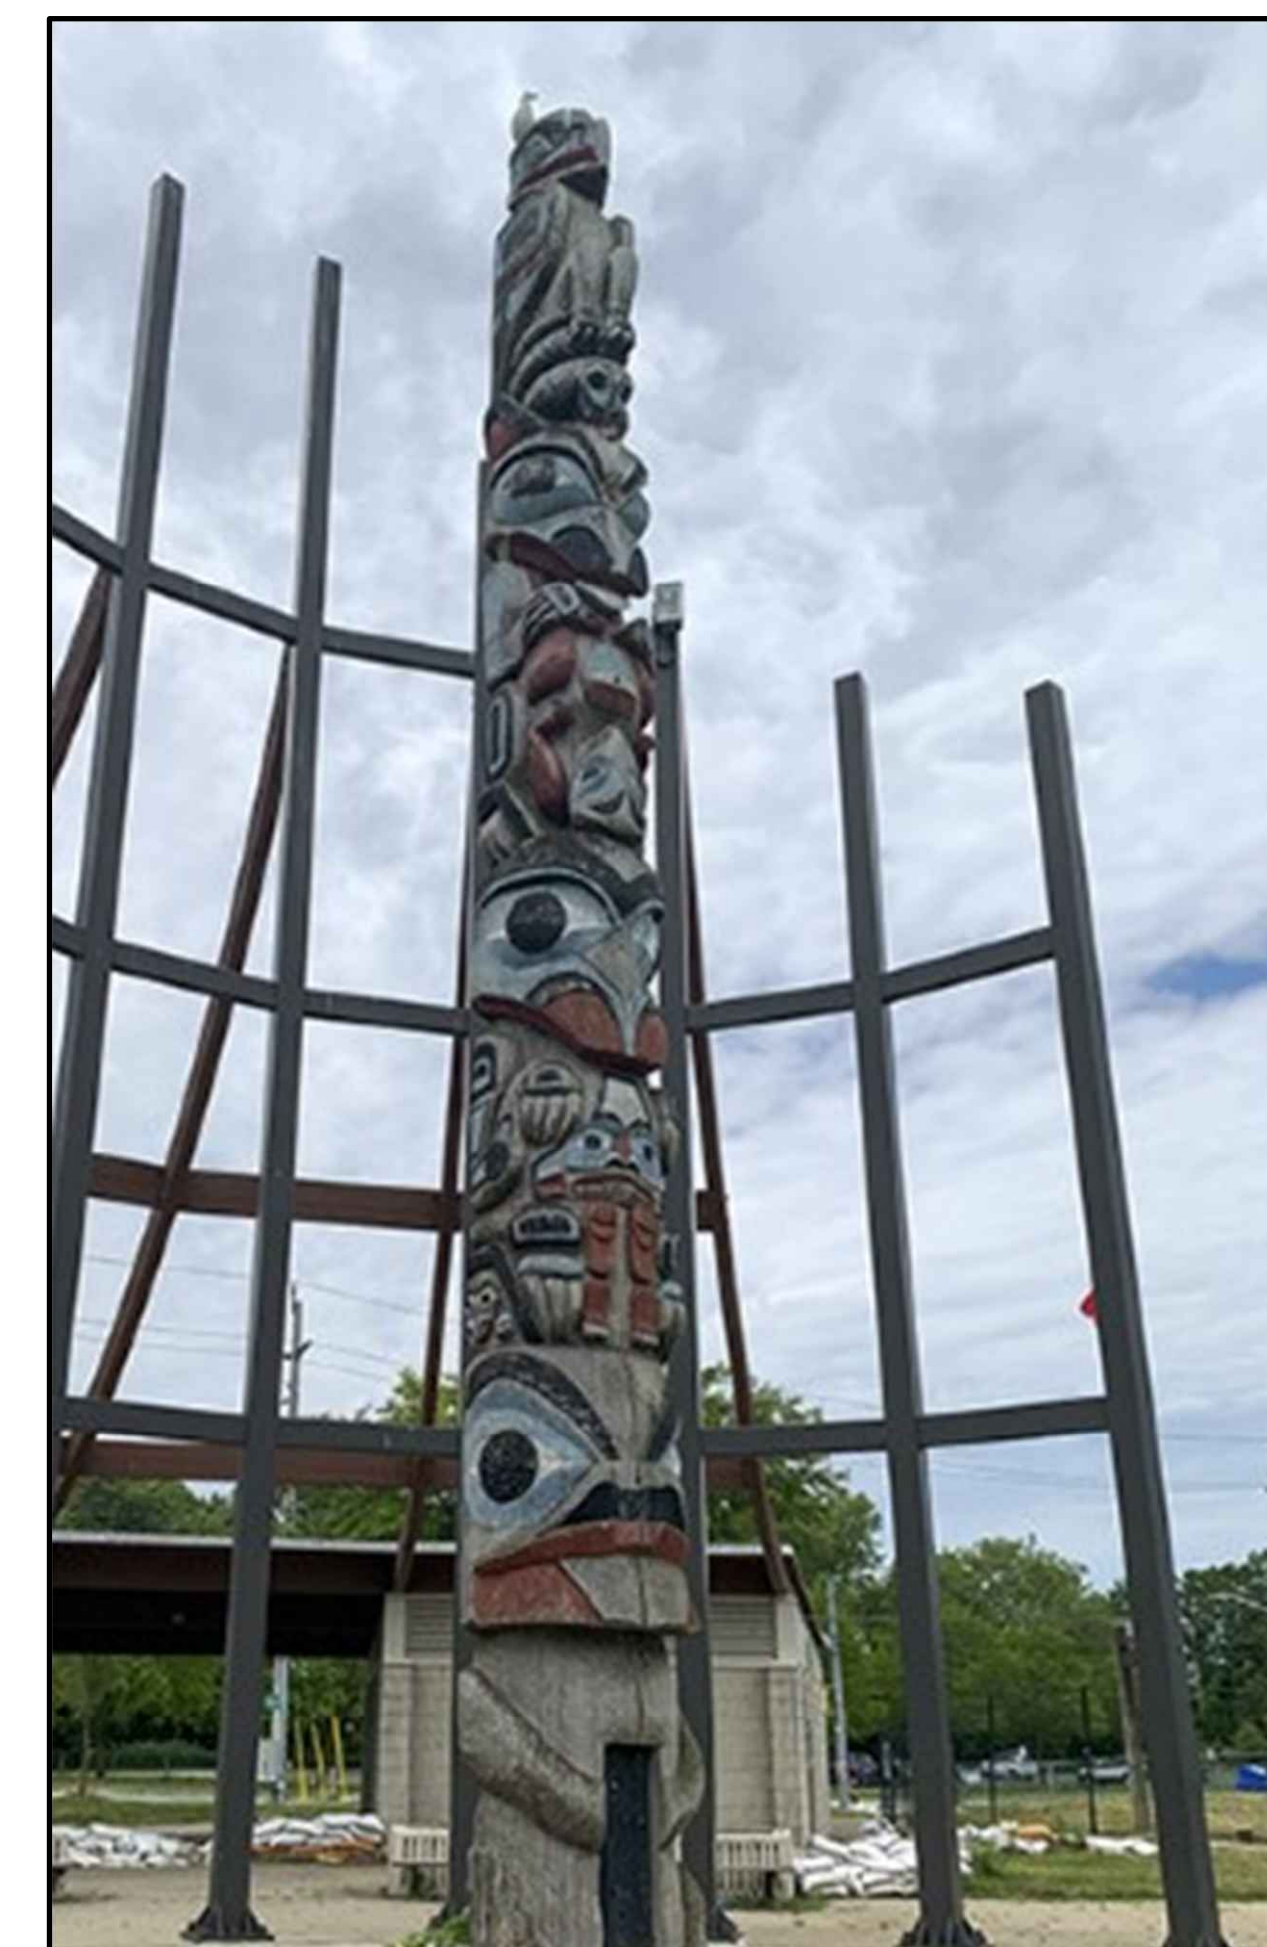
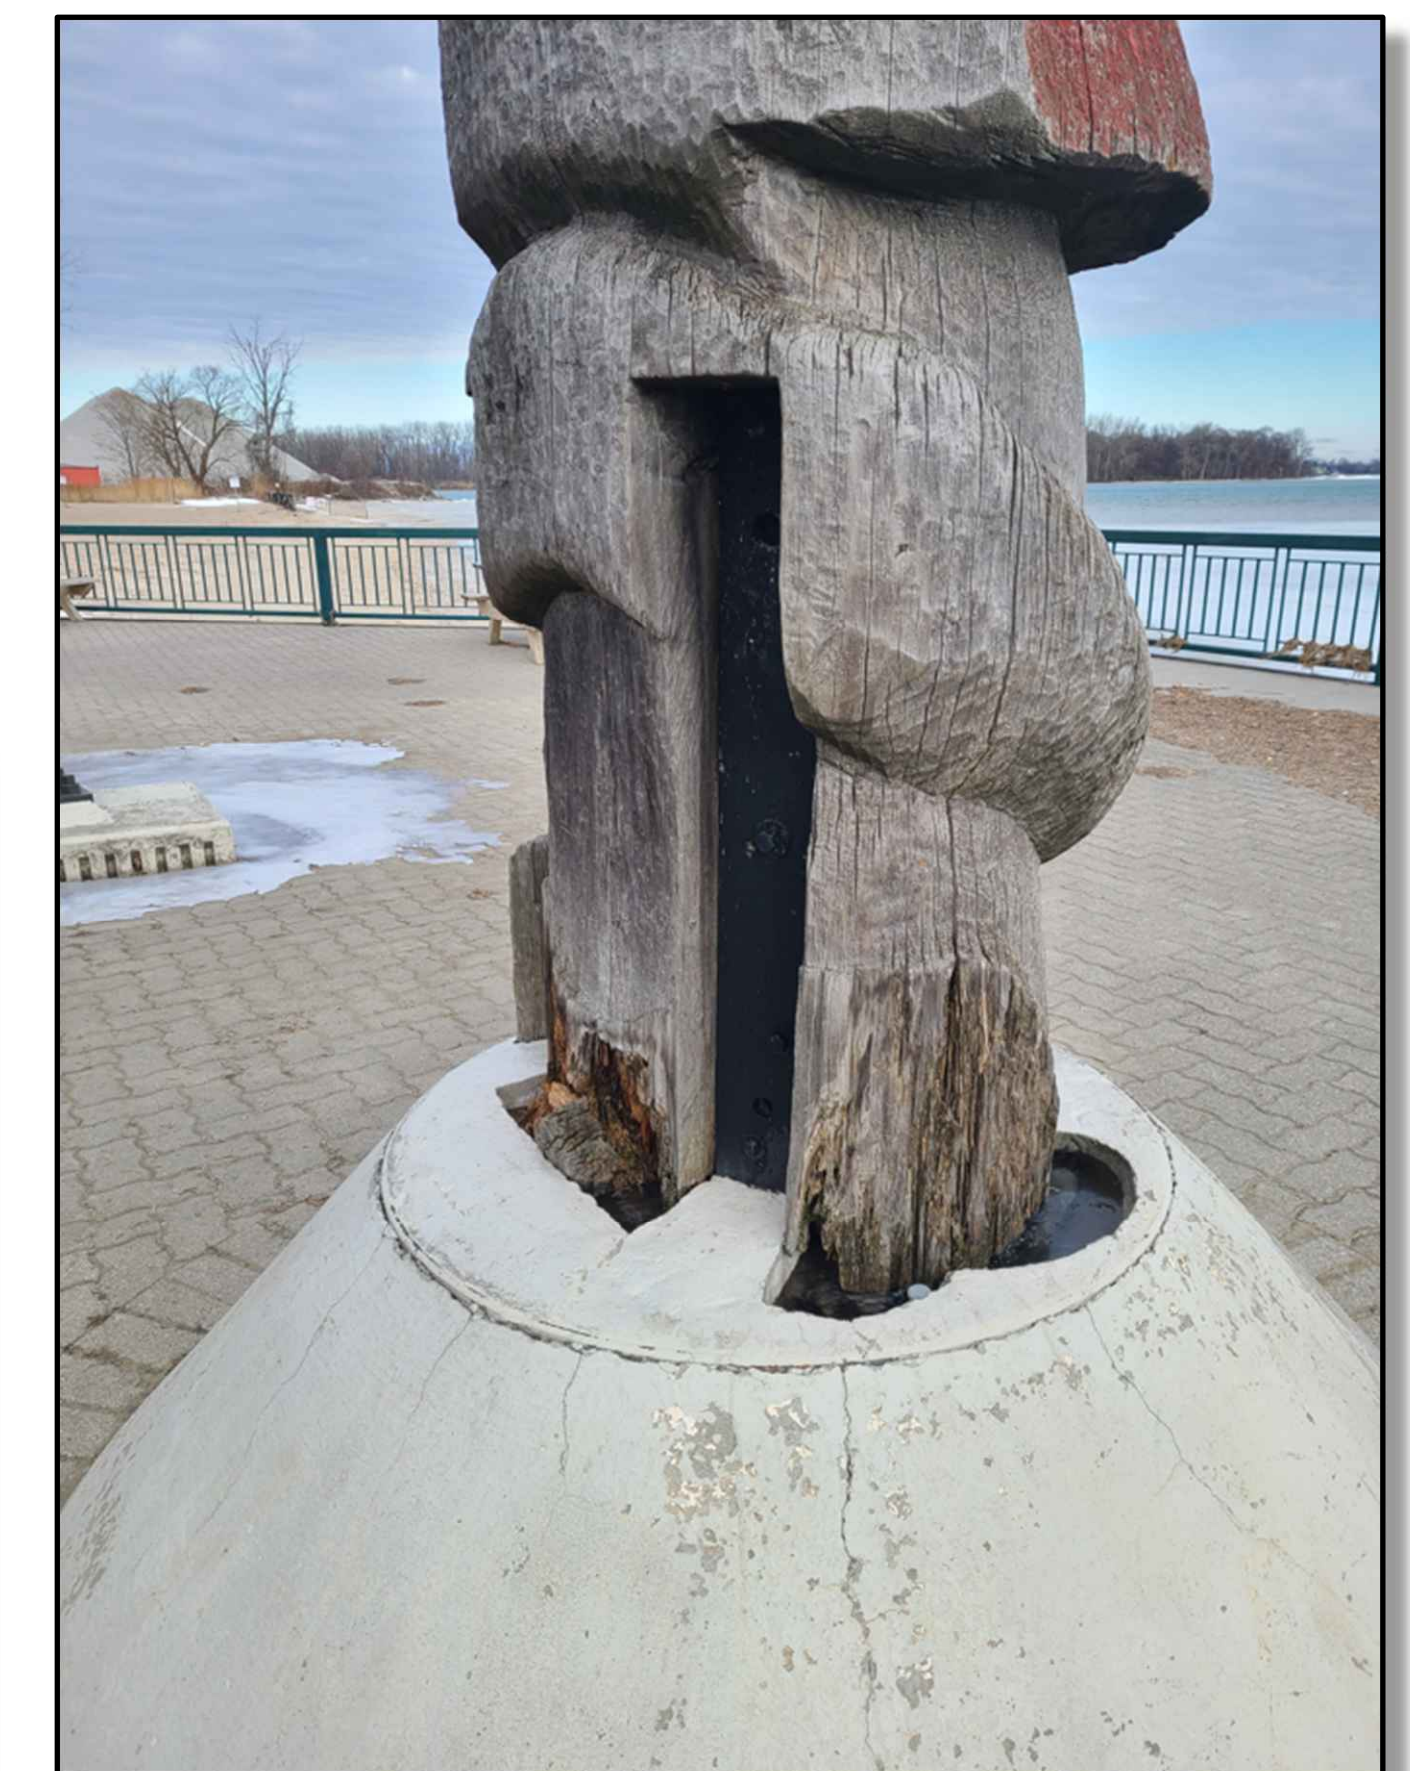
#### **Totem Pole Condition**

The existing connection at the base of the pole is in need of repairs. The concrete is starting to crumble and the wood is splintered and broken around the connection point. As well, the decorative paint on the pole is starting to wear and fade.
