# Environmental Evaluation Report

0 Catherine Street, Windsor

Rock Developments East Windsor Inc.

January 10, 2025

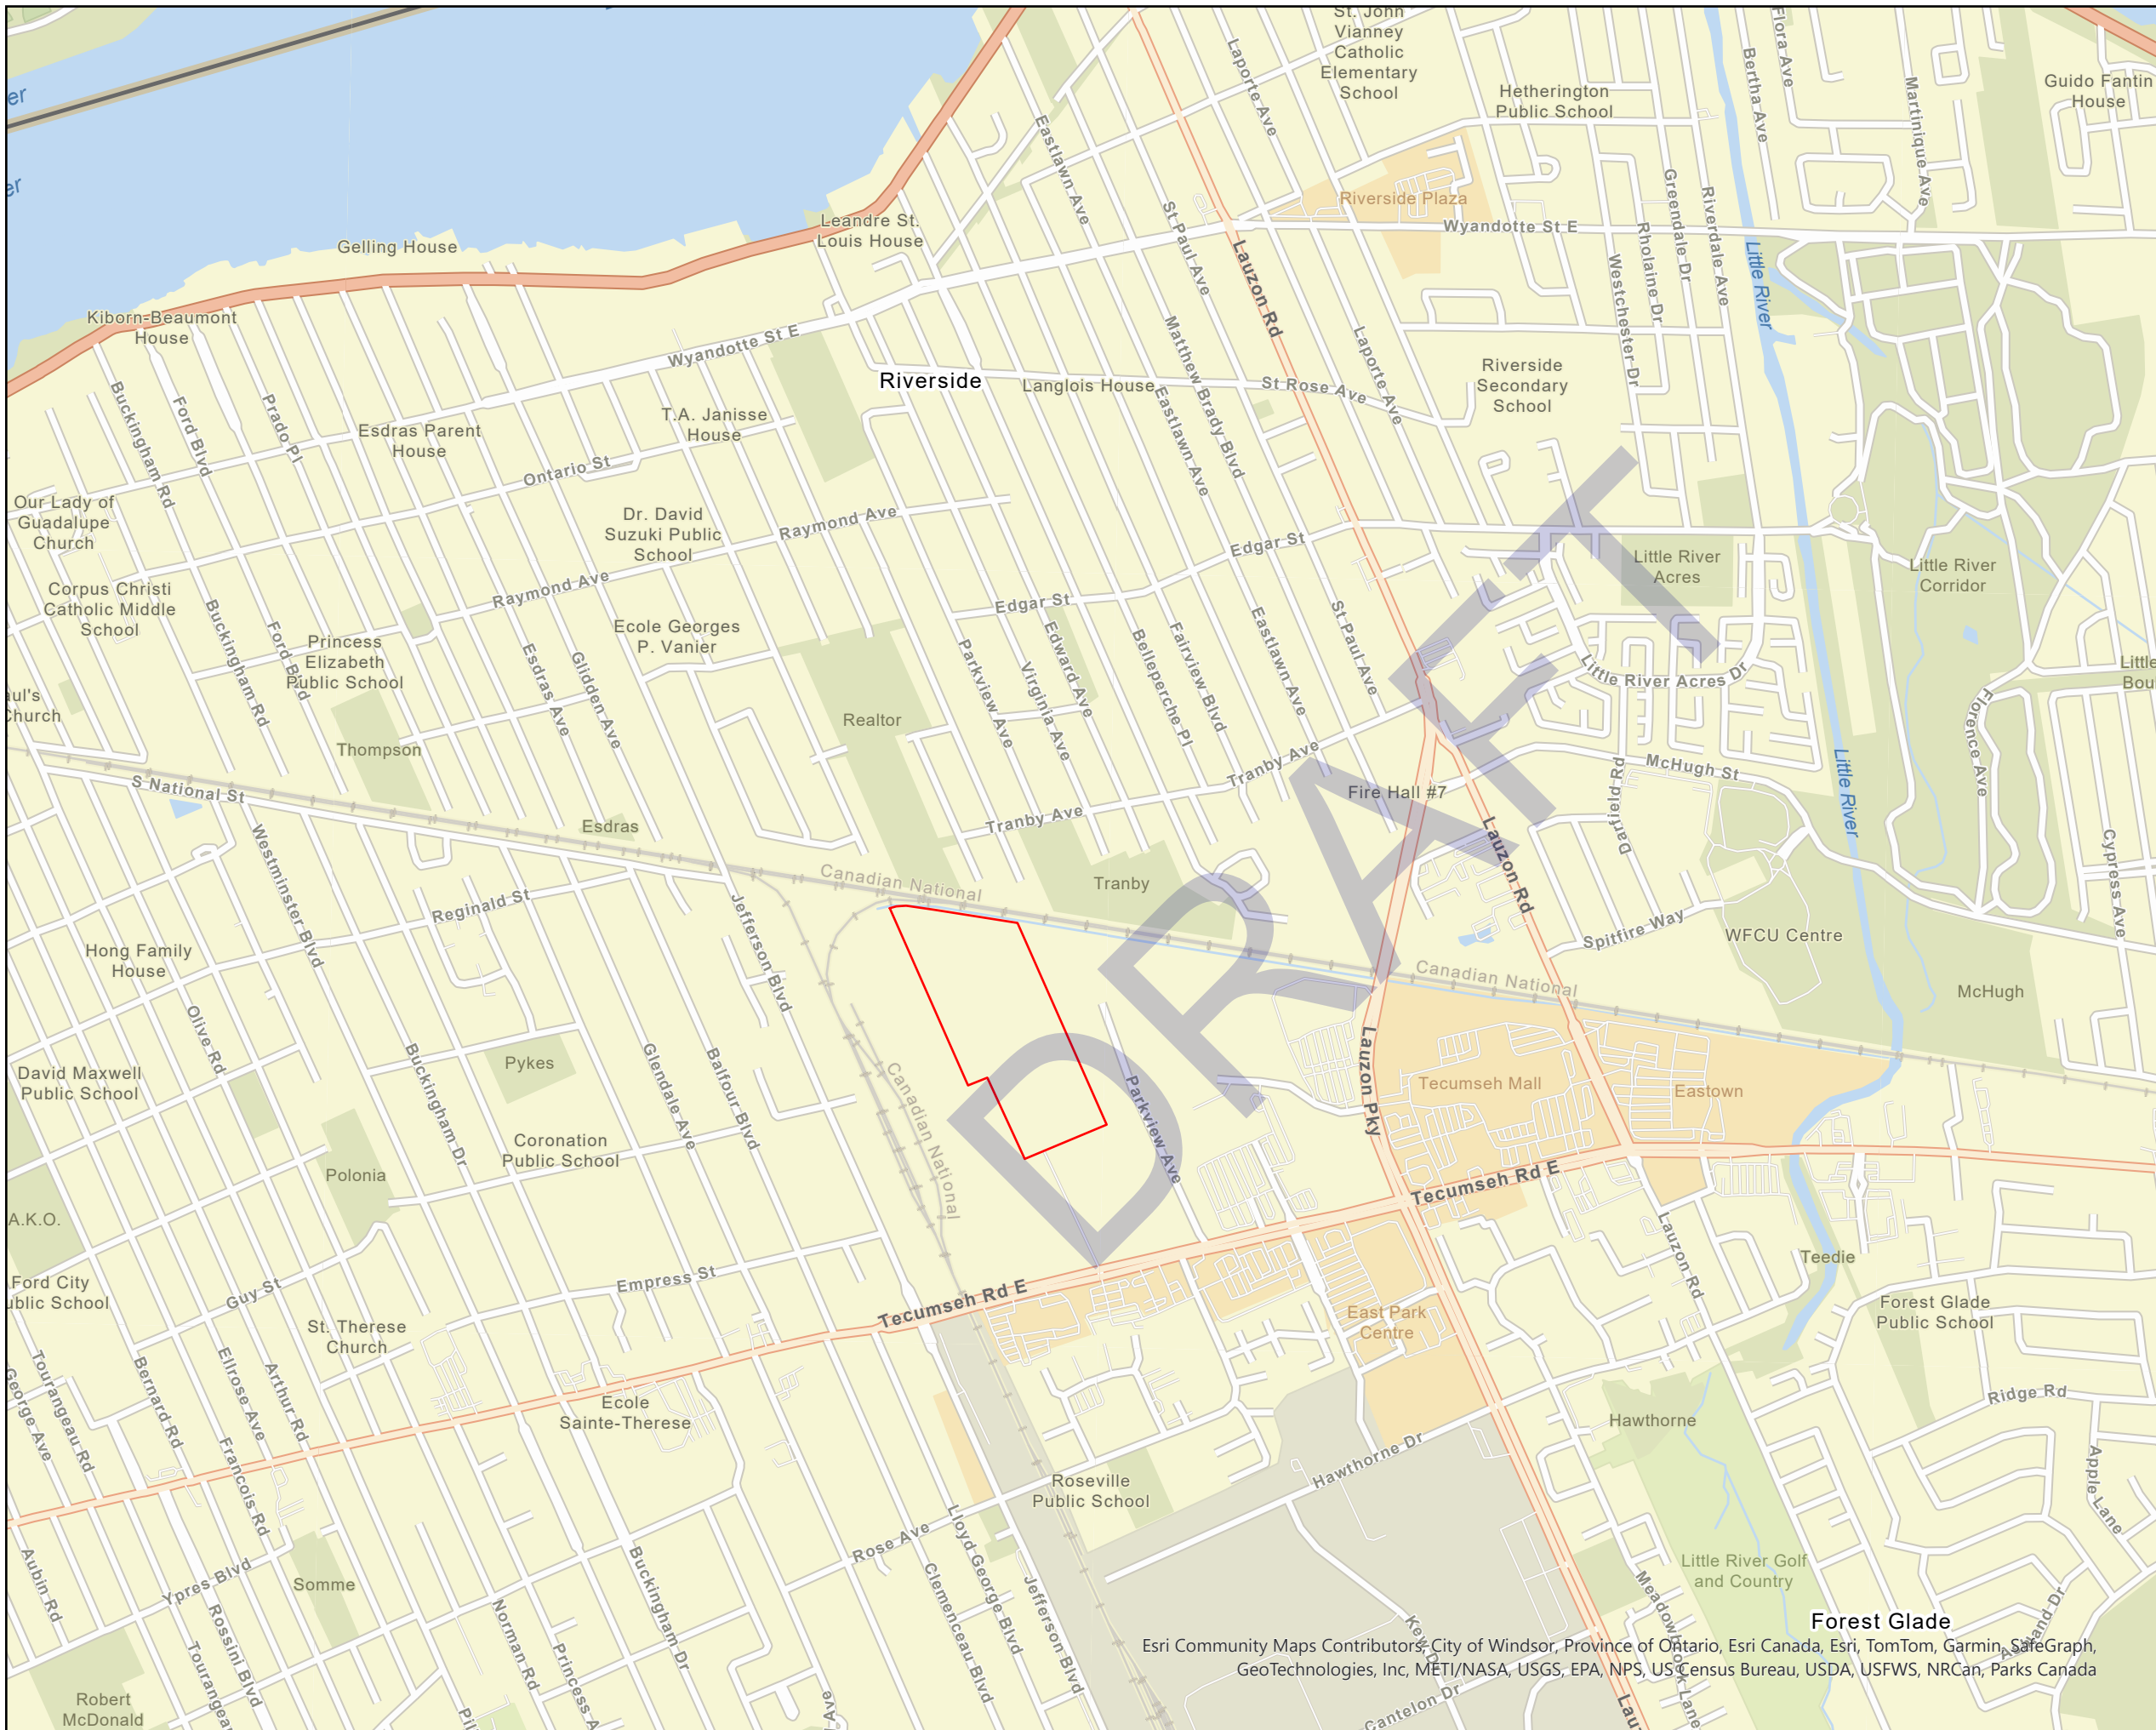
# Key Plan

The Subject Property is approximately 600m long (north - south) and 250m wide (east - west) with an area of approximately 14.6 hectares. The Subject Property currently consists of agricultural and disturbed land. It is bordered by a rail corridor to the north, agricultural land to the east, a Home Depot to the south and a meadow to the west. An agricultural drain exists to the north of the property, flowing in an eastward direction. **Figure 1** shows the property in a regional context.

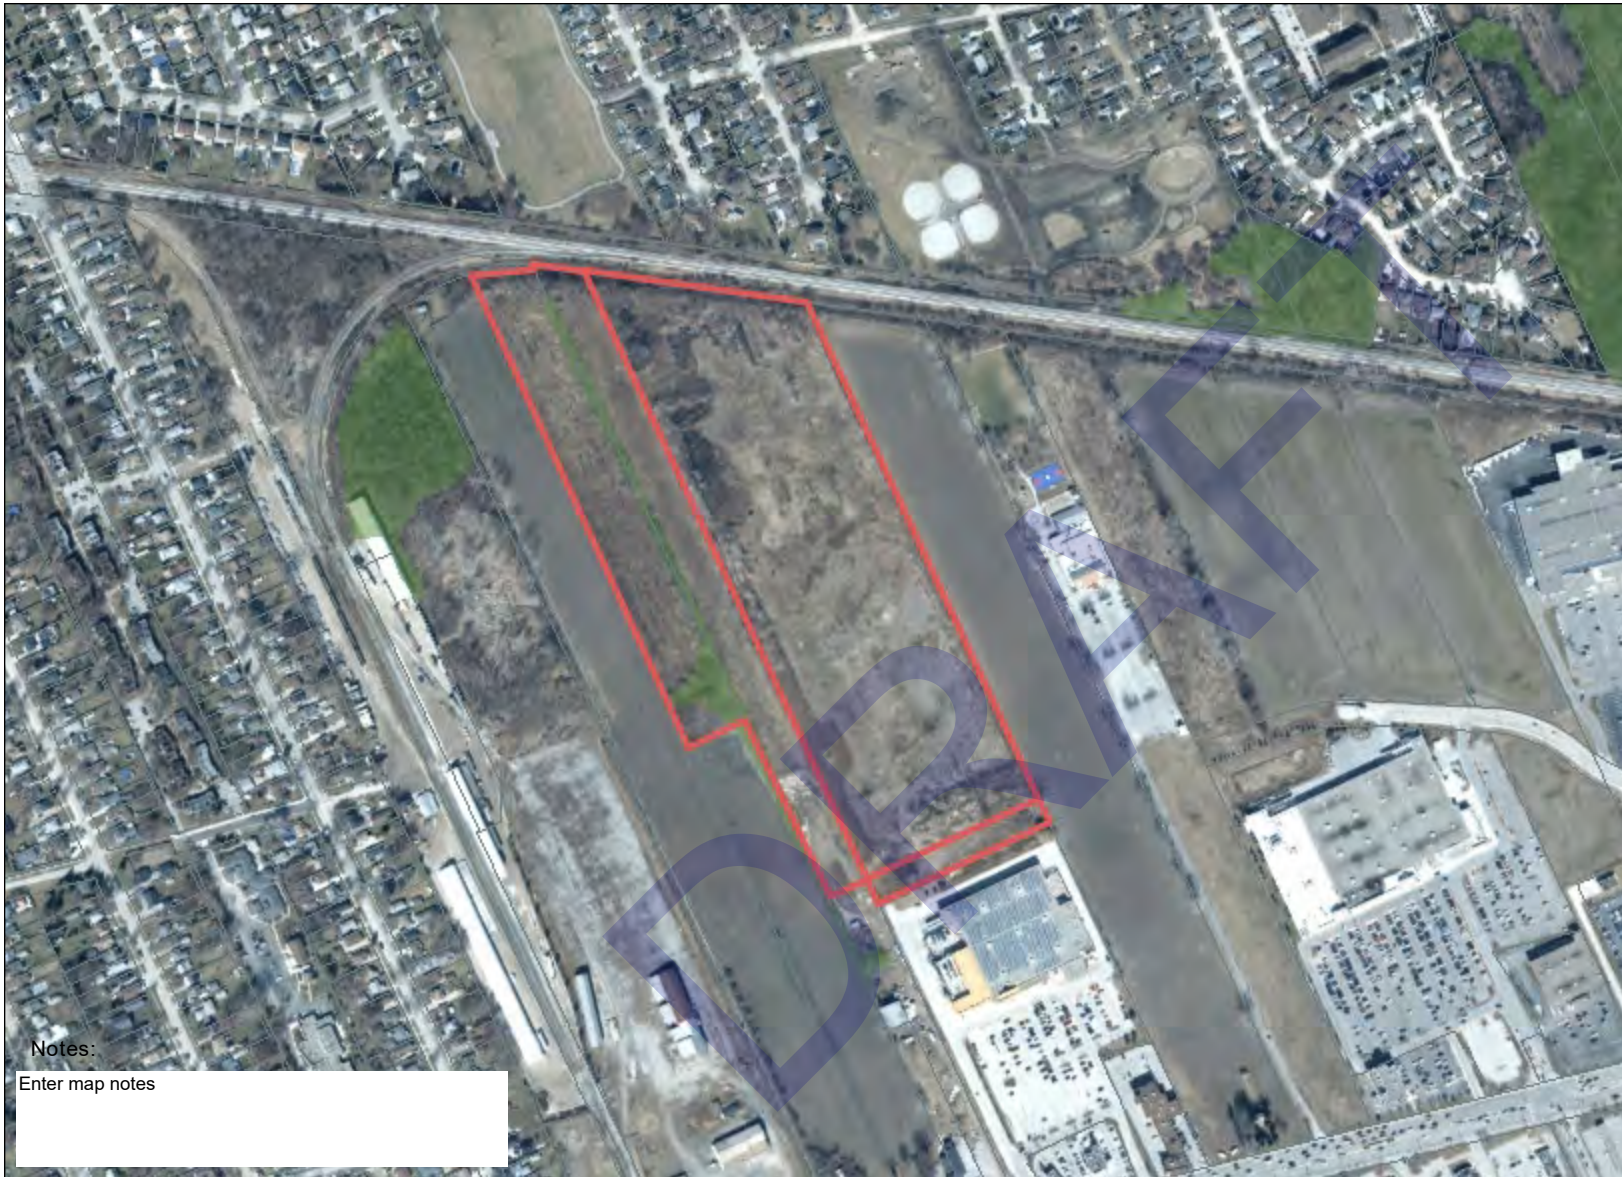
### Figure 3 - Natural Heritage Features

According to the Ministry of Natural Resources and Forestry Make-A-Map: Natural Heritage Areas online tool the Subject Property contains a small strip of woodland. Small patches of woodland also exist to the west and east of the property (Figure 3).

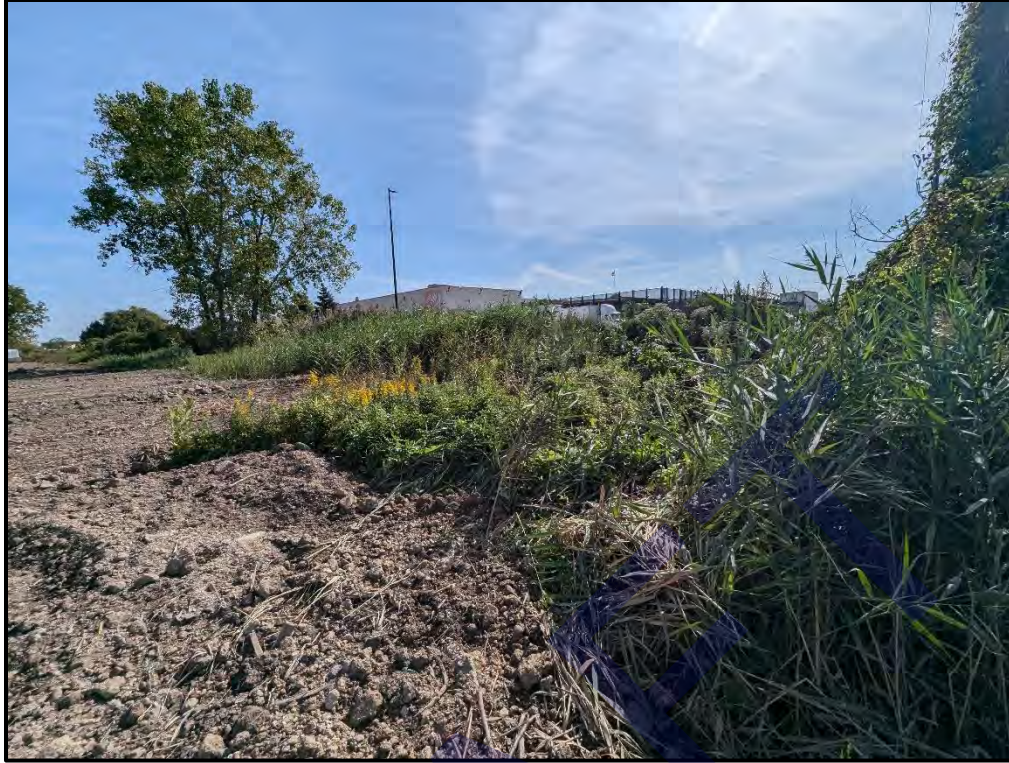
**Photo 1:** Open Disturbed Area, looking southeast.

The Open Disturbed Area occurs along the southern and part of the western property boundaries. European Reed (*Phragmites australis ssp. australis*) has established along the edges and fencerows in varying densities, from mature dense stands to sparse, linear formations. This area has been colonized by a mix of common, non-native invasive species, which are most concentrated along margins inaccessible to equipment and spread more sparsely toward the north. Evidence of recent grading and skid tracks were also observed in this area. **Photo 1** shows an example of this anthropogenic area during field investigations.

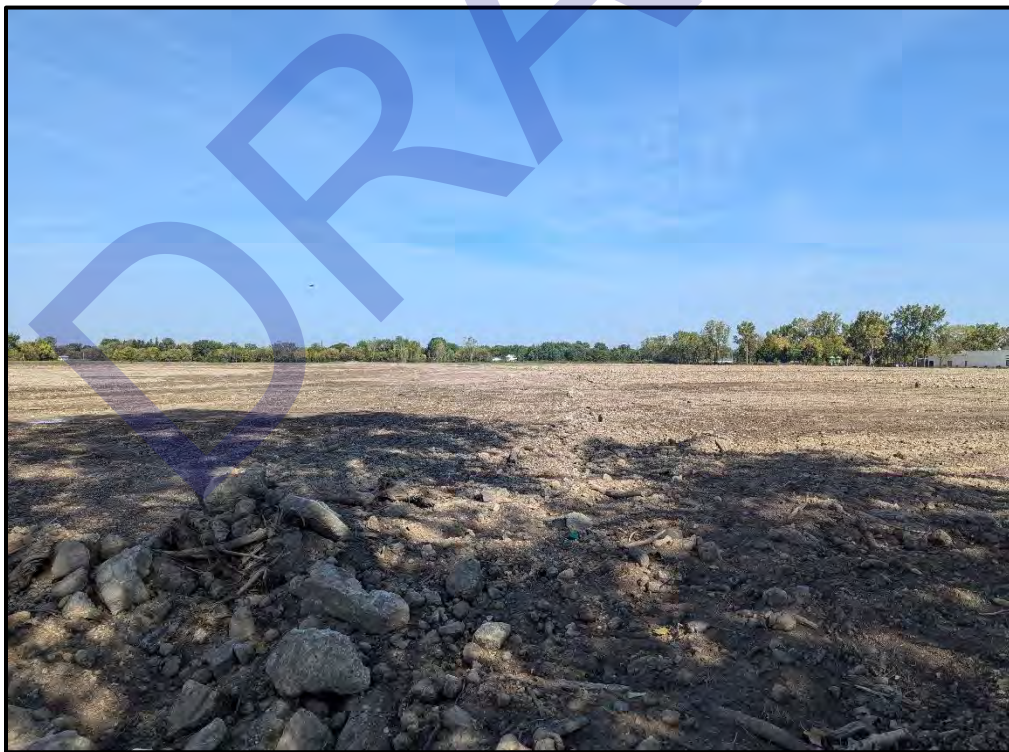
**Photo 2:** Large OAG, looking north.

The Open Agriculture (OAG) occupies the remaining portions of the Subject Property and includes two distinct sections, a large OAG and a small OAG, differentiated by crop type. The small OAG field appeared to be more recently tilled with a heavier level of recent disturbance shown through the presence of brush piles and upturned roots within the field. There was also a large section of pooling present in the small OAG field. This pooled area did not contain any vegetation. In 2024, the OAG fields were planted with soy. Soy is also planned for the 2025 growing season. At the time of site investigations, both fields had been harvested and tilled, allowing some time for non-native invasive plants to establish in scattered and patchy patterns across each field, with higher plant densities observed in the small OAG. **Photo 2** shows an example of this anthropogenic area during field investigations.

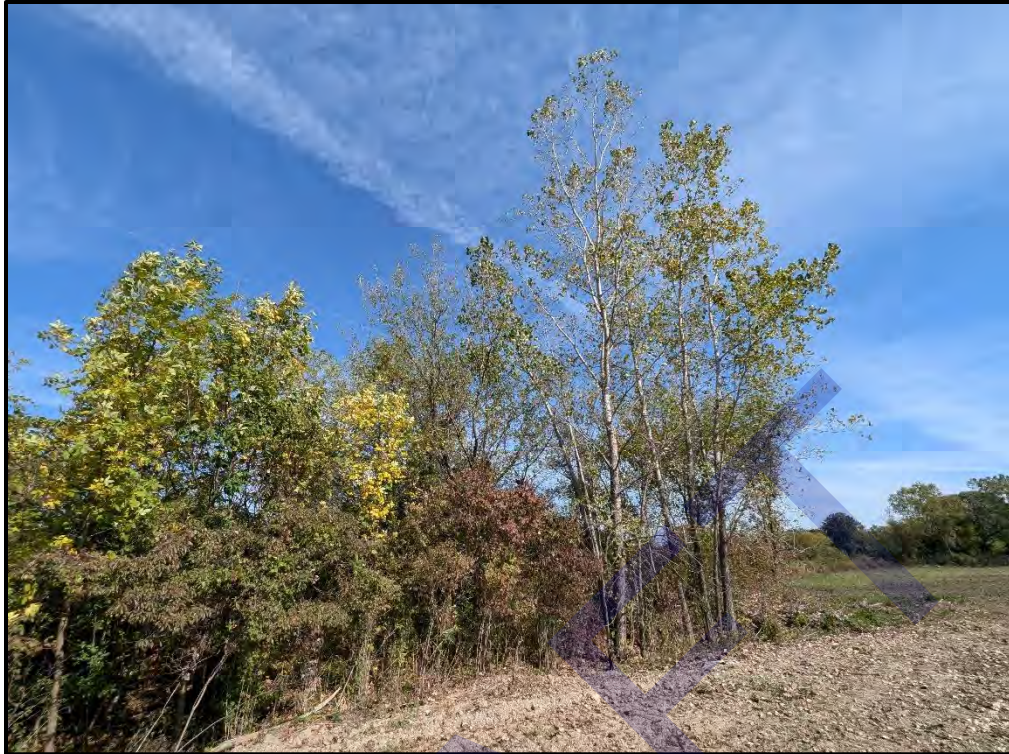
**Photo 3:** Fresh - Moist Deciduous Woodland Ecosite (WODM5), looking northeast.

The Fresh - Moist Deciduous Woodland Ecosite (WODM5) extends along the northern property boundary and is distributed across several small polygons. These polygons are predominantly composed of young trees interspersed with occasional canopy veterans. The WODM5 exhibits a semi-closed canopy observing 35% < tree cover < 60% with a cultural legacy. One WODM5 polygon, on the eastern property boundary contains a prominent standing pool of water, bordered by Eastern Cottonwood (*Populus deltoides*). Several central polygons exhibit vertical cuts along their southern edges, with exposed tree roots visible. These cuts measure approximately 1 to 1.5 meters in height. The remaining polygons exhibit a heterogeneous composition of tree species lacking typical associations. The canopy is primarily dominated by Manitoba Maple (*Acer negundo*), with occasional to rare occurrences of Eastern Cottonwood, Silver Maple (*Acer saccharinum*), and Bur Oak (*Quercus macrocarpa*). The tall shrub layer (2–10 m) is characterized by regenerating young trees, predominantly Green Ash (*Fraxinus pennsylvanica*), with occasional to rare occurrences of White Elm (*Ulmus americana*), Hackberry (*Celtis occidentalis*), and Common Apple (*Malus pumila*). A total of 26 species were observed in this community, 17 (65%) native species exist, while nine (35%) are classified as non-native. The mean Coefficient of Wetness (CW) for this community is 1.08. This number indicates that there is a slight predominance of upland species present. The mean Coefficient of Conservatism (CC) for this community is 2.08. This number indicates the floristic quality is not sufficient to identify a community of remnant natural quality. The Floristic Quality Index

(FQI) for this community is 10.59 indicating low significance from a natural quality perspective. Disturbance history includes light browse, gaps in the canopy, flooding, tracks and trails, cutting, dumping and invasive species. **Photo 3** shows an example of site conditions as they were during field investigations.

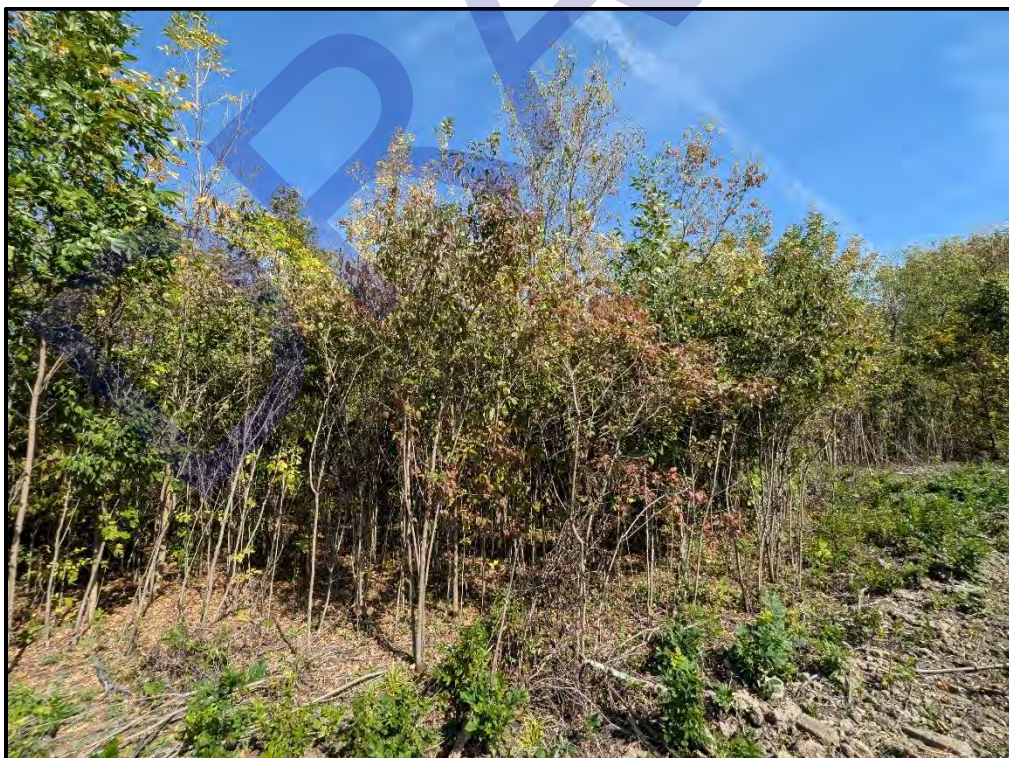
**Photo 4:** Fresh - Moist Deciduous Thicket Ecosite (THDM5), looking north.

The Fresh - Moist Deciduous Thicket Ecosite (THDM5) surrounds the WODM5 polygons and extends down to the southern edge of the Hawkins Drain. The THDM5 is dominated by a mix of common native and exotic shrub species with shrub cover > 25%; tree cover < 25%; varying from scattered and patchy to continuous. A total of 41 species were observed in this community, 22 (54%) native species exist, while 19 (46%) are classified as non-native. The mean CW for this community is 0.73. This number indicates that there is a slight predominance of upland species present. This number is slightly lower than expected due to the presence of several facultative and obligate wetland species occurring at the interface of this community and the Hawkins Drain (some within the drain bed itself). The mean CC for this community is 1.22. This number indicates the floristic quality is not sufficient to identify a community of remnant natural quality. The FQI for this community is 7.81 indicating low significance from a natural quality perspective. Disturbance history includes light browse, anthropogenic disturbance (CSP Culverts), steep banks and invasive species. **Photo 4** shows an example of site conditions as they were during field investigations.

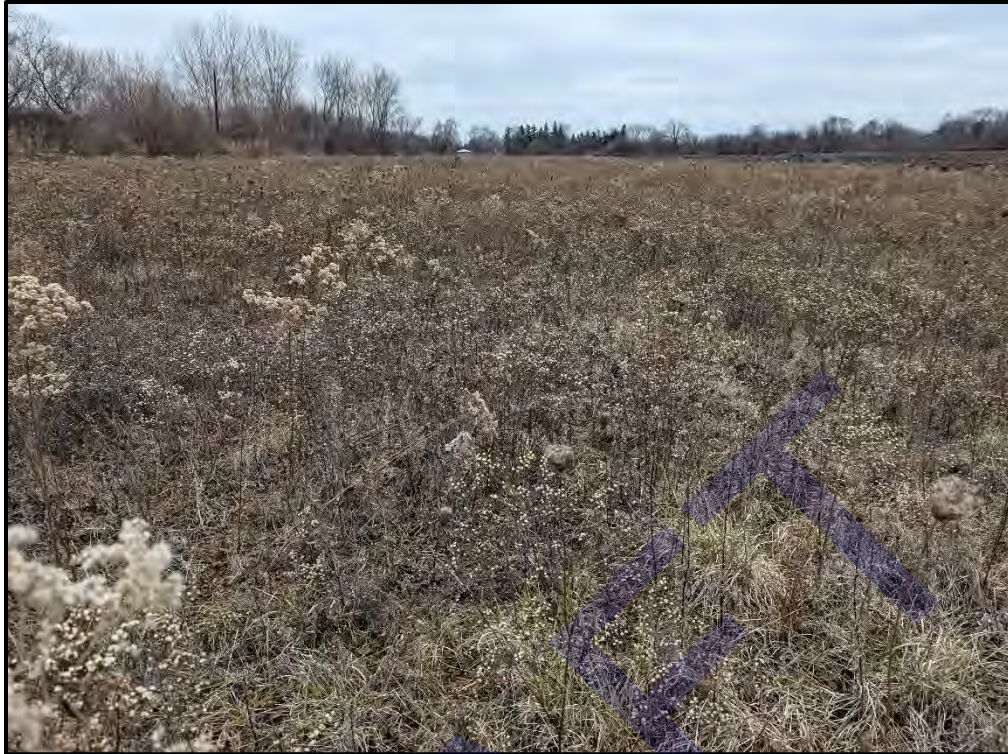
**Photo 5:** Fresh - Moist Mixed Meadow Ecosite (MEMM4), looking north.

The Fresh - Moist Mixed Meadow Ecosite (MEMM4) is located on the adjacent lands to the west and along the northern bank of the Hawkins Drain. The MEMM4 is an open herbaceous community with tree and shrub cover < 25%, ranging from scattered and patchy to continuous meadow. The MEMM4 ecosite located on the adjacent lands is a higher-quality mixed meadow characterized by greater native species diversity and the presence of several provincially significant plants. Portions of this MEMM4 polygon exhibit areas of standing, pooled water, with facultative wetland species present; however, their coverage does not exceed 50%. The MEMM4 located along the northern bank of the drain is dominated by invasive species and demonstrates relatively low species diversity in comparison. A total of 48 species were observed in this community, 23 (48%) native species exist, while 25 (52%) are classified as non-native. The mean CW for this community is 1.33. This number indicates that there is a slight predominance of upland species present. The mean CC for this community is 1.04. This number indicates the floristic quality is not sufficient to identify a community of remnant natural quality. The FQI for this community is 10.43 indicating low significance from a natural quality perspective. Disturbance history includes light browse, flooding and invasive species. **Photo 5** shows an example of site conditions as they were during field investigations.

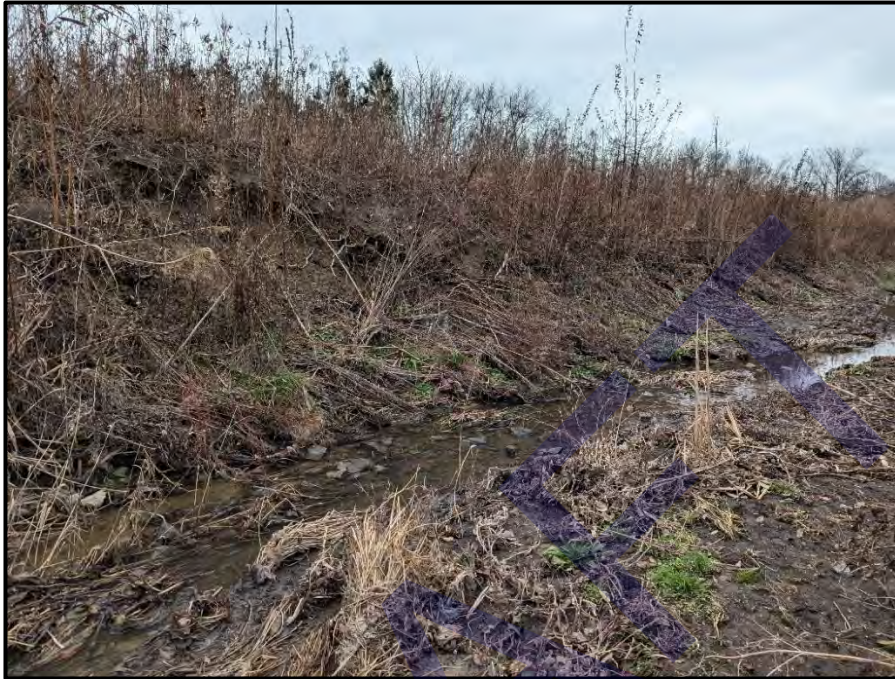
Picture 6: Hawkins drain, looking east, during December 2024 field investigations.

Hawkins Drain is a channelized watercourse, classified as a Class F intermittent drain by DFO, typically remains dry for at least three months each year; however, during December 2024 field investigations, it was observed to contain relatively deep flowing water. Multiple outlets along the northern property border facilitate water flow from the THDM5 and WODM5 communities into the drain, yet only the eastern CSP culvert (Outlet F) and Reach B (Agricultural Ditch) are operating effectively, as the inlets to the other drainage culverts have become buried. Although there is some evidence of bank erosion, the area is predominantly covered with dense vegetation, indicating a relatively healthy ecosystem. This drain likely acts as a movement corridor for local wildlife.

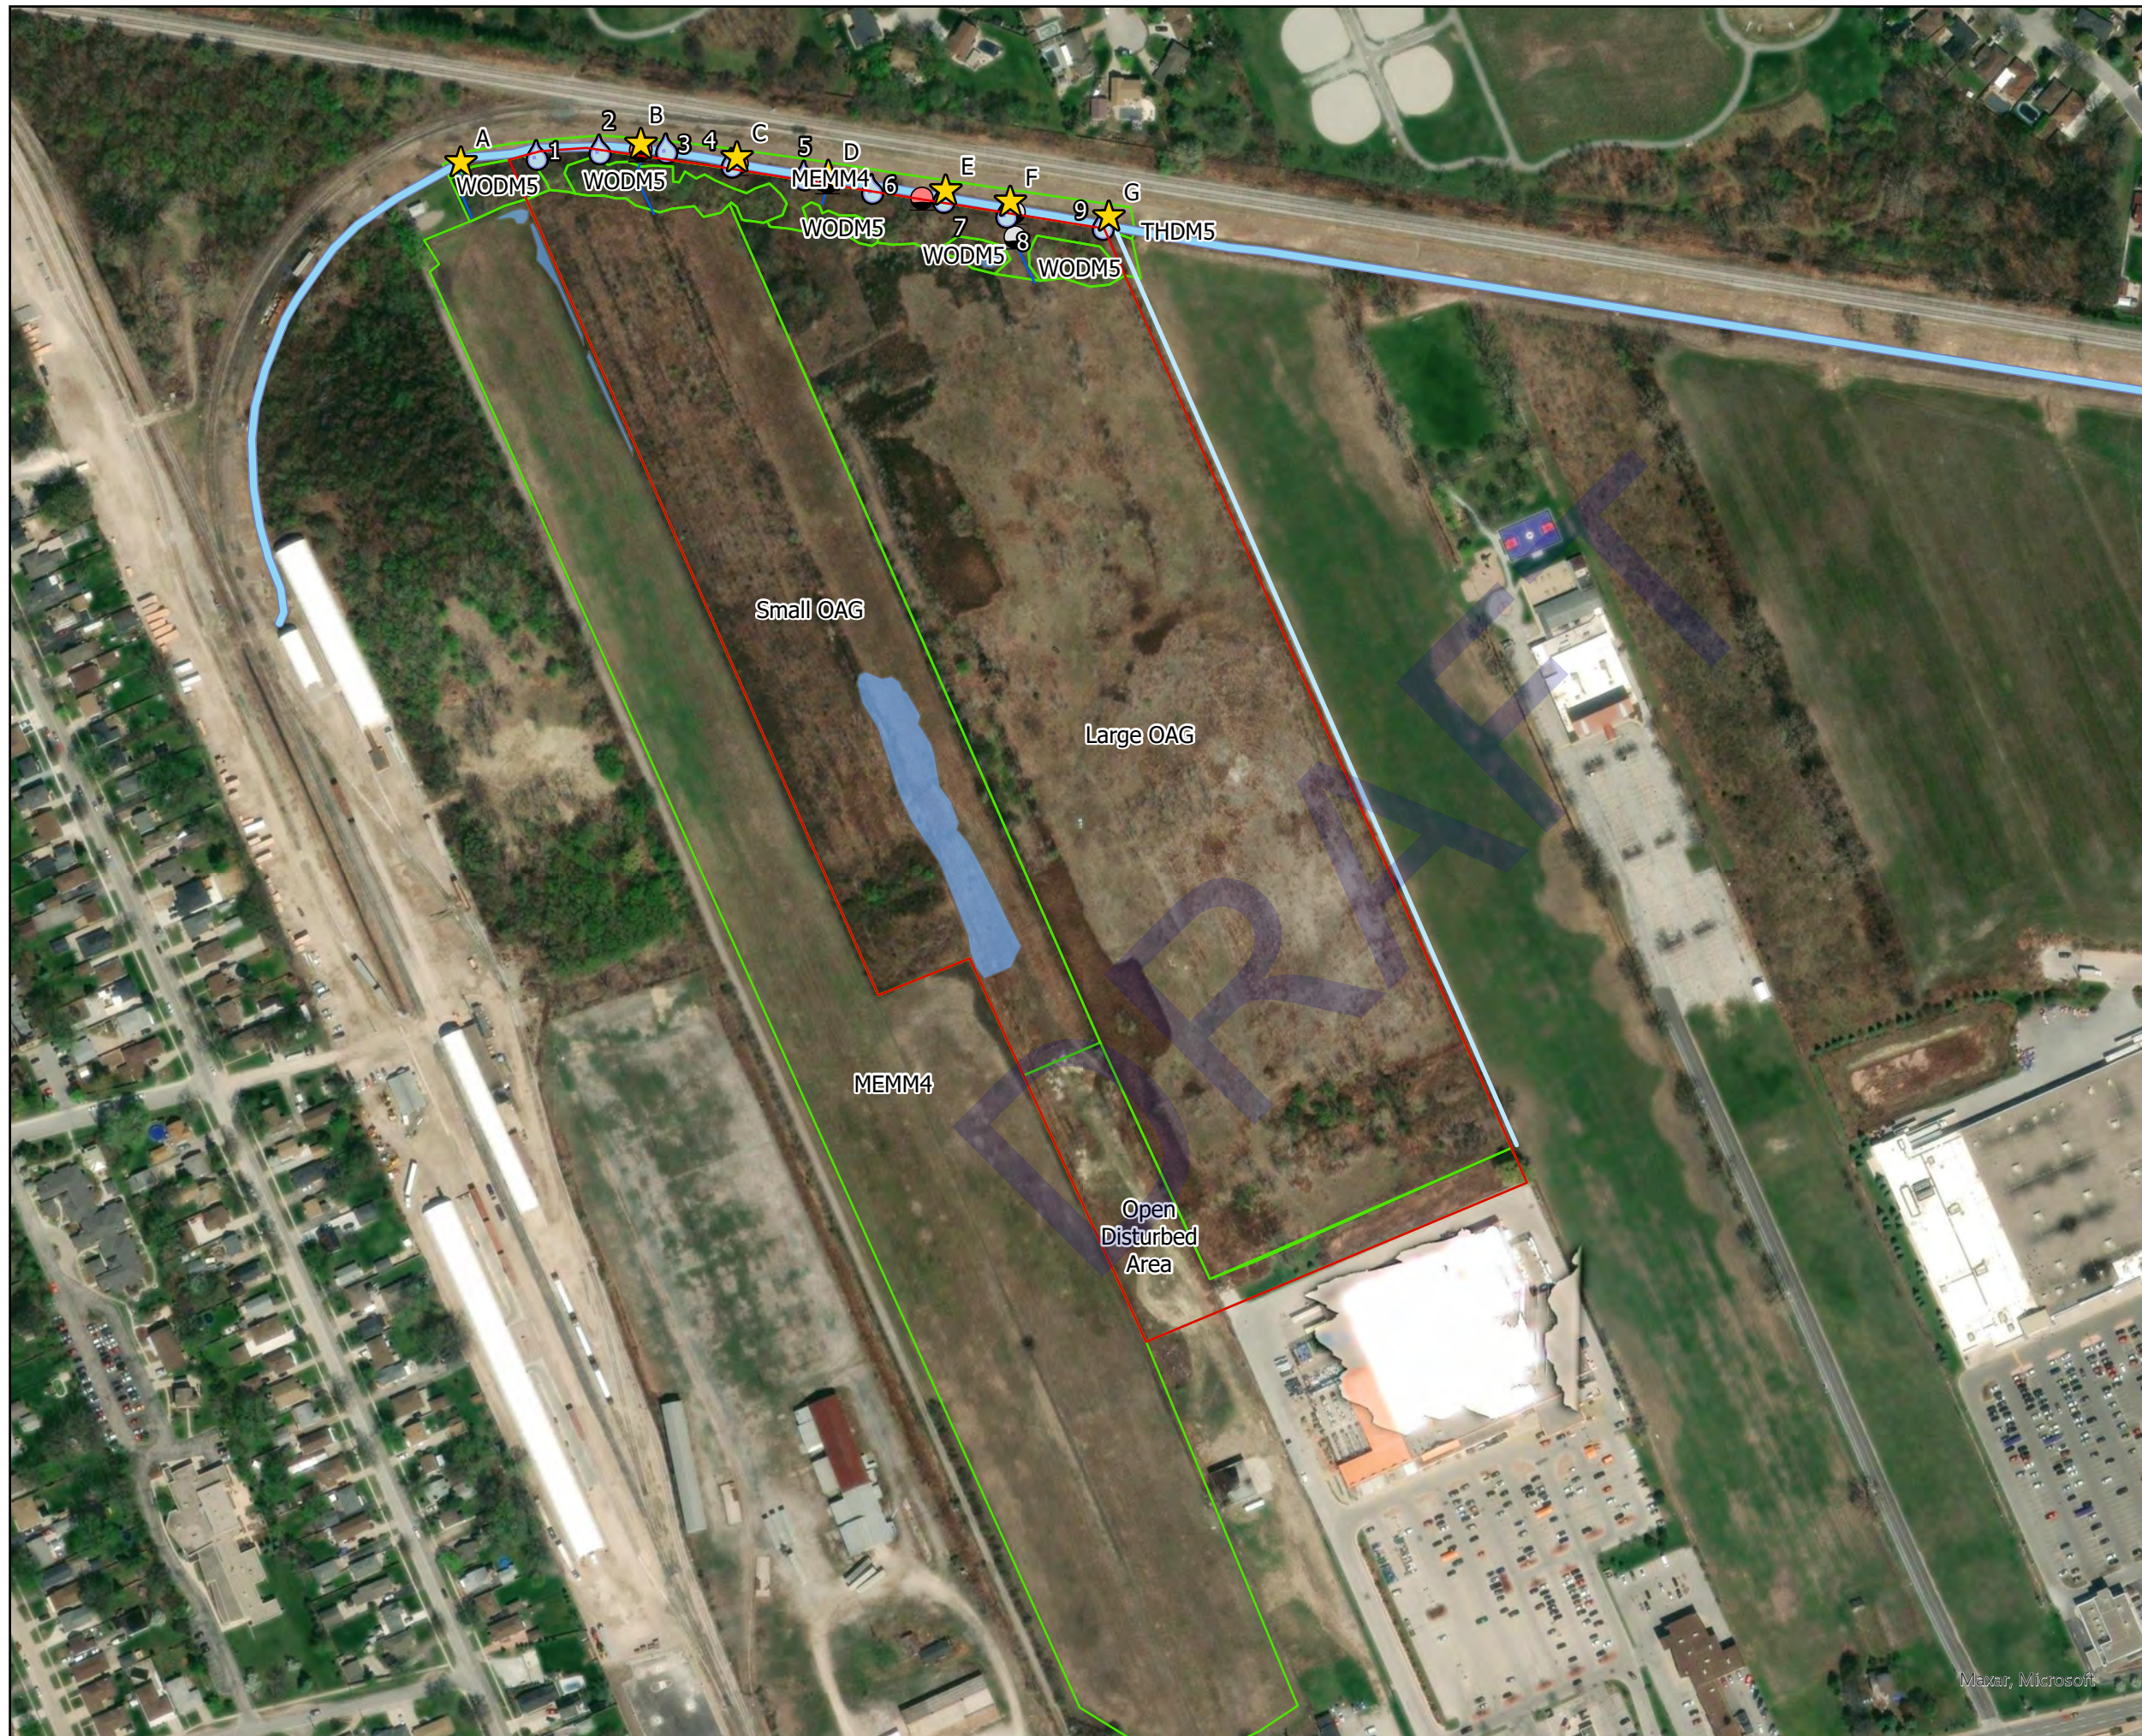
Figure No.: 6  
 Project No.: IES24-211  
 Scale: 1:3,200  
 Date: January 9, 2025  
 Creator: Nicole Wajmer

An Aquatic Assessment was conducted along Hawkins Drain to evaluate the current aquatic and ecological conditions in the area. Despite being classified as a Class F Drain, indicative of an intermittent watercourse, significant amounts of slowly flowing water were observed during the December field investigations. The banks of the drain were found to be relatively steep and densely vegetated. Notably, a CN railway runs along the top of the northern bank, while the southern banks are characterized by woodland and thicket features present on the Subject Property. Evidence of erosion at the toe of the slope and riparian areas suggests that the drain is capable of supporting higher flow in different seasons. Additionally, several small headwater drainage features originating from the Subject Property discharge into Hawkins Drain, further contributing to its hydrology. Based on these observations, it is likely that Hawkins Drain can sustain warm water fish species, enhancing its ecological value. **Table 5** summarizes the results of the aquatic assessment and **Figure 6** shows survey points within them.

To conduct the assessment the HDF was separated into two main reaches. While smaller HDFs that flowed northward ultimately emptying into Hawkins Drain were observed within the THDM5 and WODM5 communities, they were not formally evaluated as they will be retained and protected through mitigation measures as part of the proposed development. The reach delineation, data point locations, and culverts can be seen in **Figure 6**. Results from the HDF Assessment are summarized in **Table 6**.

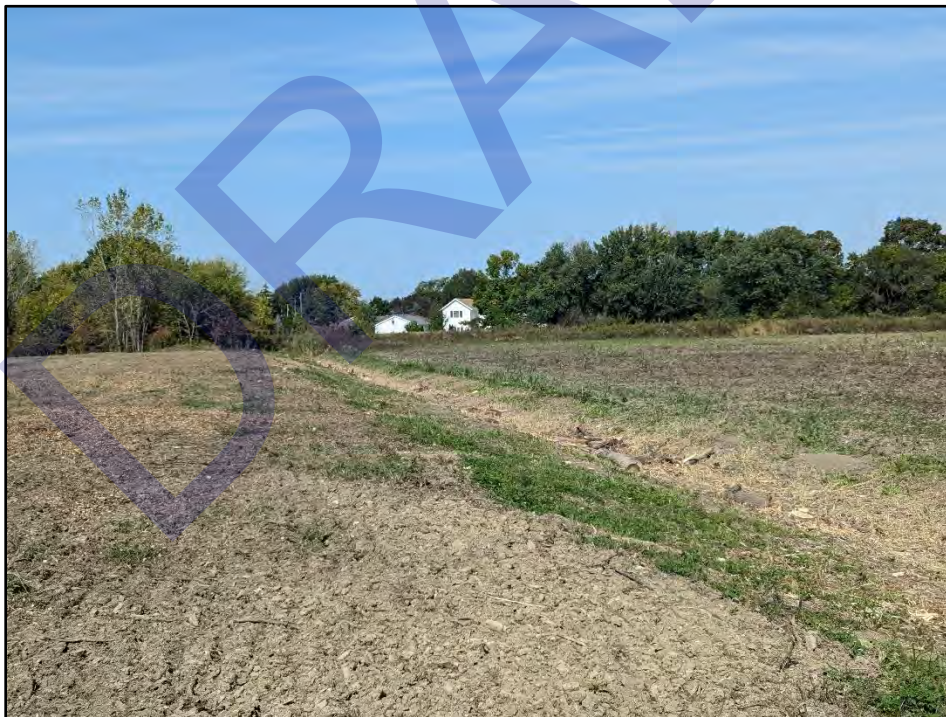
**Photo 9:** Agricultural Ditch during October 3<sup>rd</sup>, 2024, site visit.

The man-made channelized HDF is a constructed ditch situated between two agricultural fields, designed to facilitate the movement of water and sediment northward into Hawkins Drain. Evidence of past disturbances, including the removal of trees and the clearing of stumps and logs, suggests that the area was actively modified to create this drainage system. At its northern outlet, the drain passes through a THDM5 community and is reinforced with rip rap to prevent erosion. During the December 2024 field investigations, water was observed actively flowing through the feature, following a heavy rain event that had occurred the previous day. This channel not only serves its drainage purpose but also likely transports agricultural chemicals from the adjacent fields into Hawkins Drain.

Vegetation at the end of ditch is dominated by European Reed, Sweetbriar, Panicked Aster, Tall Goldenrod, Reed Canarygrass, Yellow Avens, Grass-Oleaved Goldenrod and Rough-leaved Dogwood.

Reach 2 (Agricultural Drain) has contributing functions for hydrology and fish habitat as ephemeral water flow in the spring or after large events transports allochthonous materials downstream to fish-bearing reaches and provides sources of food. Reach 2 has limited functions for riparian and terrestrial habitats as adjacent riparian and terrestrial habitats consist of cropped land. As such, the management recommendation is Mitigation. Refer to **Section 5.3** for mitigation recommendations for the HDFs.

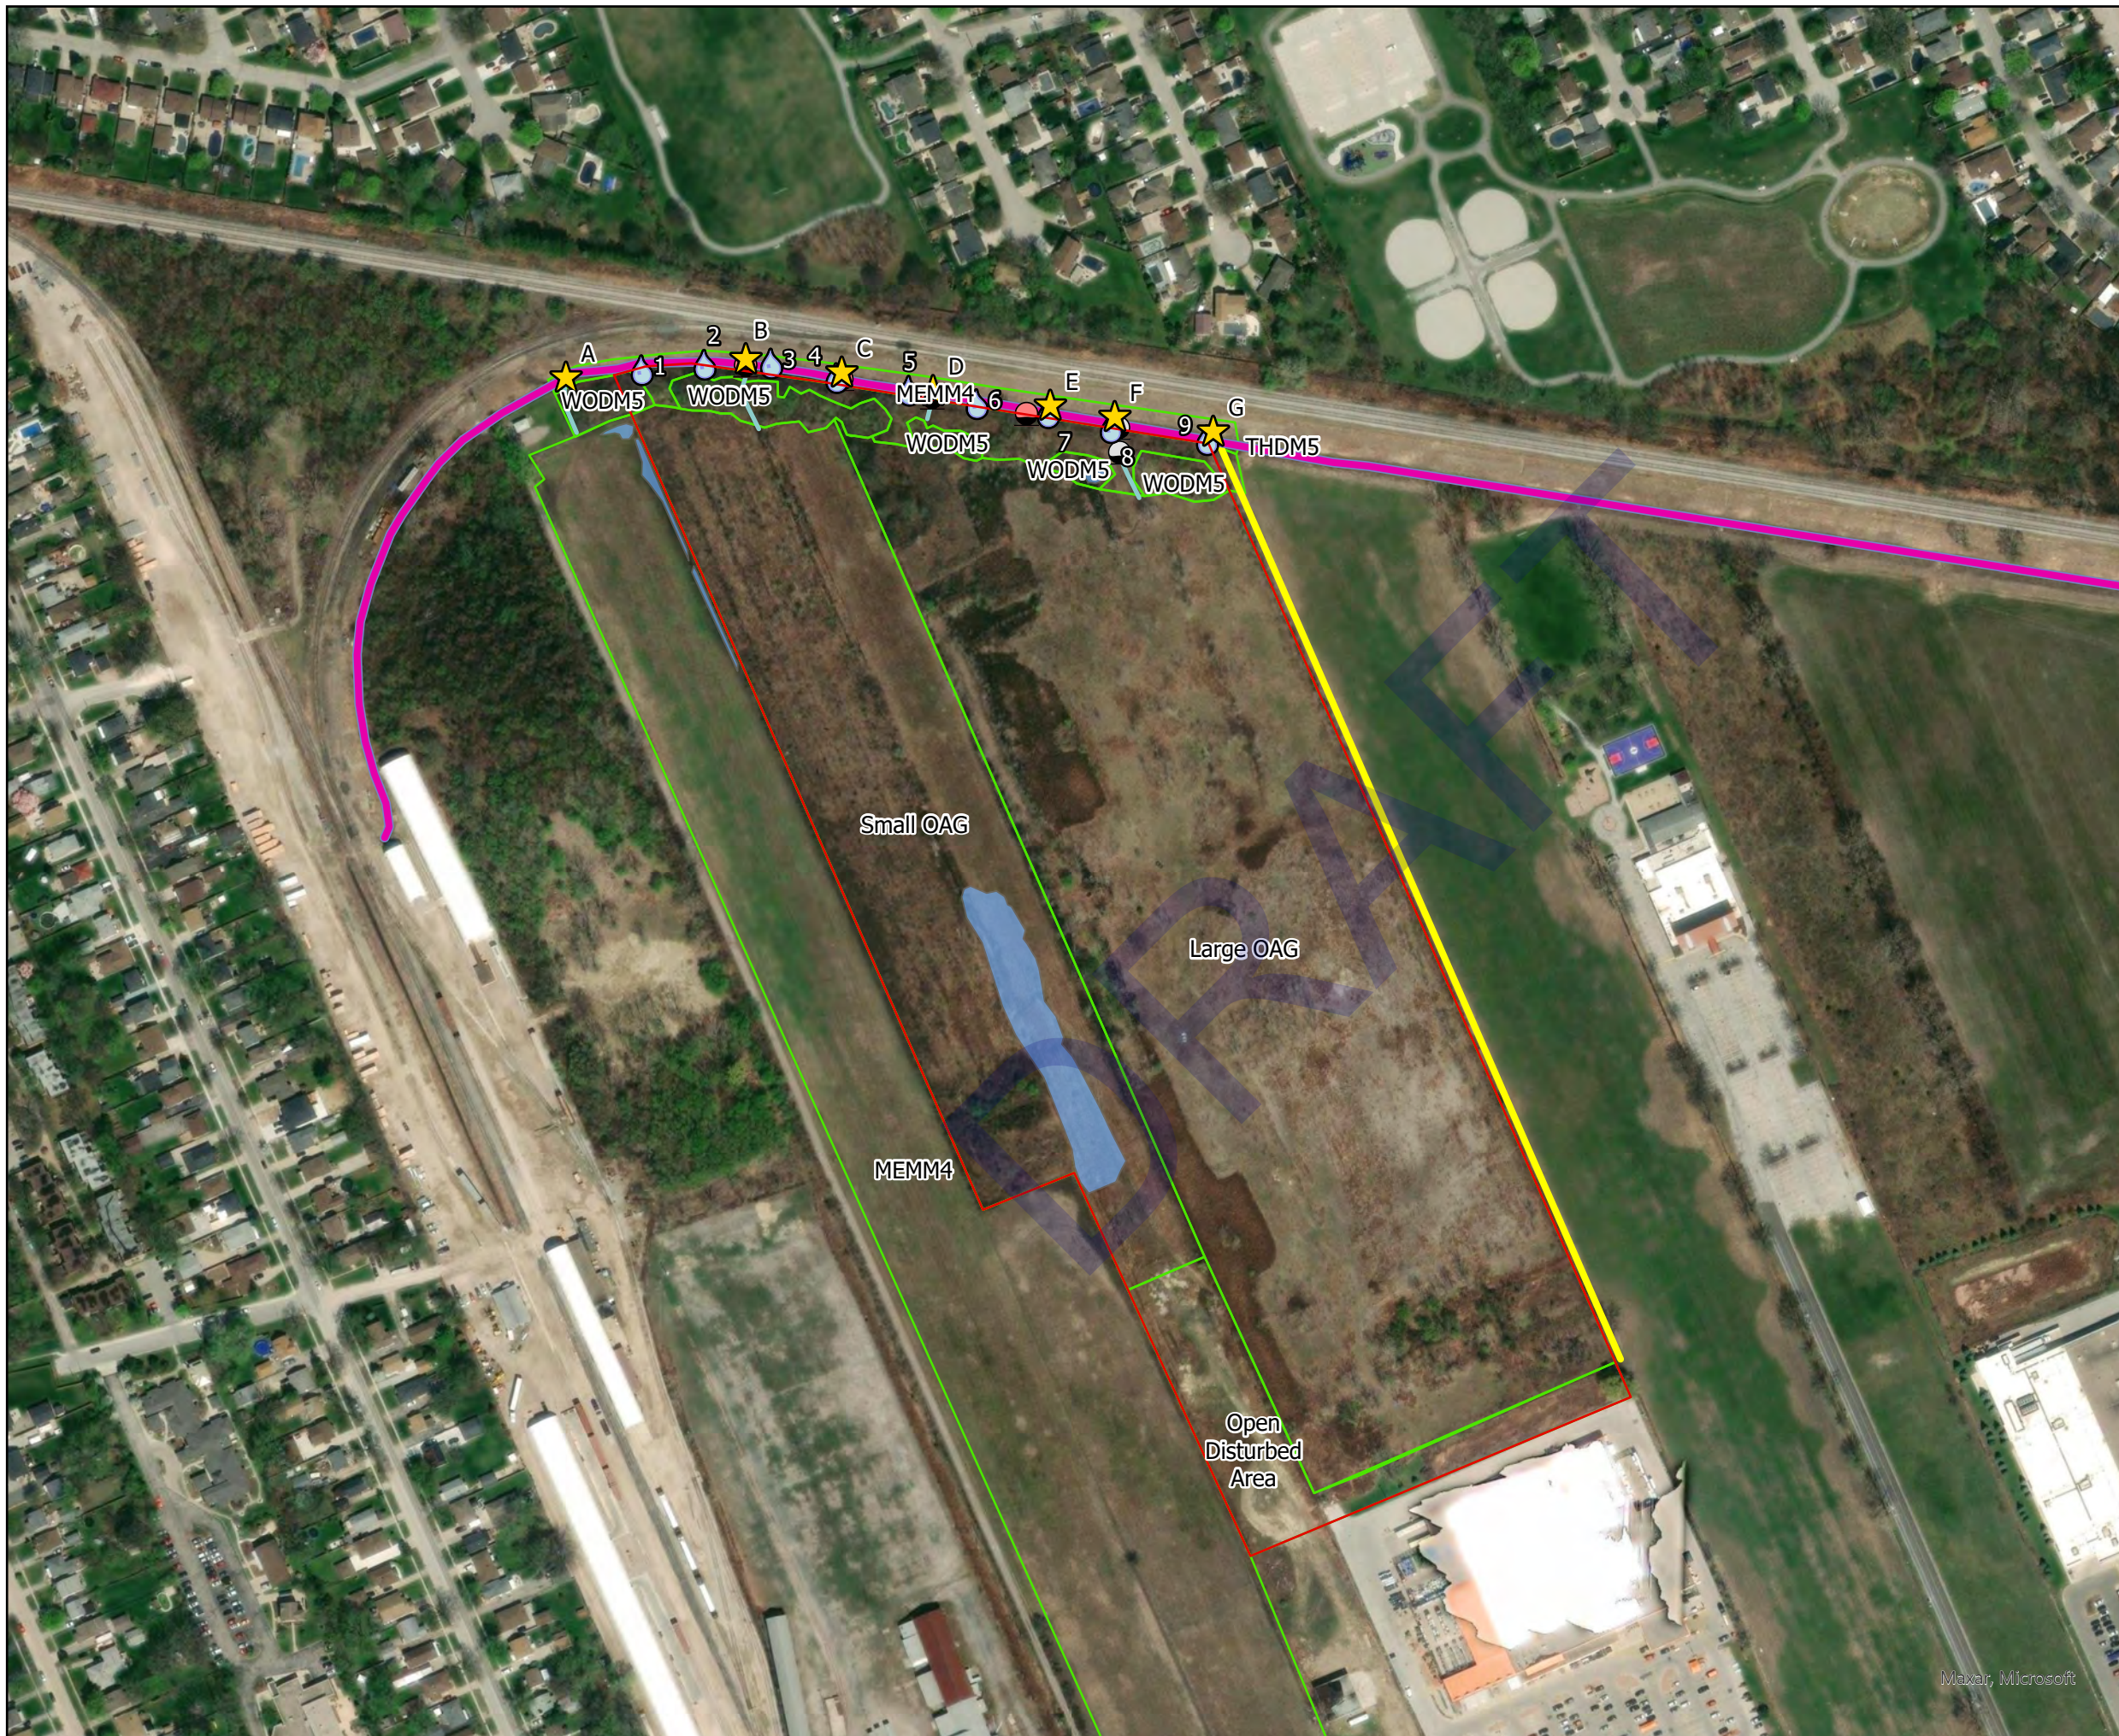
# Headwater Drainage Feature Assessment

Drainage Feature Segment	STEP 1	STEP 2	STEP 3	STEP 4	Management Recommendation
	Hydrology	Riparian	Fish Habitat	Terrestrial Habitat	
Reach 1 (Hawkins Drain)	Important Functions	Important Functions	Valued Functions	Contributing Functions	Protection
Reach 2 (Agricultural Ditch)	Contributing Functions	Limited Functions	Contributing Functions	Limited Functions	Mitigation

Reach 1 (Hawkins Drain) has important functions for hydrology and riparian habitat. The water is likely present throughout most of the year whether it be flowing or standing surface water. Additionally, the southern bank between 1.5 – 10m is dominated by thicket/scrubland communities. Reach 1 contains a minimum of valued habitat for fish, providing seasonal areas for feeding, cover, refuge and migration. It contains a minimum of contributing functions for terrestrial habitat as it supports a movement corridor that connects upstream and downstream features. As such, the management recommendation for Reach 1 is Protection.
