# Environmental Evaluation Report

0 Catherine Street, Windsor

Rock Developments East Windsor Inc.

January 10, 2025

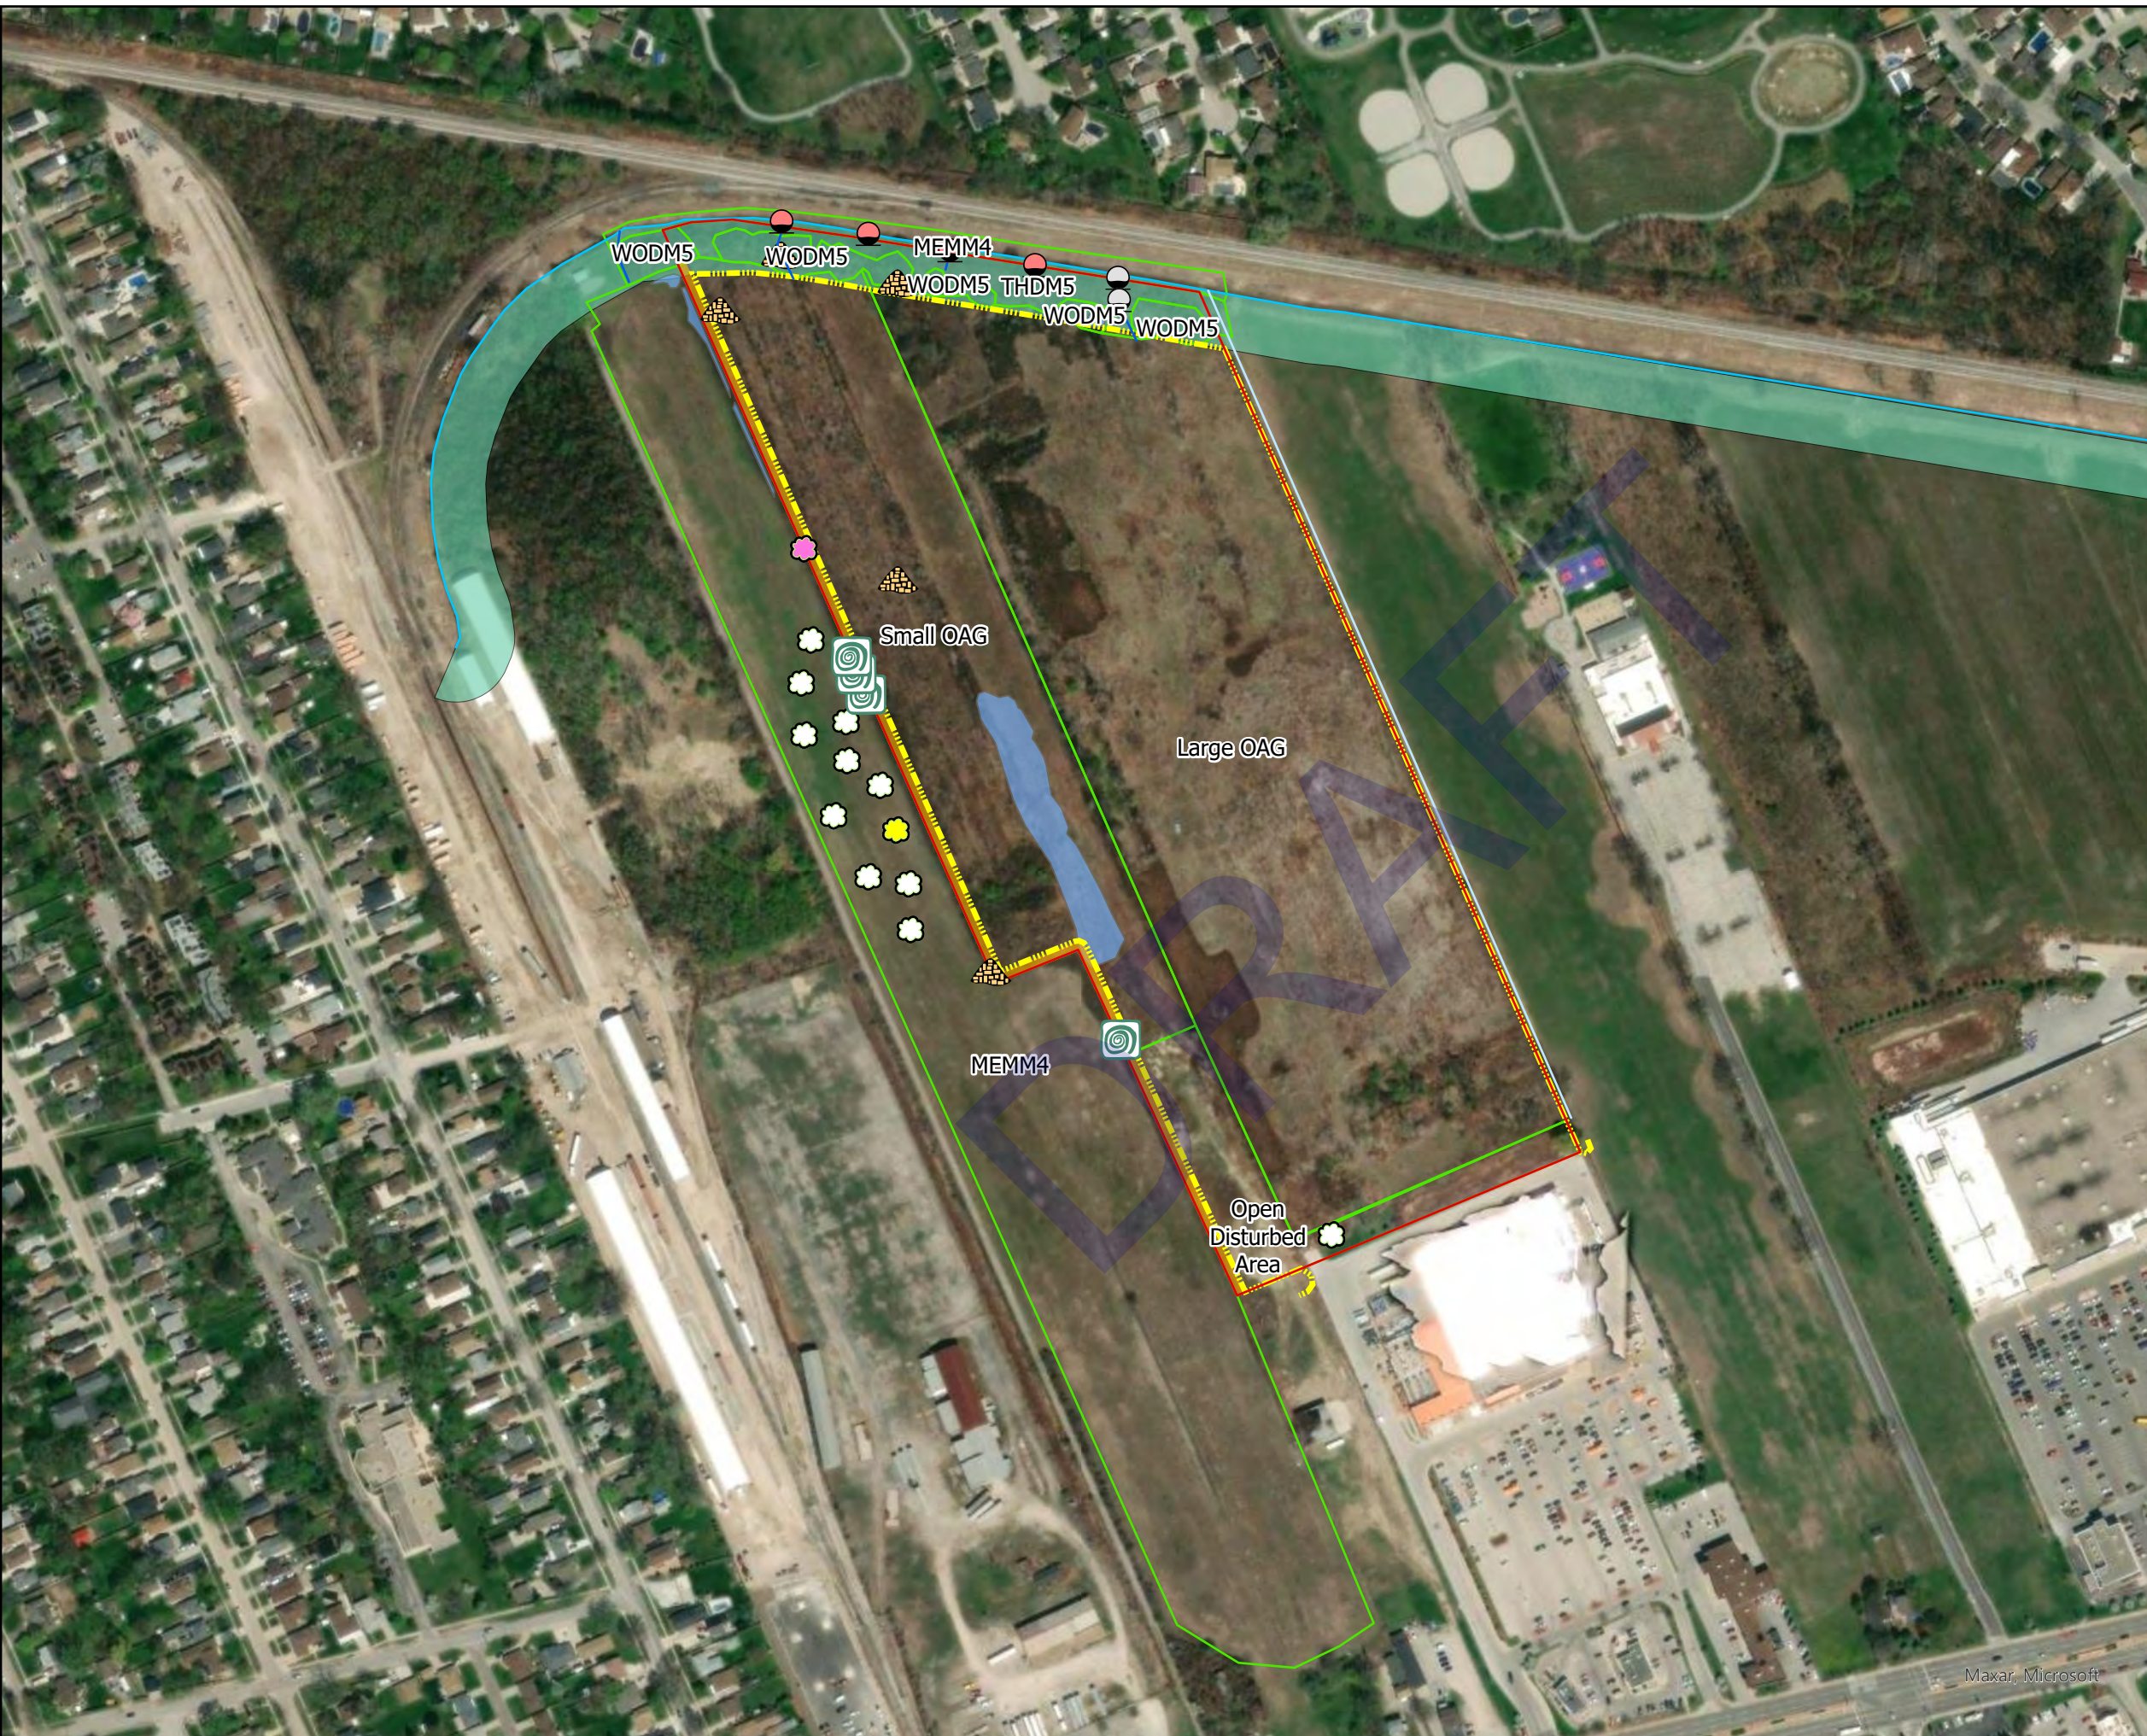
Figure No.: 8  
 Project No.: IES24-211  
 Scale: 1:15,000  
 Date: January 9, 2025  
 Creator: Nicole Wajmer

- Legal Parcel
  - ELC
  - Hawkins Drain (Class F)
  - Fish Habitat Bufer (30m)
  - Agricultural Drainage Ditch
  - Headwater Drainage Feature (HDF)
  - Pooling/Standing Water
  - Brushpile, Rock Pile or Uprooted Tree
  - Tall Boneset (*Eupatorium altissimum*) - S1
  - Stiff Goldenrod (*Solidago rigida*) - S3
  - Missouri Ironweed (*Vernonia missurica*) - S3
  - Chimneystack Crayfish (*Fallicambarus fodiens*) Burrow - S3
  - Chimney Crayfish Burrow Buffer (5m)
  - Snake Exclusion Fencing
- ### CSP Culverts
- Buried (Potential Snake Hibernaculum)
  - Functioning
