Species at Risk Impact Assessment

0 Catherine Street, Windsor

January 10, 2025

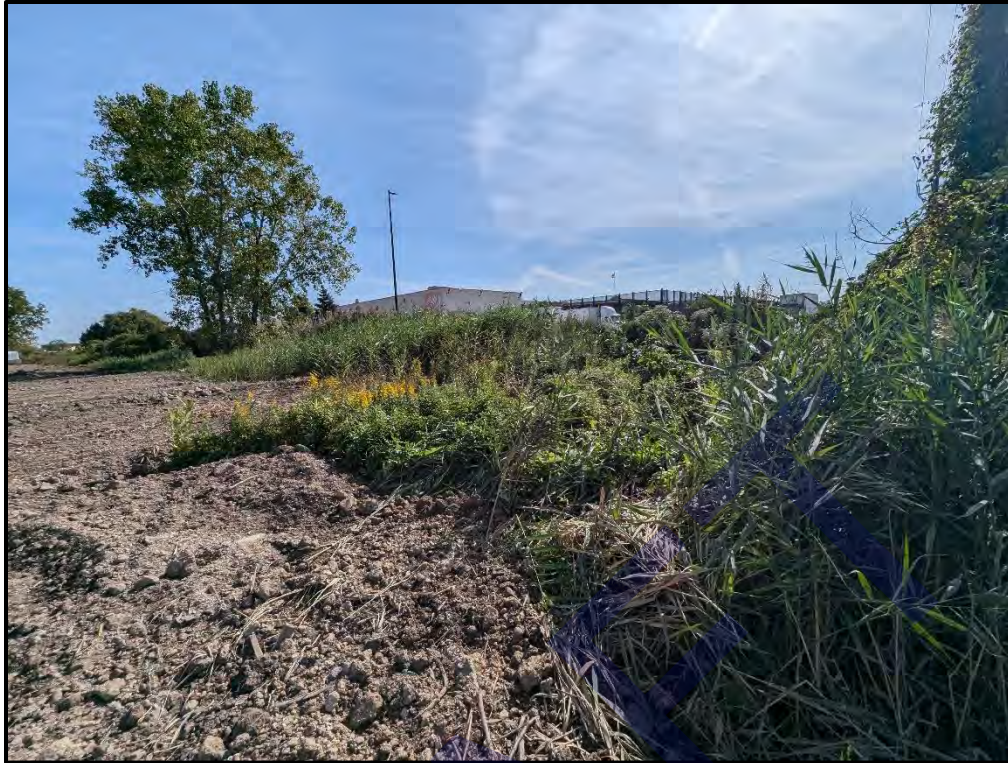
Photo 1: Open Disturbed Area, looking southeast.

The Open Disturbed Area occurs along the southern and part of the western property boundaries. European Reed (*Phragmites australis ssp. australis*) has established along the edges and fencerows in varying densities, from mature dense stands to sparse, linear formations. This area has been colonized by a mix of common, non-native invasive species, which are most concentrated along margins inaccessible to equipment and spread more sparsely toward the north. Evidence of recent grading and skid tracks were also observed in this area. **Photo 1** shows an example of this anthropogenic area during field investigations.

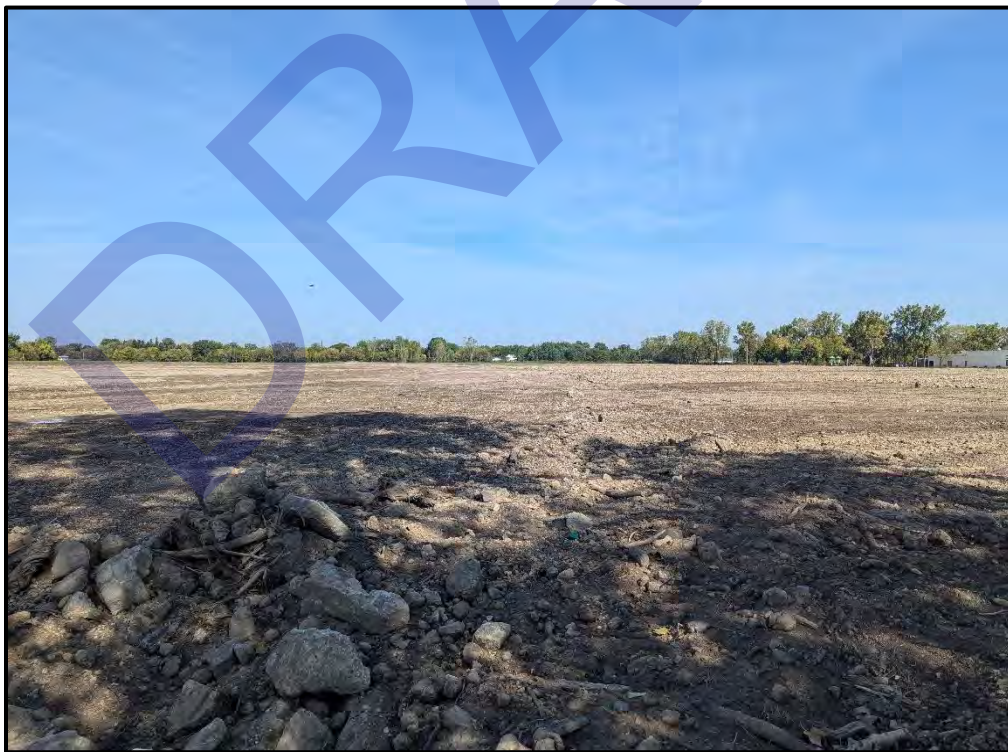
Photo 2: Large OAG, looking north.

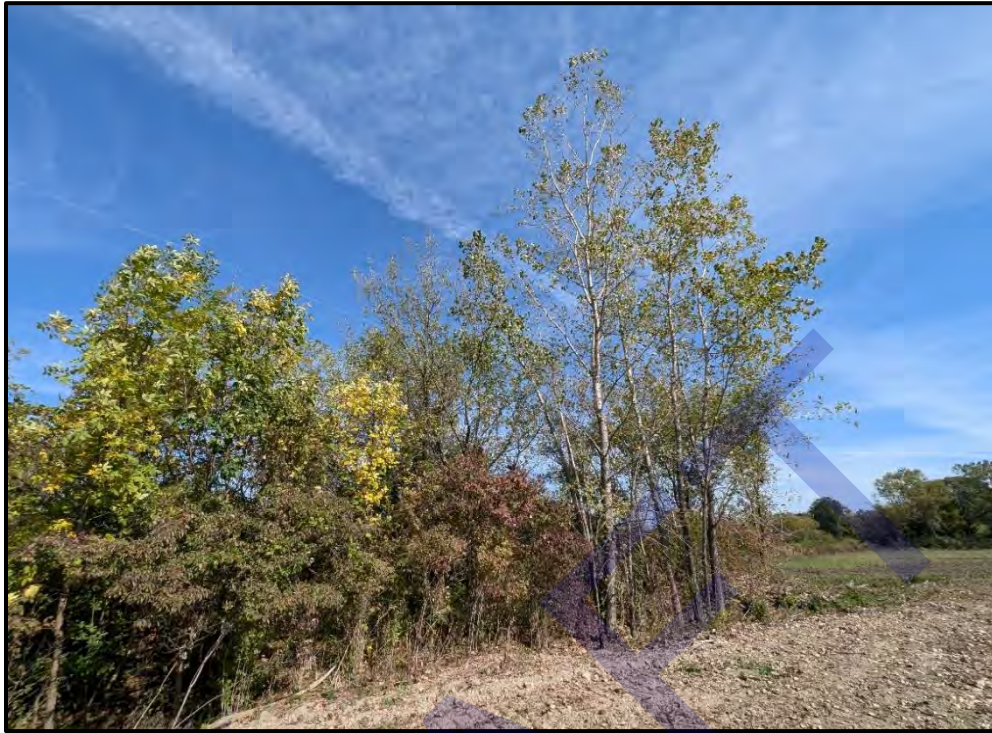
Photo 3: Fresh - Moist Deciduous Woodland Ecosite (WODM5), looking northeast.

The Fresh - Moist Deciduous Woodland Ecosite (WODM5) extends along the northern property boundary and is distributed across several small polygons. These polygons are predominantly composed of young trees interspersed with occasional canopy veterans. The WODM5 exhibits a semi-closed canopy observing 35% < tree cover < 60% with a cultural legacy. One WODM5 polygon, on the eastern property boundary contains a prominent standing pool of water, bordered by Eastern Cottonwood (*Populus deltoides*). Several central polygons exhibit vertical cuts along their southern edges, with exposed tree roots visible. These cuts measure approximately 1 to 1.5 meters in height. The remaining polygons exhibit a heterogeneous composition of tree species lacking typical associations. The canopy is primarily dominated by Manitoba Maple (*Acer negundo*), with occasional to rare occurrences of Eastern Cottonwood, Silver Maple (*Acer saccharinum*), and Bur Oak (*Quercus macrocarpa*). The tall shrub layer (2–10 m) is characterized by regenerating young trees, predominantly Green Ash (*Fraxinus pennsylvanica*), with occasional to rare occurrences of White Elm (*Ulmus americana*), Hackberry (*Celtis occidentalis*), and Common Apple (*Malus pumila*). A total of 26 species were observed in this community, 17 (65%) native species exist, while nine (35%) are classified as non-native. The mean Coefficient of Wetness (CW) for this community is 1.08. This number indicates that there is a slight predominance of upland species present. The mean Coefficient of Conservatism (CC) for this community is 2.08. This number indicates the floristic quality is not sufficient to identify a community of remnant natural quality. The Floristic Quality Index (FQI) for this community is 10.59 indicating low significance from a natural quality perspective. Disturbance history includes light browse, gaps in the canopy, flooding, tracks and trails, cutting, dumping and invasive species. **Photo 3** shows an example of site conditions as they were during field investigations.

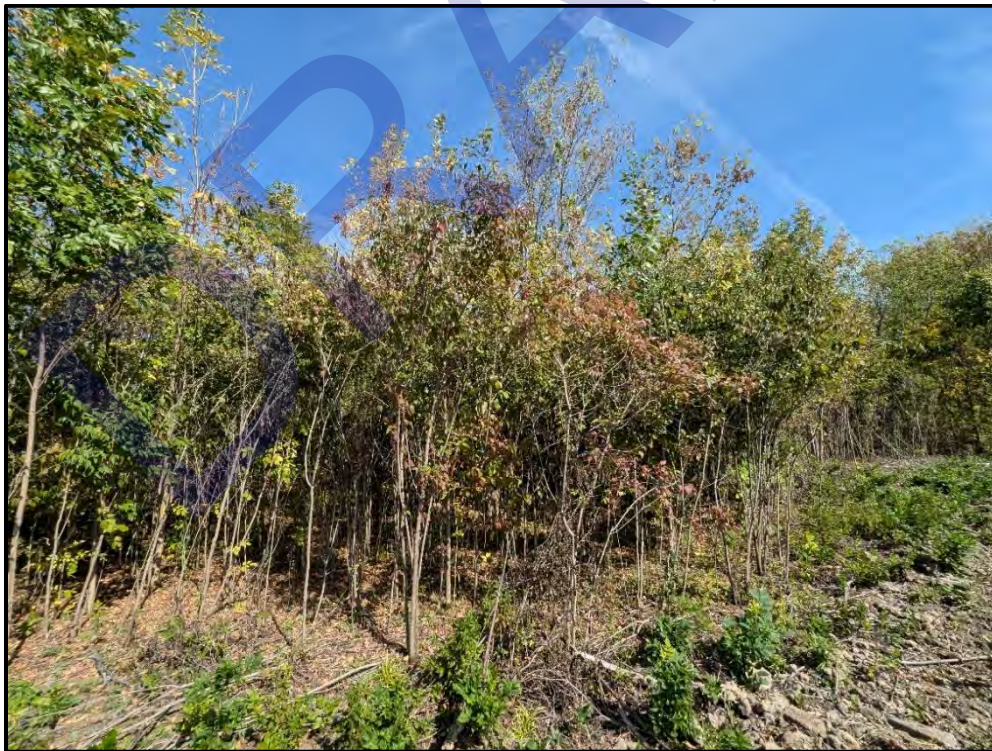
Photo 4: Fresh - Moist Deciduous Thicket Ecosite (THDM5), looking north.

The Fresh - Moist Deciduous Thicket Ecosite (THDM5) surrounds the WODM5 polygons and extends down to the southern edge of the Hawkins Drain. The THDM5 is dominated by a mix of common native and exotic shrub species with shrub cover > 25%; tree cover < 25%; varying from scattered and patchy to continuous. A total of 41 species were observed in this community, 22 (54%) native species exist, while 19 (46%) are classified as non-native. The mean CW for this community is 0.73. This number indicates that there is a slight predominance of upland species present. This number is slightly lower than expected due to the presence of several facultative and obligate wetland species occurring at the interface of this community and the Hawkins Drain (some within the drain bed itself). The mean CC for this community is 1.22. This number indicates the floristic quality is not sufficient to identify a community of remnant natural quality. The FQI for this community is 7.81 indicating low significance from a natural quality perspective. Disturbance history includes light browse, anthropogenic disturbance (CSP Culverts), steep banks and invasive species. **Photo 4** shows an example of site conditions as they were during field investigations.

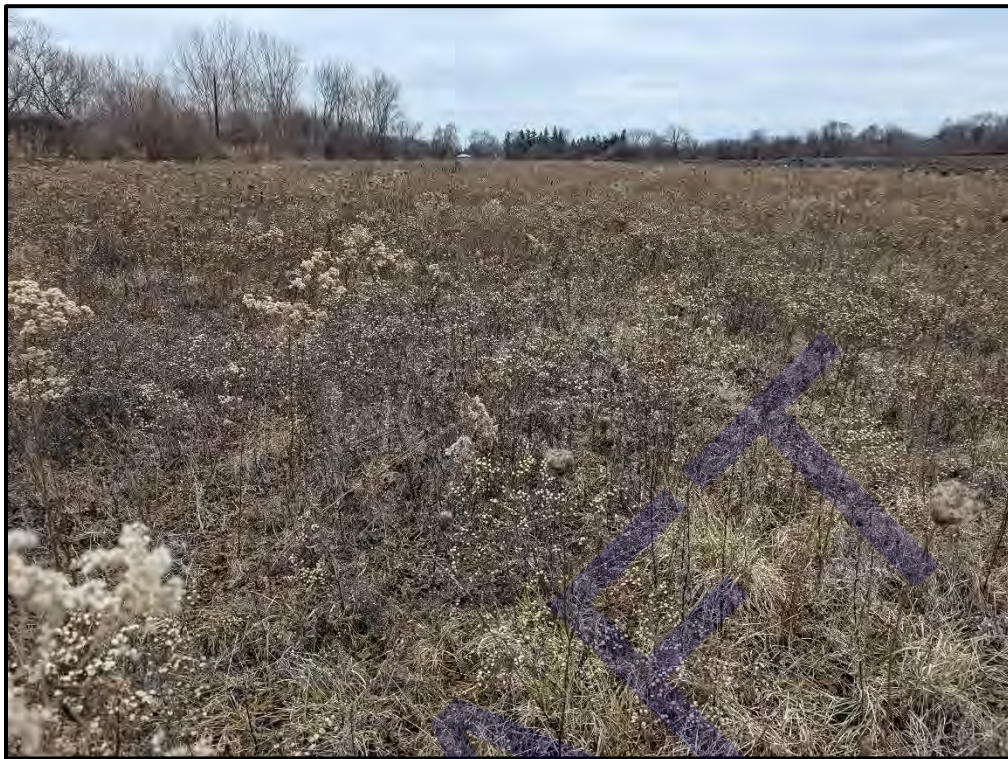
Photo 5: Fresh - Moist Mixed Meadow Ecosite (MEMM4), looking north.

The Fresh - Moist Mixed Meadow Ecosite (MEMM4) is located on the adjacent lands to the west and along the northern bank of the Hawkins Drain. The MEMM4 is an open herbaceous community with tree and shrub cover < 25%, ranging from scattered and patchy to continuous meadow. The MEMM4 ecosite located on the adjacent lands is a higher-quality mixed meadow characterized by greater native species diversity and the presence of several provincially significant plants. Portions of this MEMM4 polygon exhibit areas of standing, pooled water, with facultative wetland species present; however, their coverage does not exceed 50%. The MEMM4 located along the northern bank of the drain is dominated by invasive species and demonstrates relatively low species diversity in comparison. A total of 48 species were observed in this community, 23 (48%) native species exist, while 25 (52%) are classified as non-native. The mean CW for this community is 1.33. This number indicates that there is a slight predominance of upland species present. The mean CC for this community is 1.04. This number indicates the floristic quality is not sufficient to identify a community of remnant natural quality. The FQI for this community is 10.43 indicating low significance from a natural quality perspective. Disturbance history includes light browse, flooding and invasive species. **Photo 5** shows an example of site conditions as they were during field investigations.

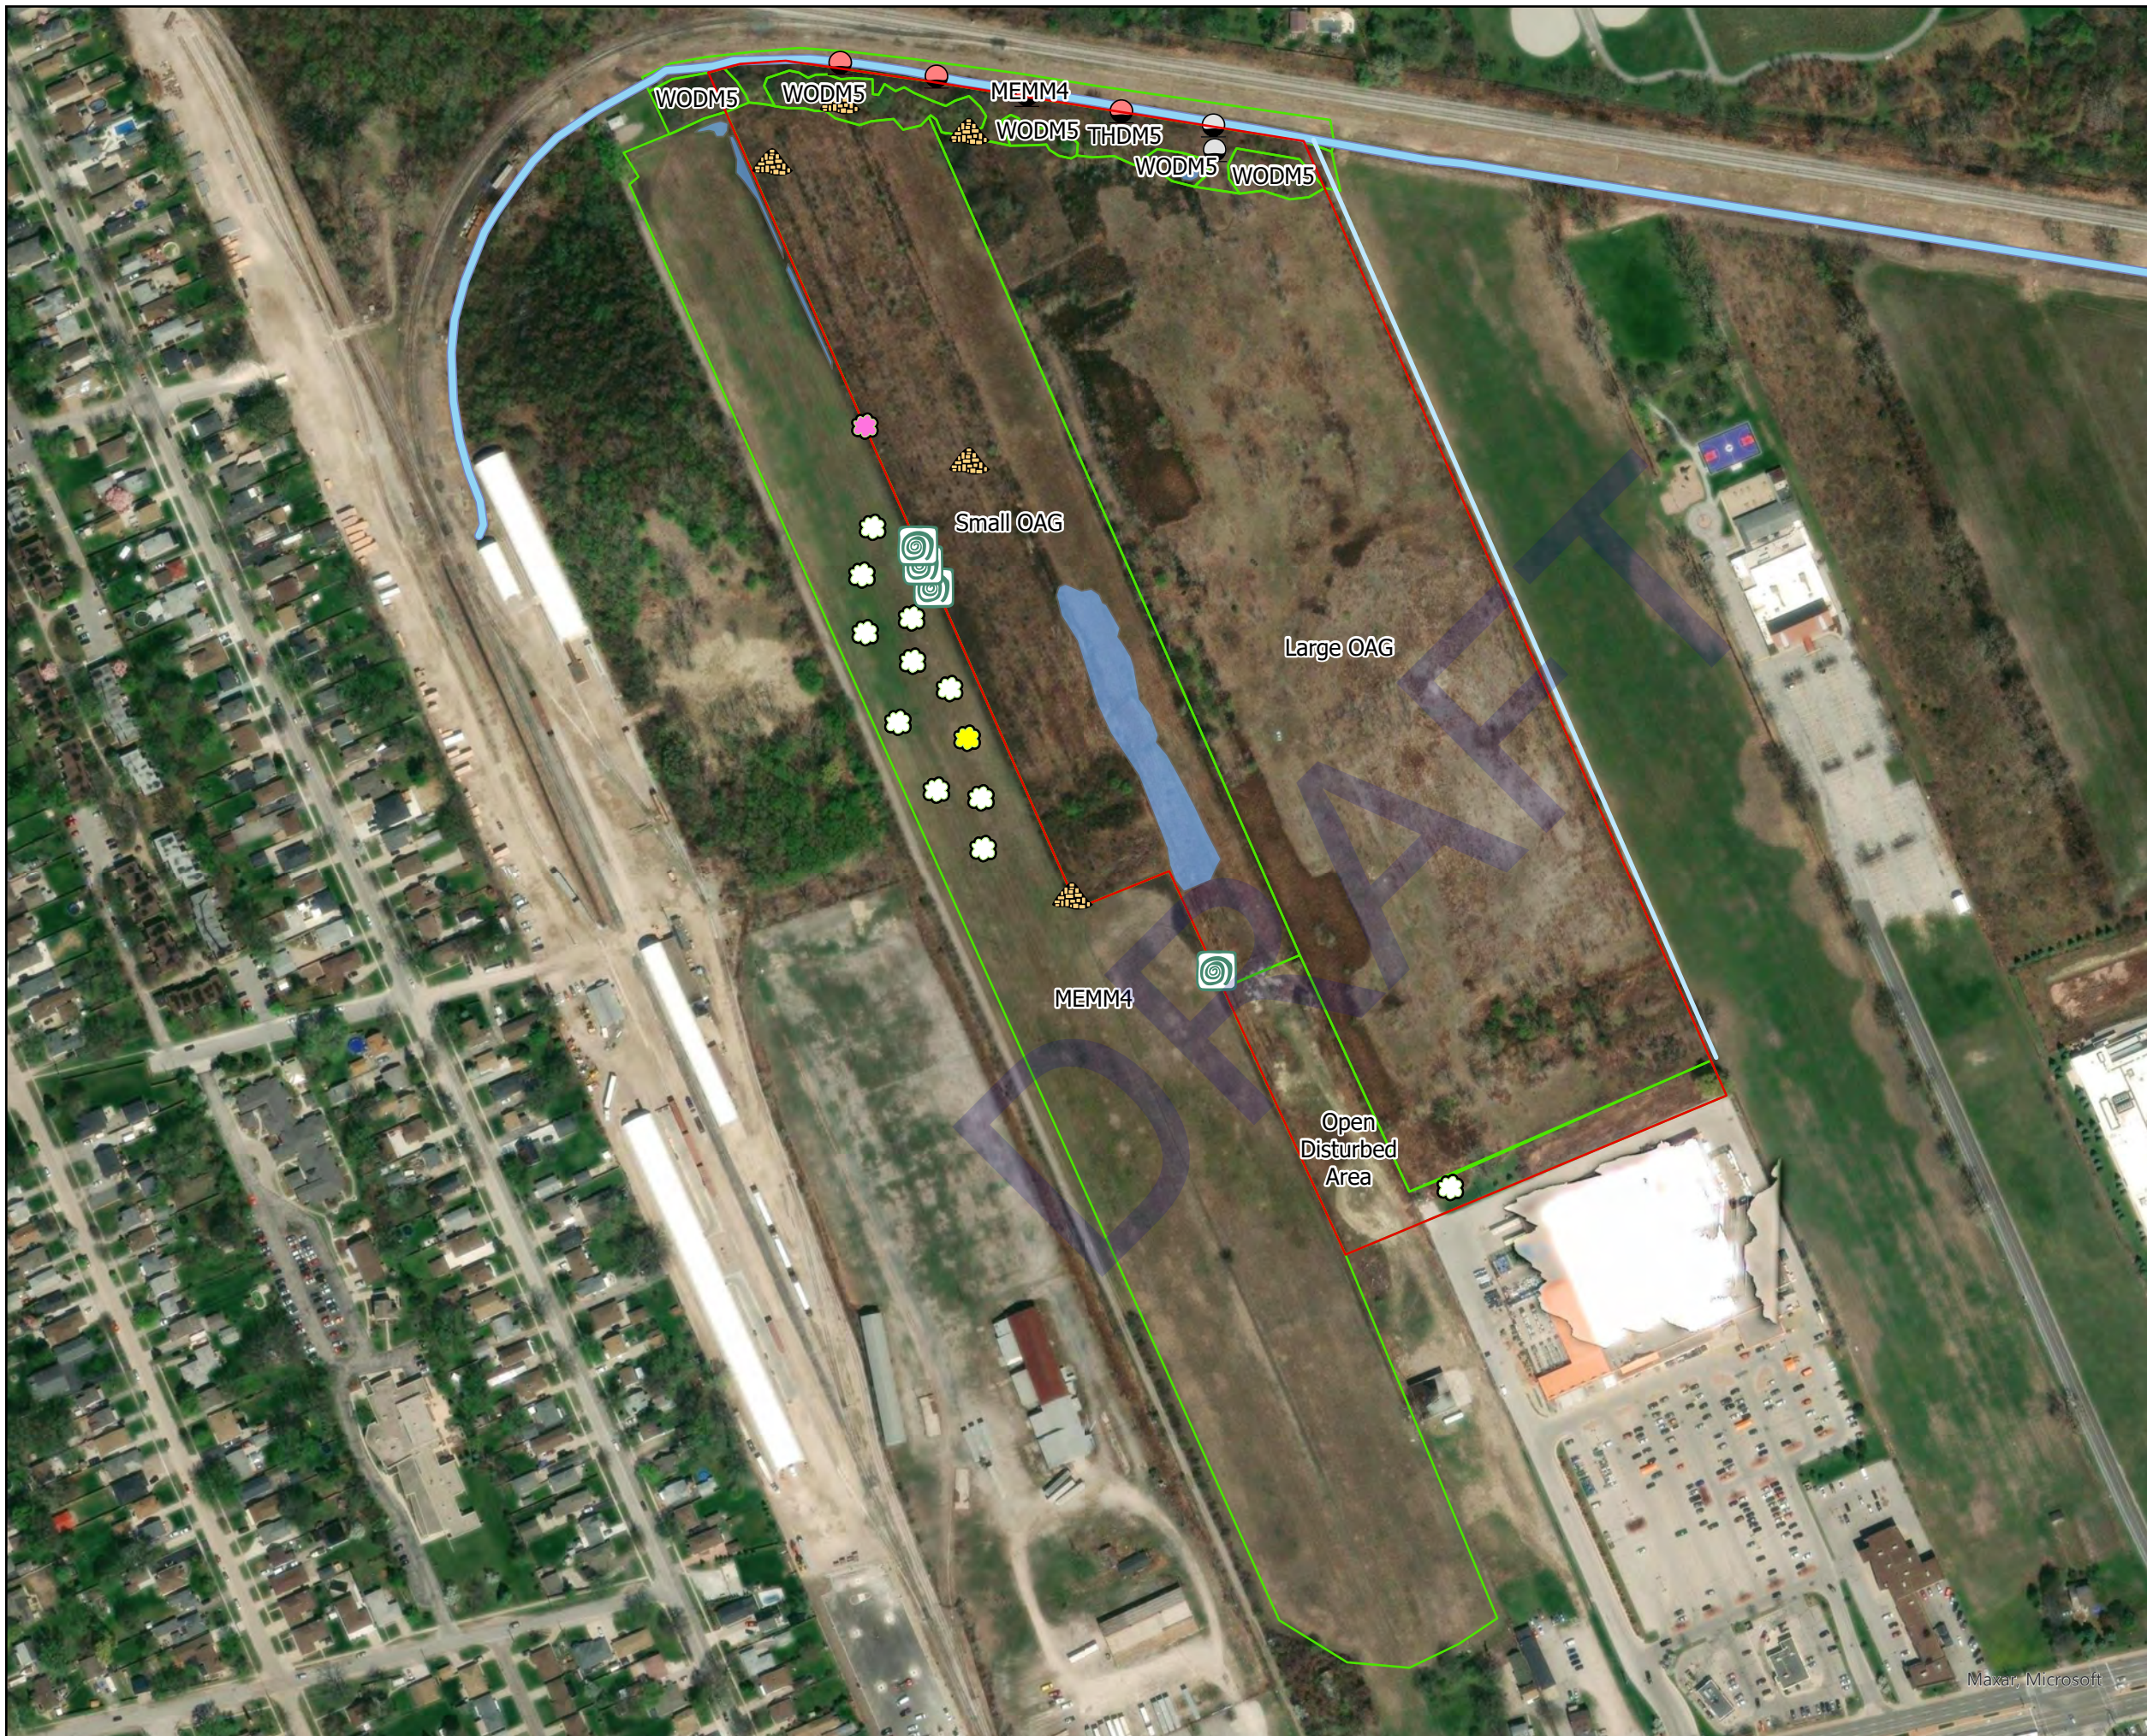
Existing Conditions

- Legal Parcel
- Tall Boneset (*Eupatorium altissimum*) - S1
- Missouri Ironweed (*Vernonia missurica*) - S3
- Stiff Goldenrod (*Solidago rigida*) - S3
- Chimneystack Crayfish (*Fallicambarus fodiens*) Burrow - S3
- Brushpile, Rock Pile or Uprooted Tree
- Hawkins Drain (Class F)
- Agricultural Drainage Ditch
- Pooling/Standng Water
- CSP Culverts**
- Buried (Potential Snake Hibernaculum)
- Fuctioning
- ELC**
- WODM5: Fresh - Moist Deciduous Woodland Ecosite
- THDM5: Fresh - Moist Deciduous Thicket Ecosite
- MEMM4: Fresh - Moist Mixed Meadow Ecosite
- Large OAG: Open Agriculture
- Small OAG: Open Agriculture
- Open Disturbed Area

Chimney (or digger) Crayfish (*Fallicambarus fodiens*) holes were observed along the western property border adjacent to the meadow (**Table 9; Figure 5**). Chimney crayfish construct burrows which are marked by a chimney of mud pellets left over from construction. Chimney crayfish have a provincial s-rank of Vulnerable (S3).

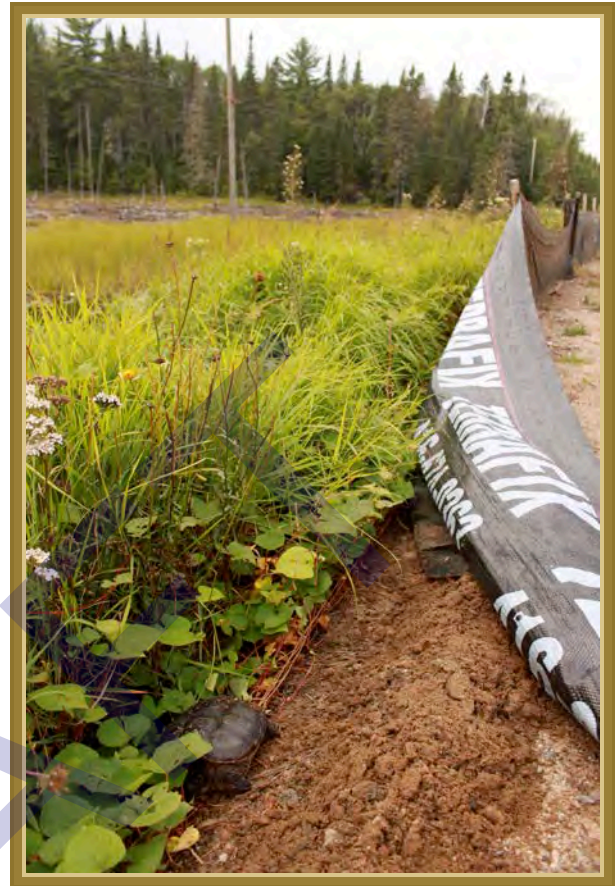
Plate 1. Light-duty geotextile fencing with pre-attached wooden stakes used to exclude turtles from a road as seen on a regular maintenance check (photo credit: Brad Steinberg).

Generally, light-duty geotextile fences are not effective if they exceed 1 metre in height unless purposely manufactured for greater height (e.g. stakes placed at closer intervals or cross braces). If greater height is required consider using heavy duty geotextile, hardware cloth or other fencing materials.

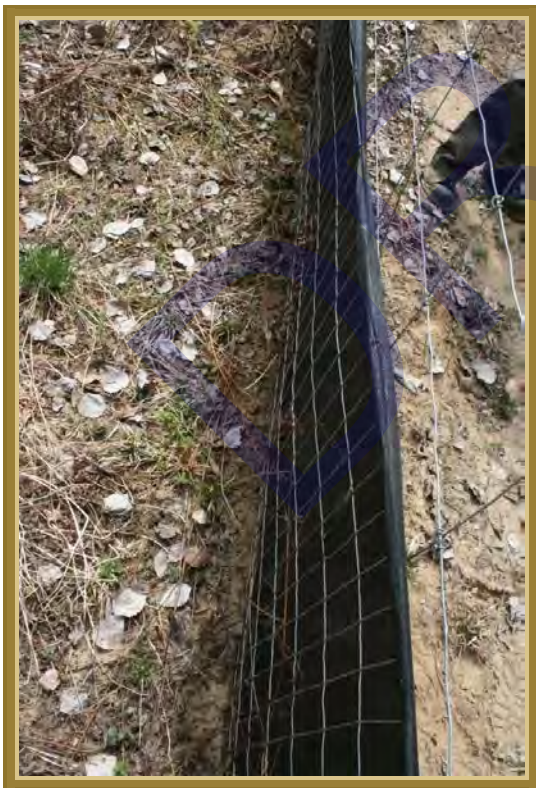
Plate 2. Example of a heavy-duty geotextile fencing used to exclude snake species (photo credit: Jeremy Rouse).

- The wire fence should be installed on the activity side to prevent animals from leveraging and climbing into the exclusion area while allowing the animal to escape if they find themselves on the wrong side (Figure 2).
- Geotextile fences across streams, ditches or waterways should have case-specific modifications.
- Contact your local MNR staff or experienced exclusion fencing contractor for advice.
- See light-duty geotextile section above and general best practices below for additional details.

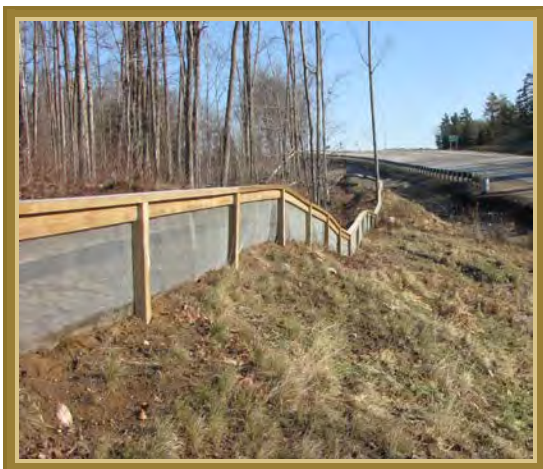
Plate 3. Example of a galvanized mesh fencing used for the long-term exclusion of snakes and turtles from the adjacent highway (photo credit: Megan Bonenfant).

- Secure the fence on posts placed a recommended 2.5 m apart with the stakes on the activity side (Figure 2).
- Pull the mesh taut and staple or secure with screws and a metal stripping to prevent the mesh from being ripped when pressure is applied.
- Installing a top rail or folding the mesh over a taut smooth wire reduces tearing (Plates 3 and 4).
- An outward facing lip installed on the species side ensures that snakes and amphibians are unable to climb or jump over the fence (Figure 2; Plate 4)
- Tears can be mended with 18-gauge galvanized wire.
- See general best practices section below for additional details.

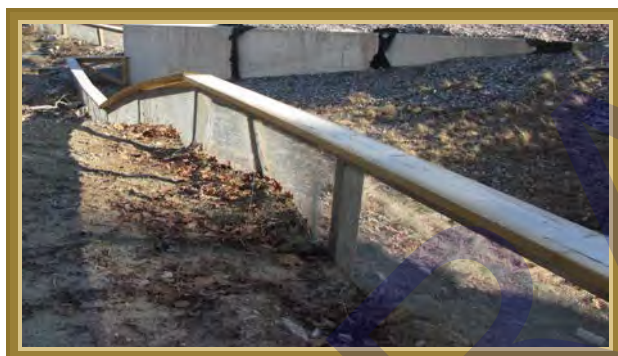
Plate 4. Long-term to permanent exclusion fencing using galvanized mesh with over-hanging lip to prevent animals from climbing or jumping over (photo credit: Megan Bonenfant).

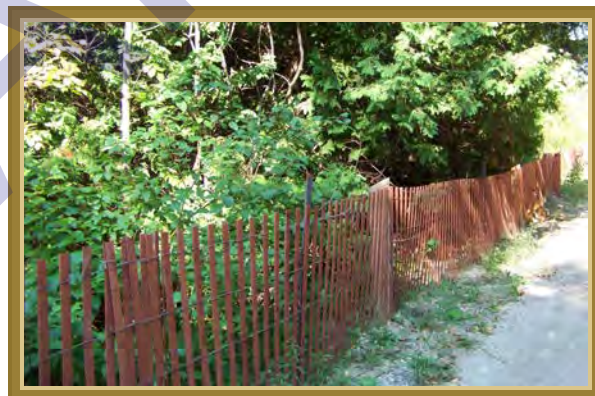
Plate 5. Example of a wood lath snow fencing used to exclude turtles (photo credit: Karine Beriault).

- The fencing should be attached to heavy plastic or metal stakes using heavy-duty wire staples or tie-wire.
- The stakes are recommended to be placed at 2 to 3 m intervals and securely driven into the ground 30 cm or more.
- Wood lath snow fencing across streams, ditches or waterways should have case-specific modifications.
- Wood lath snow fencing lends itself well to being combined with other types of material to ensure complete exclusion.
- See general best practices section below for additional details.

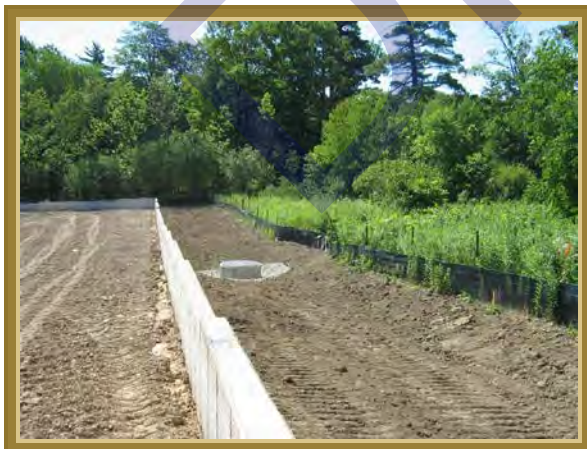
Plate 6. Stand-alone continuous concrete wall used to exclude salamander species installed as pre-cast forms (photo credit: Steven Roorda).

Concrete, metal or vinyl walls can stand alone or be combined with woven wire or chain link fences. They are durable, require minimal maintenance and are effective in excluding target species from high risk areas and guiding them to crossing structures or other desired locations (Plates 6 and 7). This fence type is comprised of a continuous vertical face of concrete, metal or vinyl sheeting with no gaps. Concrete walls can be installed as either pre-cast sections or pour directly in place.

The wall height depends upon the target species, but they are usually between 45 and 60 cm tall and buried 25 cm. Concrete, metal or vinyl exclusion fencing is most appropriate for salamanders, skinks, small snakes, and small turtles. For large turtle species, a chain link fence can be installed directly on top of the concrete wall for complete exclusion.

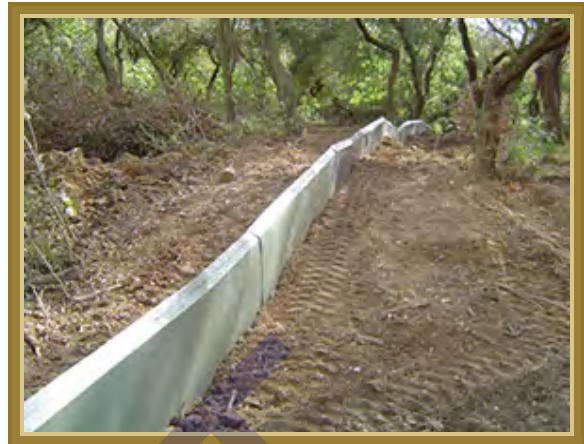
Plate 7. Pre-formed vinyl sheeting fence intended to exclude salamanders for a construction site (photo credit: Herpetosure Ltd.)

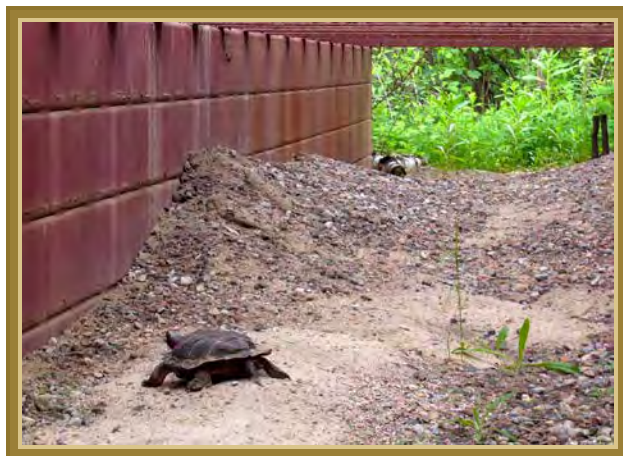
Plate 7. A wood turtle travelling through a dry eco-passage. Ecopassages such as this help to ensure the long-term connectivity of seasonal habitat for this and other reptile and amphibian species (photo credit: Amy Mui).

During the installation of fencing with an eco-passage, it is important that the fencing sits flush with the passage to ensure that

there are no gaps where animals can squeeze through.

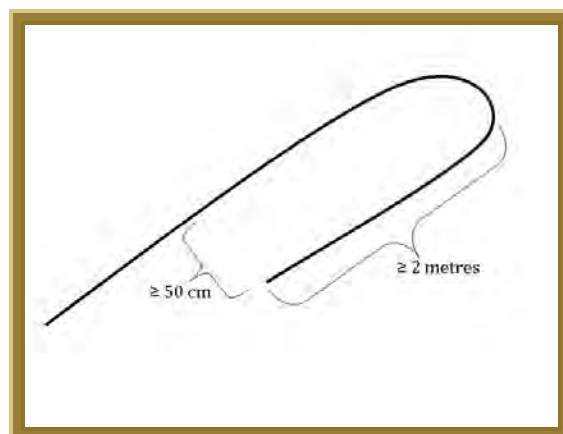
Figure 1. Diagram of the ends of the fence designed to curve inward in order to direct animals away from the area of exclusion.

- Install fences with a turn-around at the ends furthest from the wetland habitat and at any access areas to assist in redirecting animals away from any fence openings (Figure 1).

- Curving the ends of the fencing inward (i.e. away from the road or construction site) may help to reduce access to these locations. The ends may also be tied off to natural features on the landscape such as trees or rock cuts.

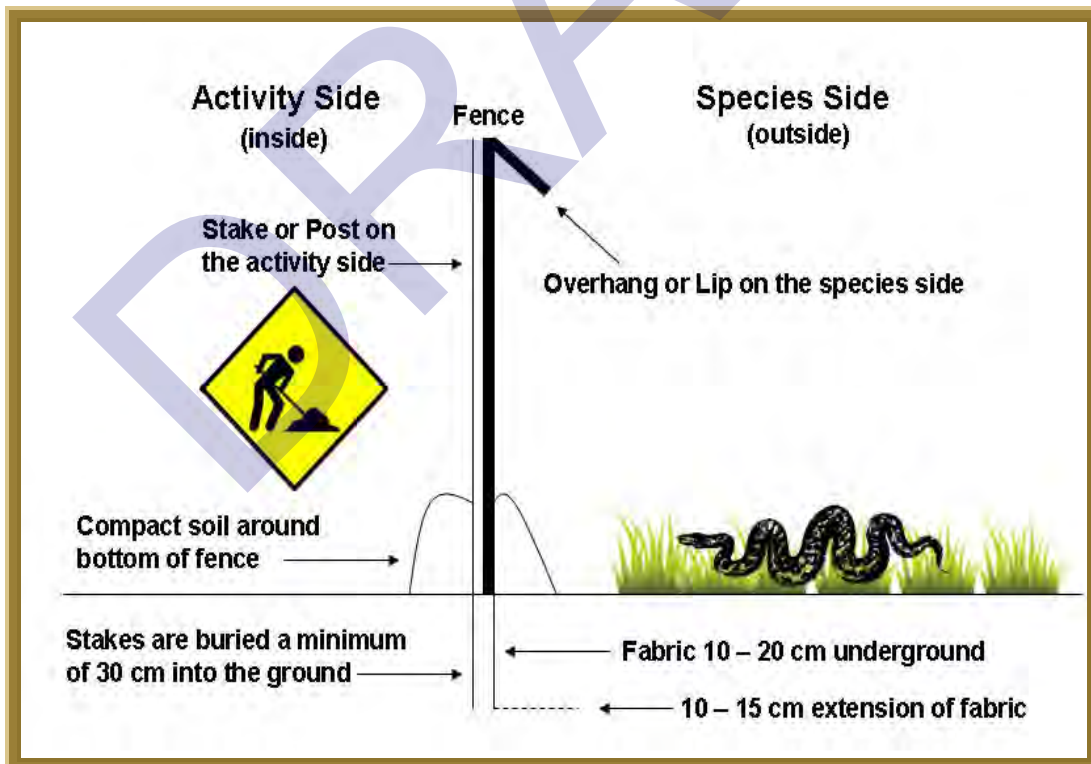
Figure 1. A side view of a basic exclusion fence including an overhang or flexible lip to deter animals from climbing or jumping over the fence. Placement of the stake on the Activity Side or on the inside of excluded area is also illustrated. This is particularly important for snake species which may use the stakes to maneuver over the fence.
