REPORT NO. 169 of the ENVIRONMENT, TRANSPORTATION & PUBLIC SAFETY STANDING COMMITTEE

<u>Clerk's Note</u>: The administrative report authored by the Policy Analyst dated November 4, 2013 entitled "Intersection Control Reviews — West of Mount Royal Drive, Villa Maria Boulevard north to Mitchell Crescent" is <u>attached</u> as background information.

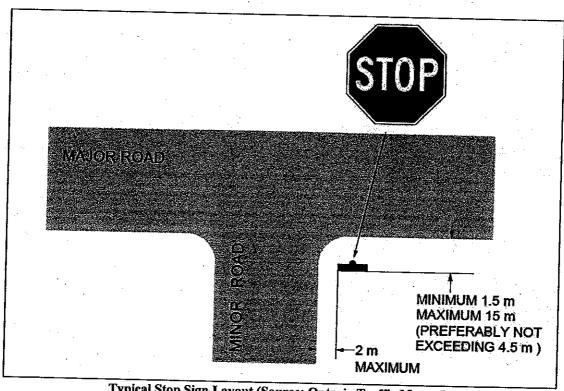
Since all nine subject intersections are "T" intersections with low traffic volumes, the minor approach (i.e. the approach where the stop control should be placed) would be the non-through street as illustrated in the following figure:

Typical Stop Sign Layout (Source: Ontario Traffic Manual)

Since the recommended sight triangle for uncontrolled operation or yield control is not provided, Administration recommends that stop signs be installed on the minor legs of all uncontrolled intersections in the study area. Additionally, in urban areas, drivers are accustomed to positive forms of traffic control such as yield and/or stop signs as is prevalent within the City of Windsor.
