PROPOSED
MULTI UNIT
RESIDENTIAL
BUILDING
1140 GOYEAU AVE.
WINDSOR, ONTARIO

EXISTING TREE
INVENTORY &
PRESERVATION
PLAN

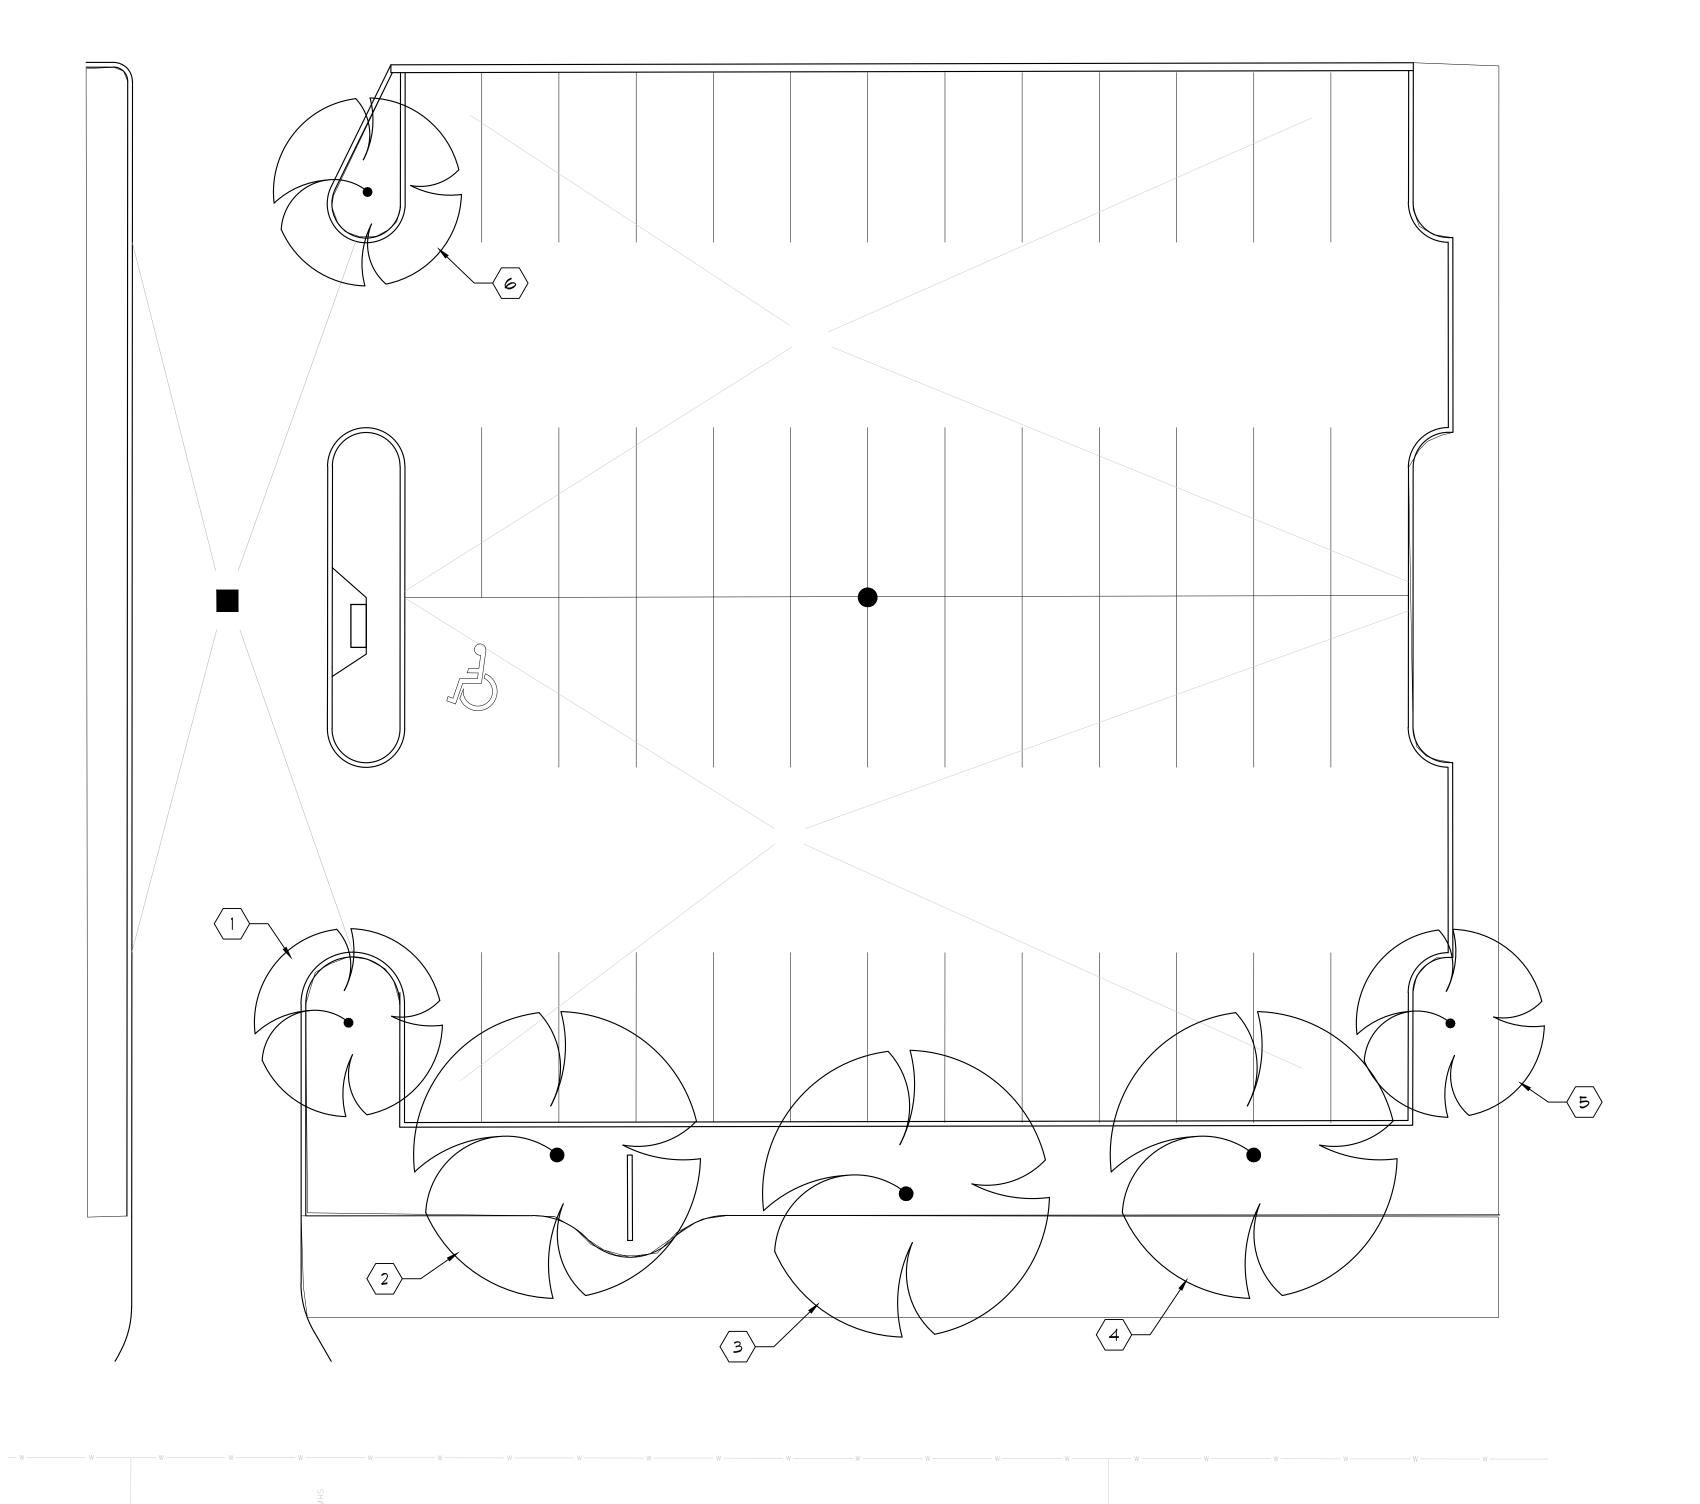
Existing Tree List and Condition					
TREE NO.	BOTANICAL NAME	COMMON NAME	SIZE (cm- dbh)	CONDITION	REMARKS
1	PYRUS CALLERYANA	CALLERY FL. PEAR	13	FAIR	Remove, Condition
2	ACER RUBRUM	RED MAPLE	10	GOOD	Retain, Trim
3	TILIA AMERICANA	BASSWOOD	20	VERY GOOD	Retain, Trim
4	ACER RUBRUM	RED MAPLE	10	POOR	Remove, Condition
5	PYRUS CALLERYANA	PYRUS CALLERYANA	10	POOR	Remove, Condition
6	PYRUS CALLERYANA	PYRUS CALLERYANA	10	POOR	Remove, Condition

- 1. The location of the existing trees was taken from the original landscape plan.
- 2. The species, size and condition of the existing trees was provided by Gerry Bezaire O.A.L.A., Bezaire Partners
- Care has been taken to obtain all information from reliable sources. All data has been verified insofar as possible. The consultant can neither guarantee nor be responsible for the accuracy of information provided by others.
- A number of the trees in poor condition is a result of the trees supports not being removed and the trees have been girdled.
